Comparison of In-Pavement Versus Non-Invasive Pavement Sensor Technologies

Mike Beyer ITS Engineer, Caltrans D02

June 22nd, 2016

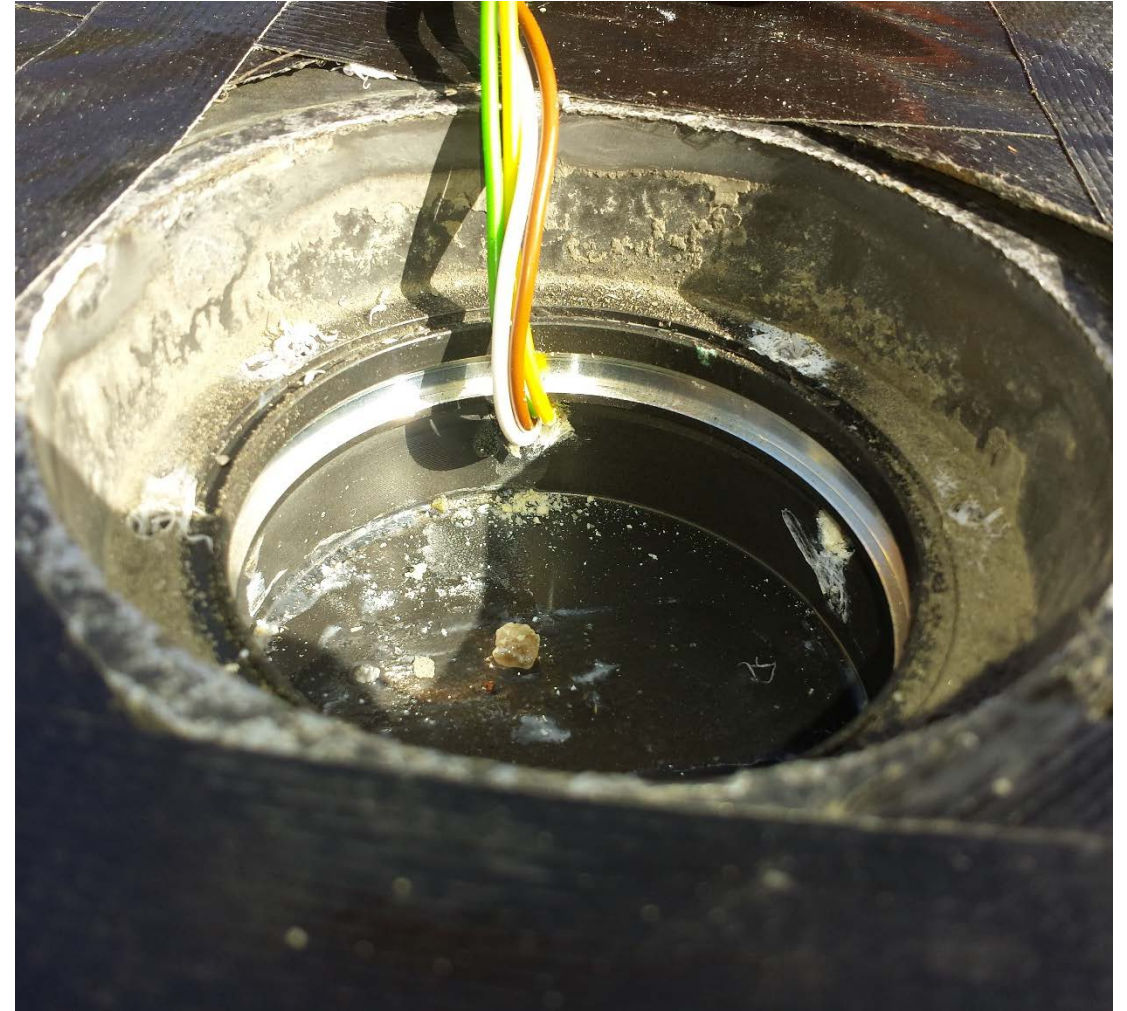
Lufft “Calibratable IPSs”

- ▶ A proposed method of calibrating and replacing IPS has seen various incarnations over the years the latest of which is produced by Lufft and included the IRS 21 and the IRS 31 series of IPS.
- ▶ These are representative of a class of IPS that include a separate housing and electronic insert that can be removed for calibration or replacement. In our district we experienced a failure rate of up to 40% with these IPS for various reasons but mostly water intrusion.
- ▶ Investigation revealed in some cases the rubber O-Ring was undersized for the recesses such that even with proper torqueing of the retaining screws the seal is insufficient.

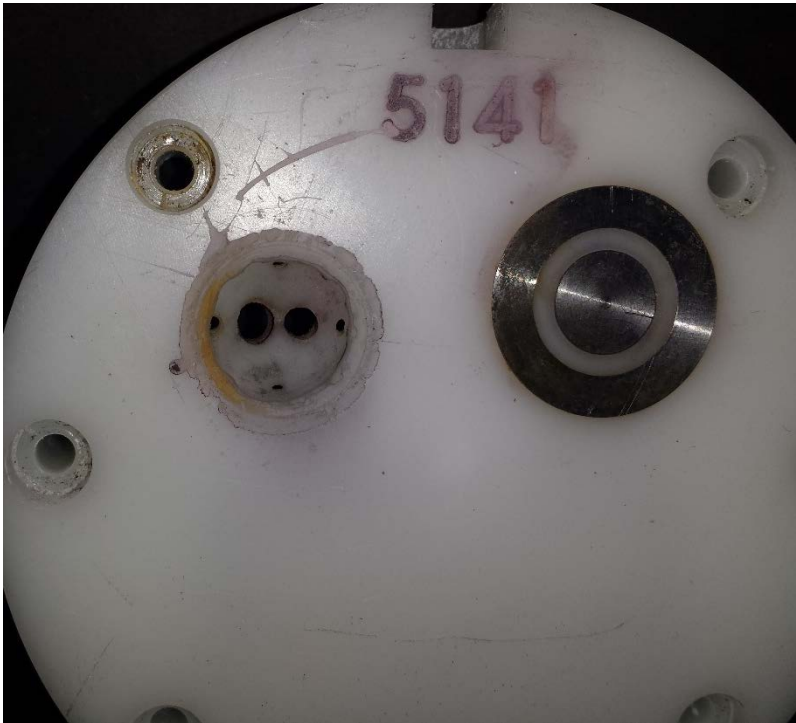
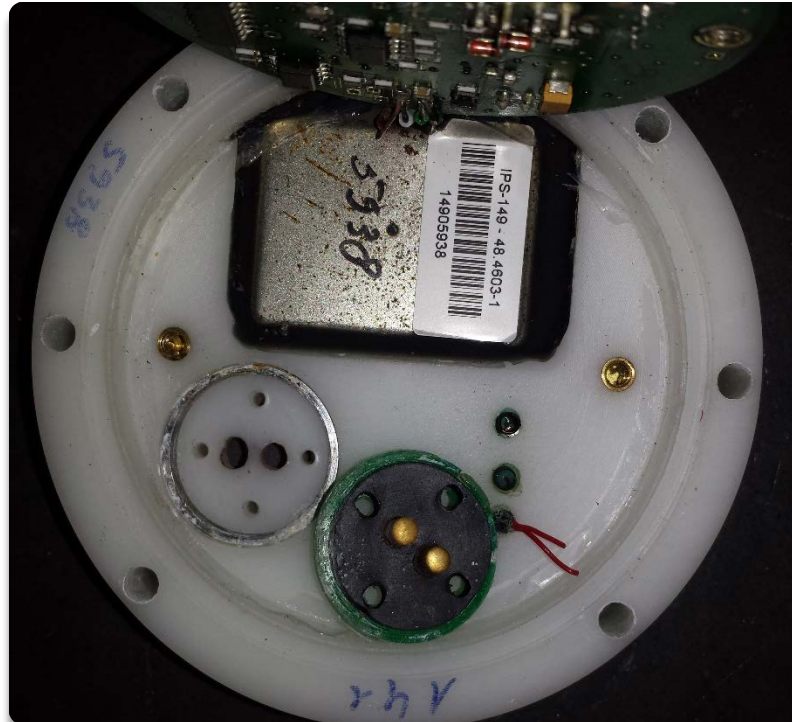
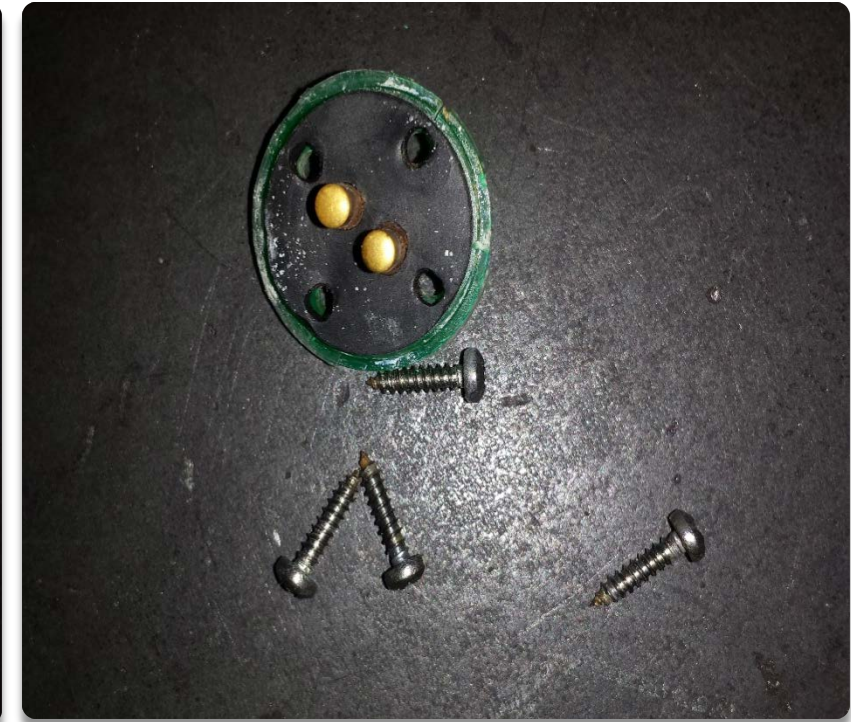
Galvanic Corrosion

Example of a Lufft IRS 21 IPS with galvanic corrosion disassembled for inspection. Note the two holes in the white plastic body have corroded to become larger than the electrodes that protrude from the interior to the external surface of the well.

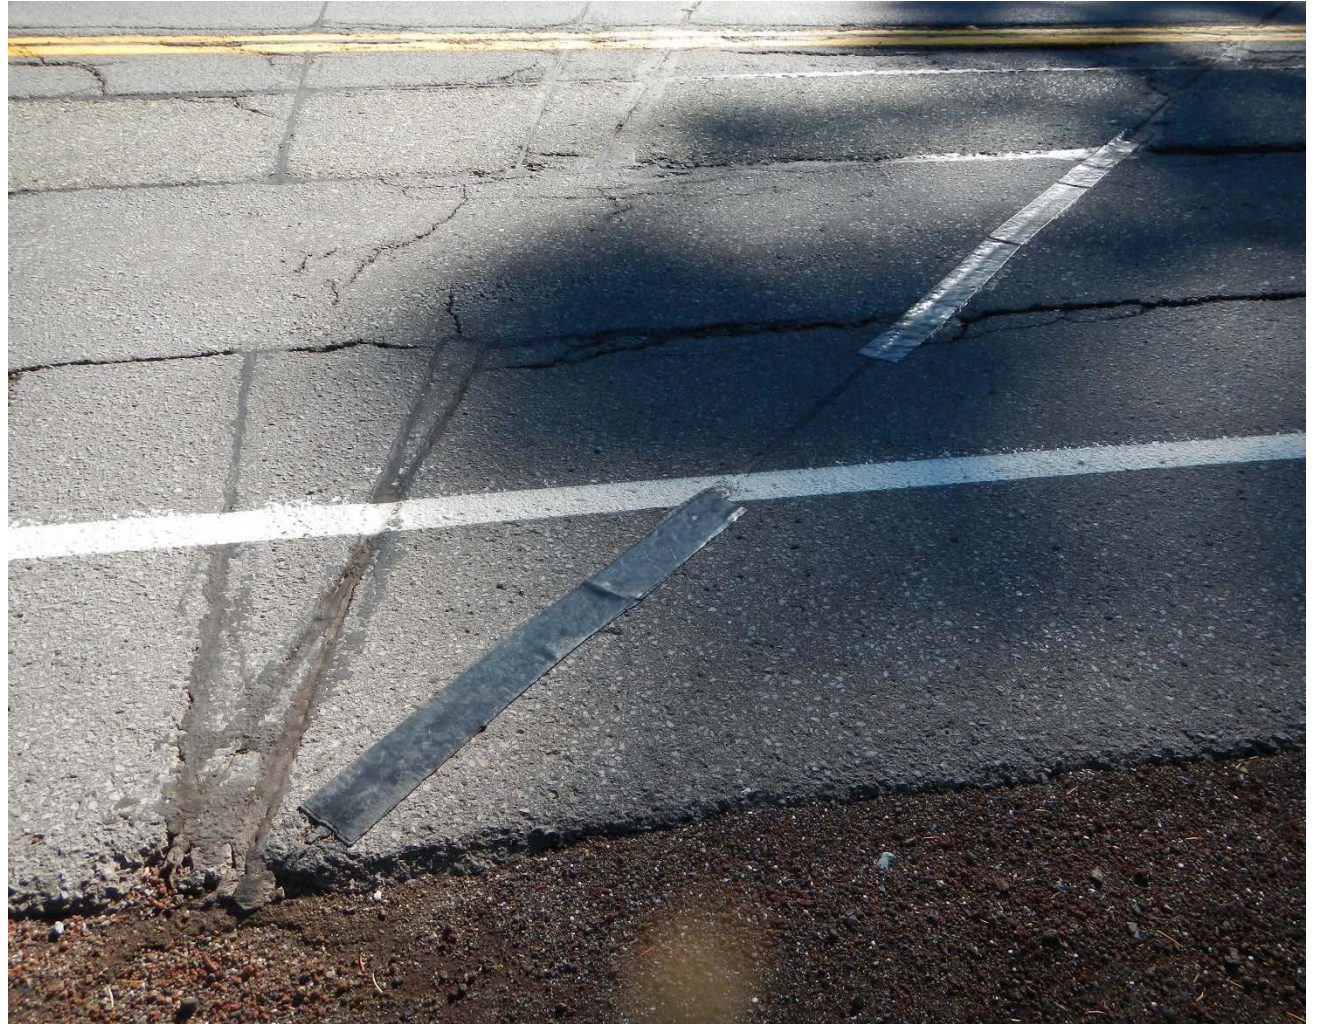
Grind Out and Saw Cut Damage.

To the right is an example of a location that has had multiple IPS failures in this case note the grinding out of the cabling.

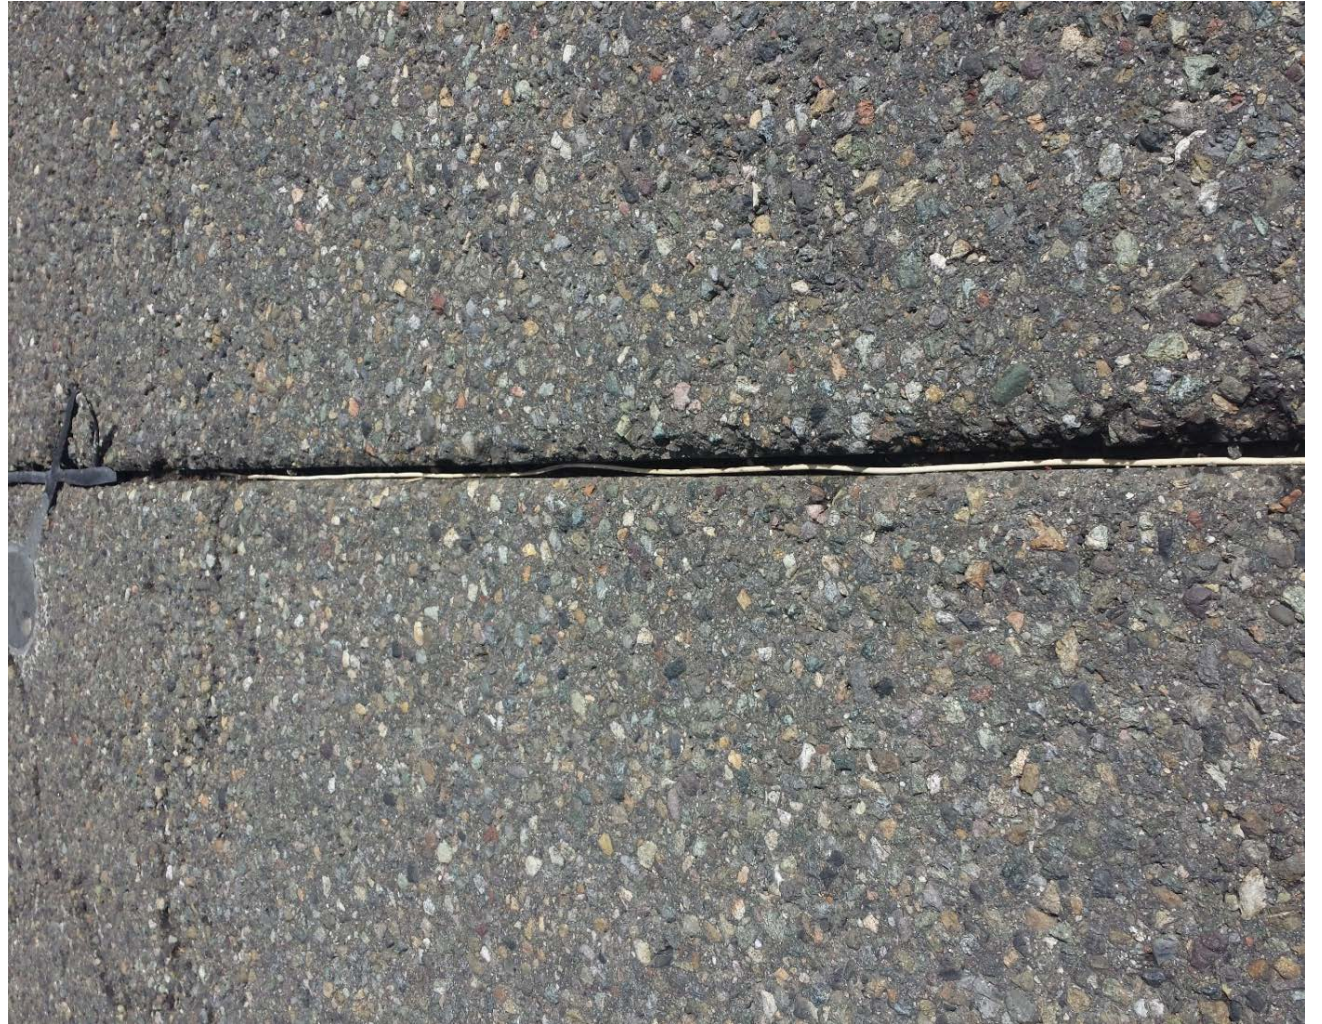
Sensor Lead in Sealant Deterioration

One failure mode is when the pavement wears near the edge of the saw cut and exposes the edges of the sealant to tire traffic. This either breaks hardened epoxy or pulls out sticky sealants which leaves the cable exposed to being damaged.

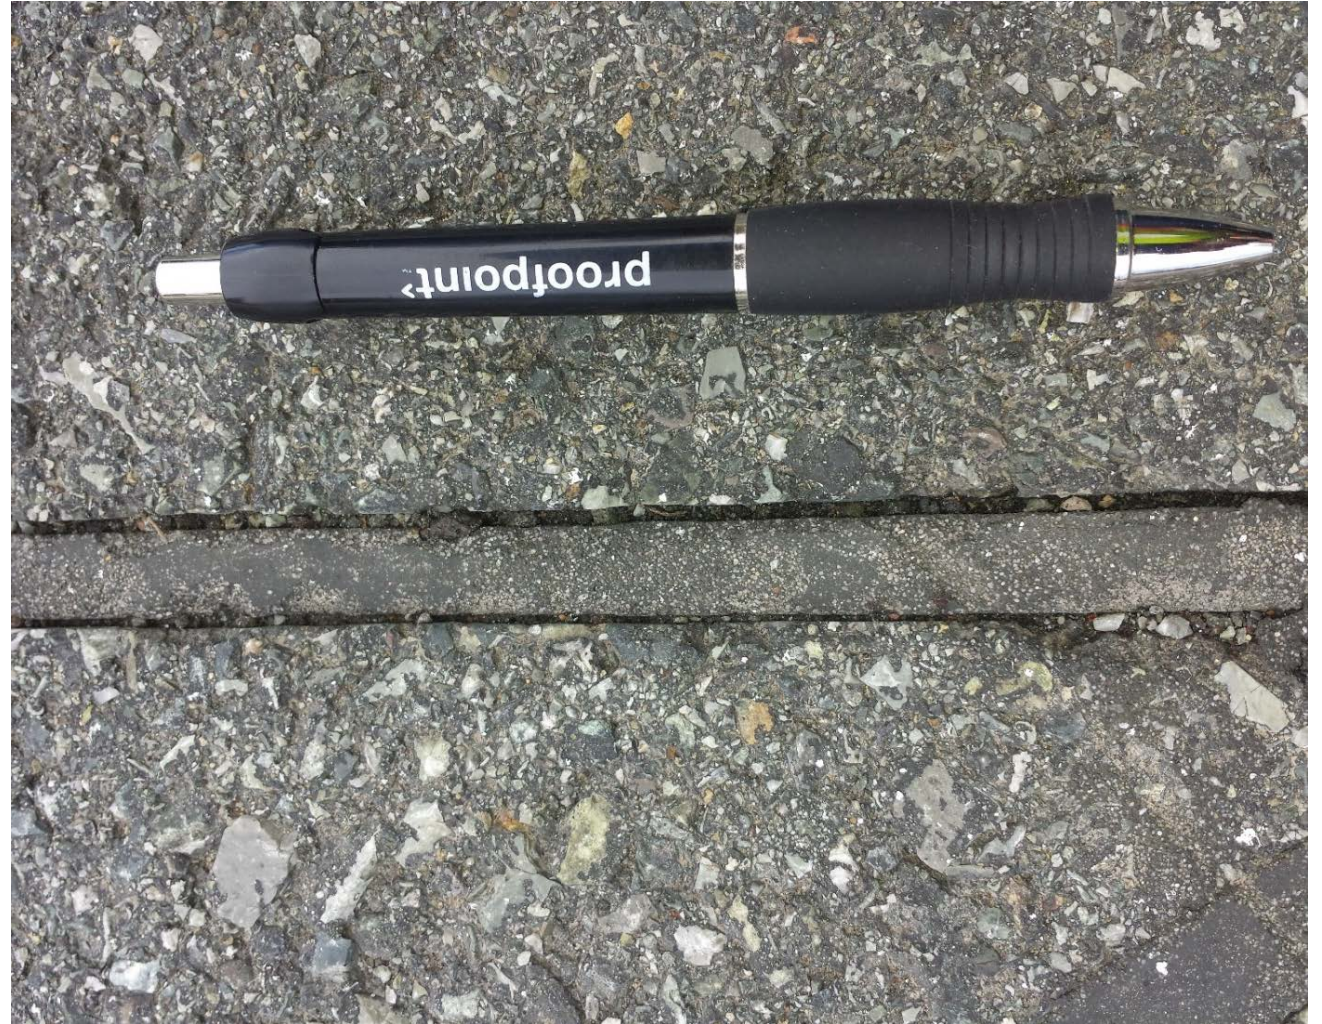
Pavement Expansion and contraction

Another failure mode is the contraction and expansion of the pavement especially the contraction phase where the pavement pulls away from a hard epoxy breaking the pavement to epoxy seal and leaving the epoxy free to work up and out.

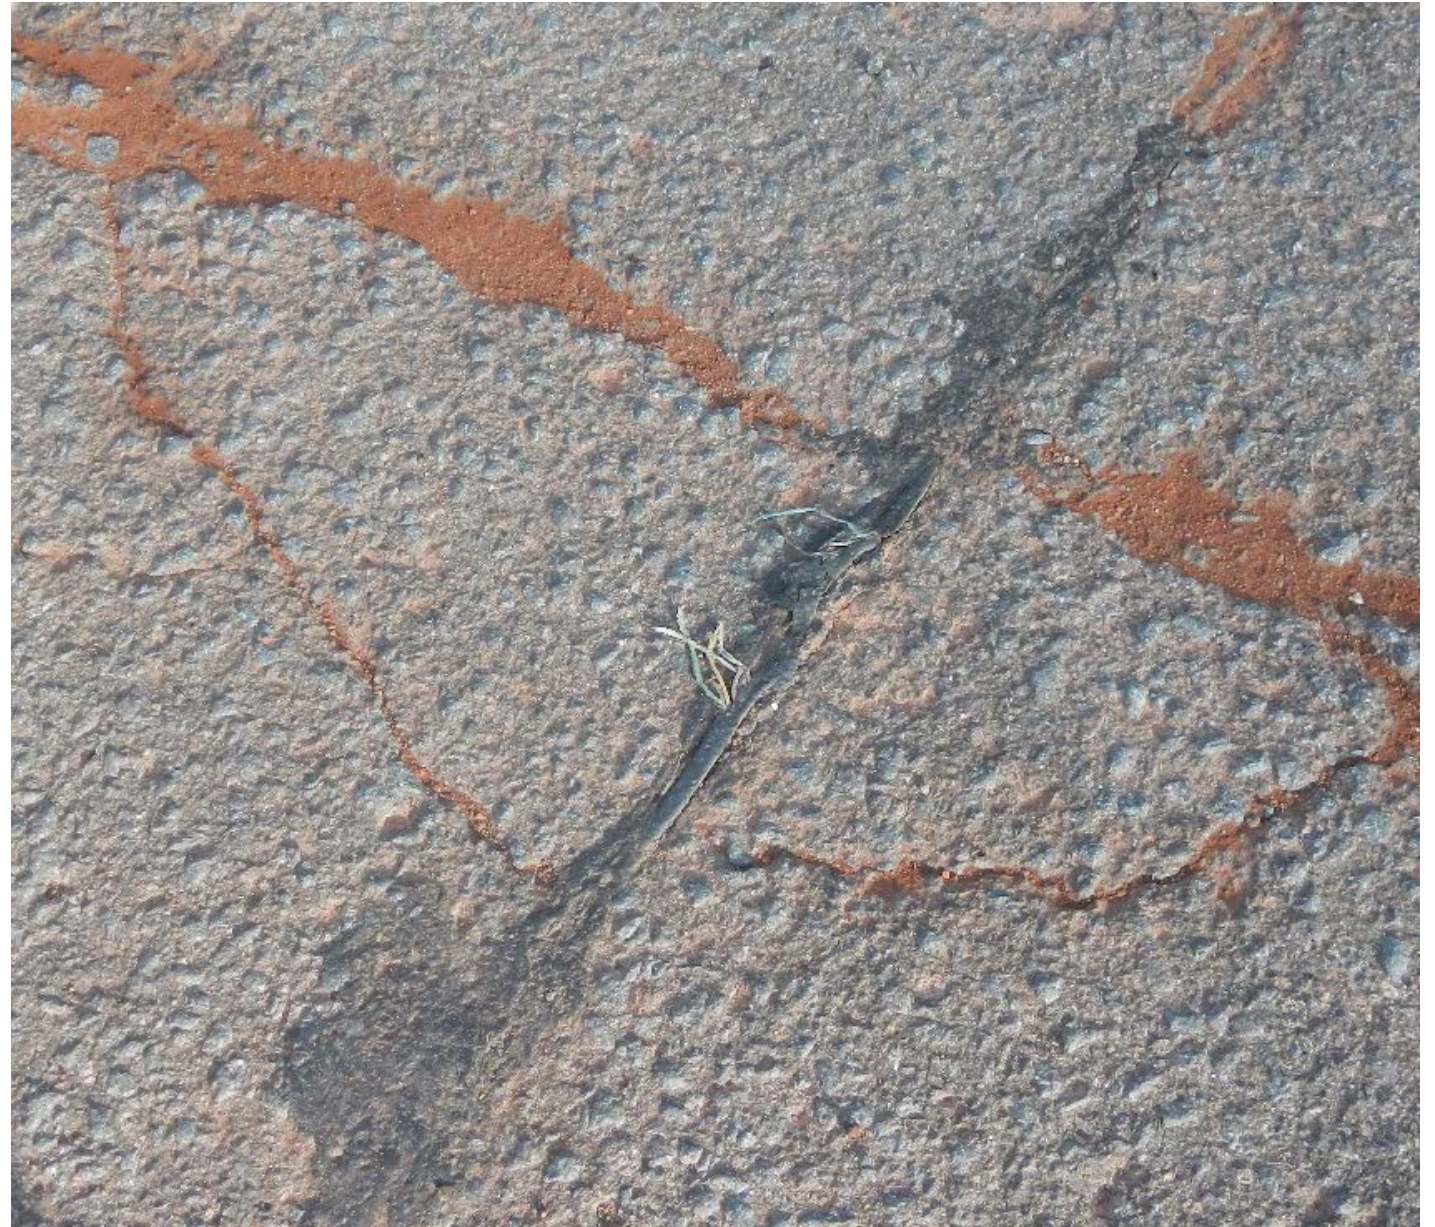
Yet Another Failure Mode

Another failure mode is using a sealant that never hardens enough. The problem here is the sealant remains pliable enough to allow the cabling to pump up through the sealant.

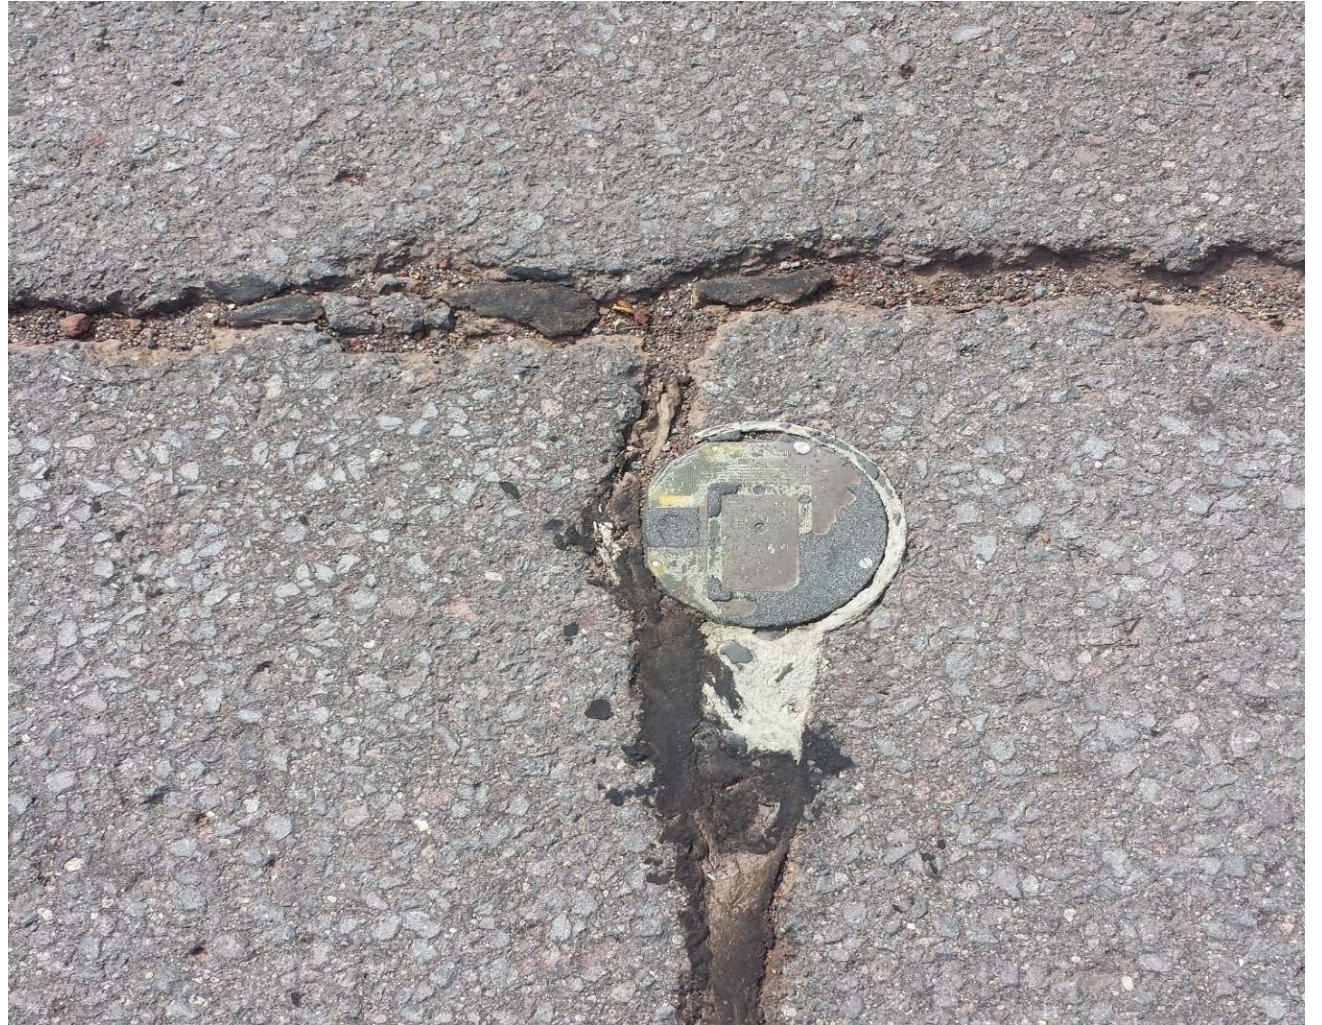
Direct Snow Plow Damage to the Sensor

This type of damage can be exceptionally difficult as it most often occurs when the pavement is inaccessible due to weather conditions like snow on the road and remaining on the shoulders making it impossible to repair. In addition the personnel who usually are needed to assist with the repair are busy with other wintertime duties.

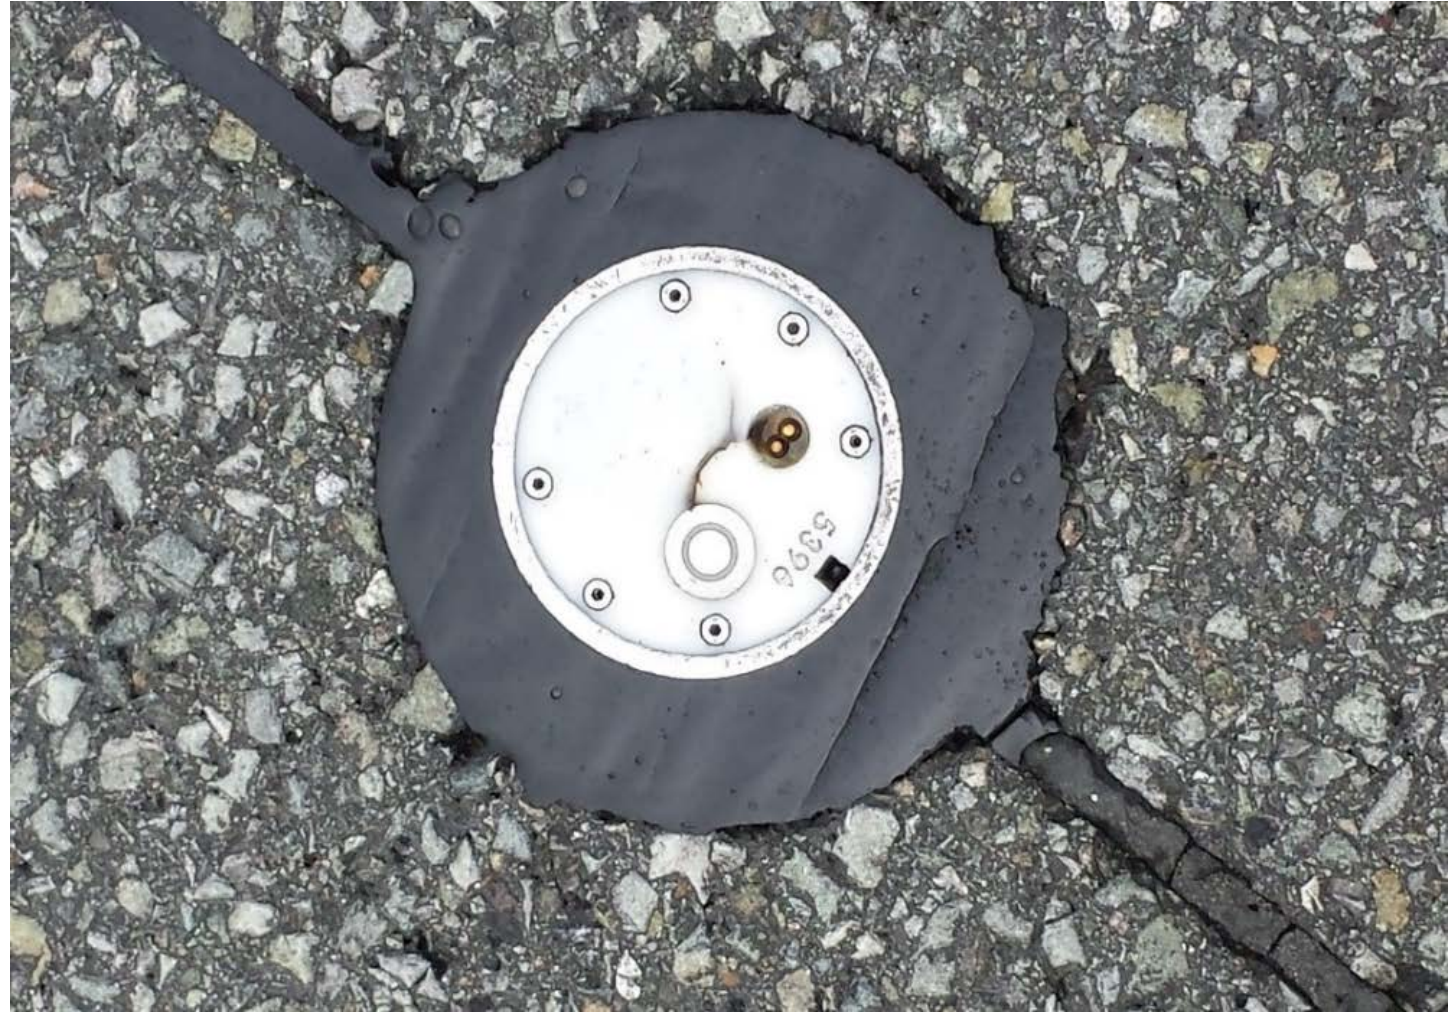
Direct Pressure Damage to the Sensor

Another failure mode for IPS is direct pressure from heavy vehicles especially when tire chains are used.

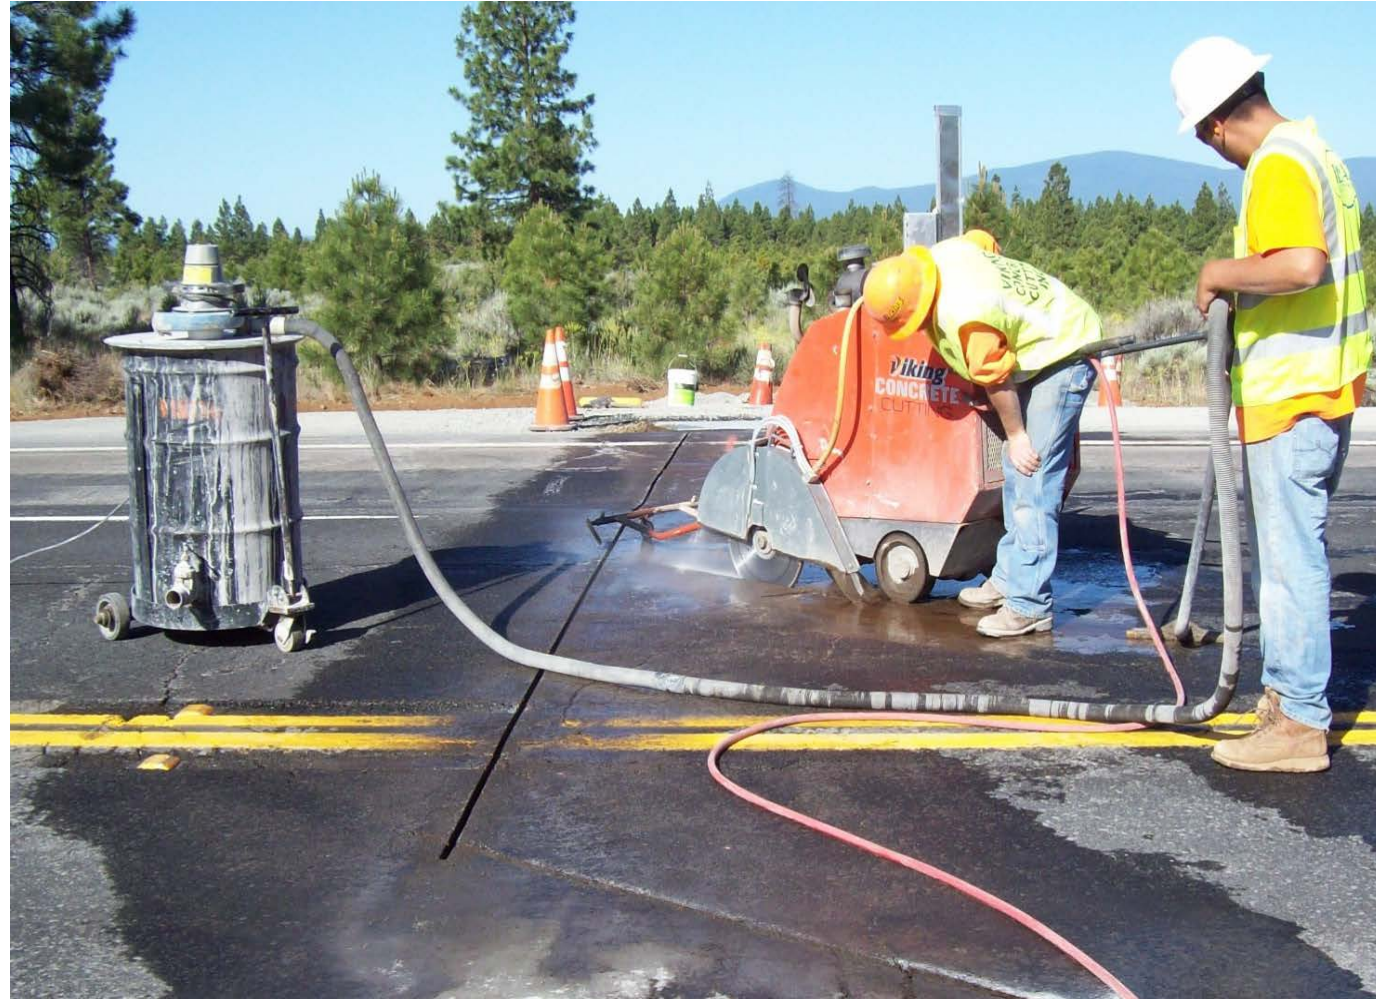
Difficulties in Repairing Damaged IPS

Some of the difficulties affecting repairs of IPS include coordinating the personnel and equipment to facilitate lane closures, make the saw cuts, core the holes for the replacement sensor, procuring the materials. Trying to coordinate these resources during winter operations can leave a system in a compromised state for prolonged periods during the critical time they are intended to be operational. \$☺\$☺\$

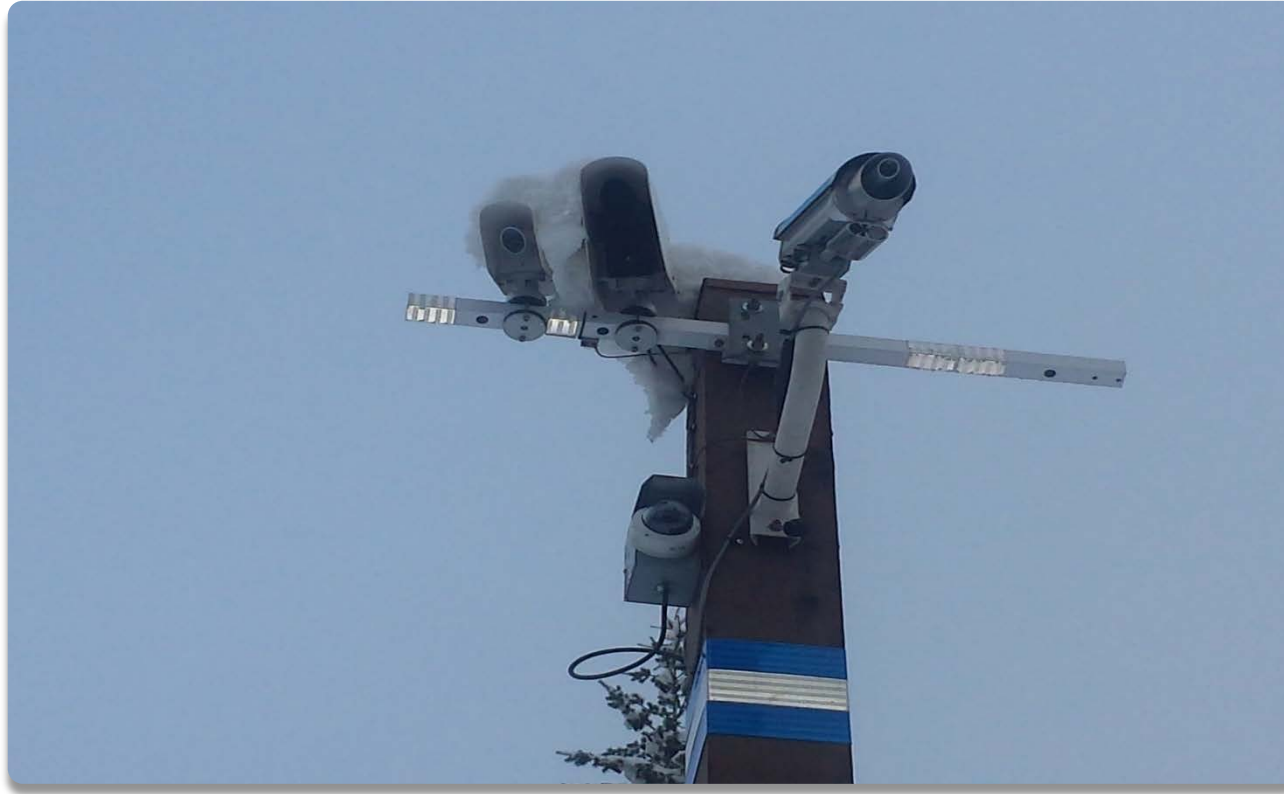
NIPS Theory of Operation

NIPS sensors are composed of two separate infrared sensor types; one for measuring the temperature of the road surface and one for measuring the surface condition. They operate on different principals one passive measuring emitted IR, one active measuring reflected IR.

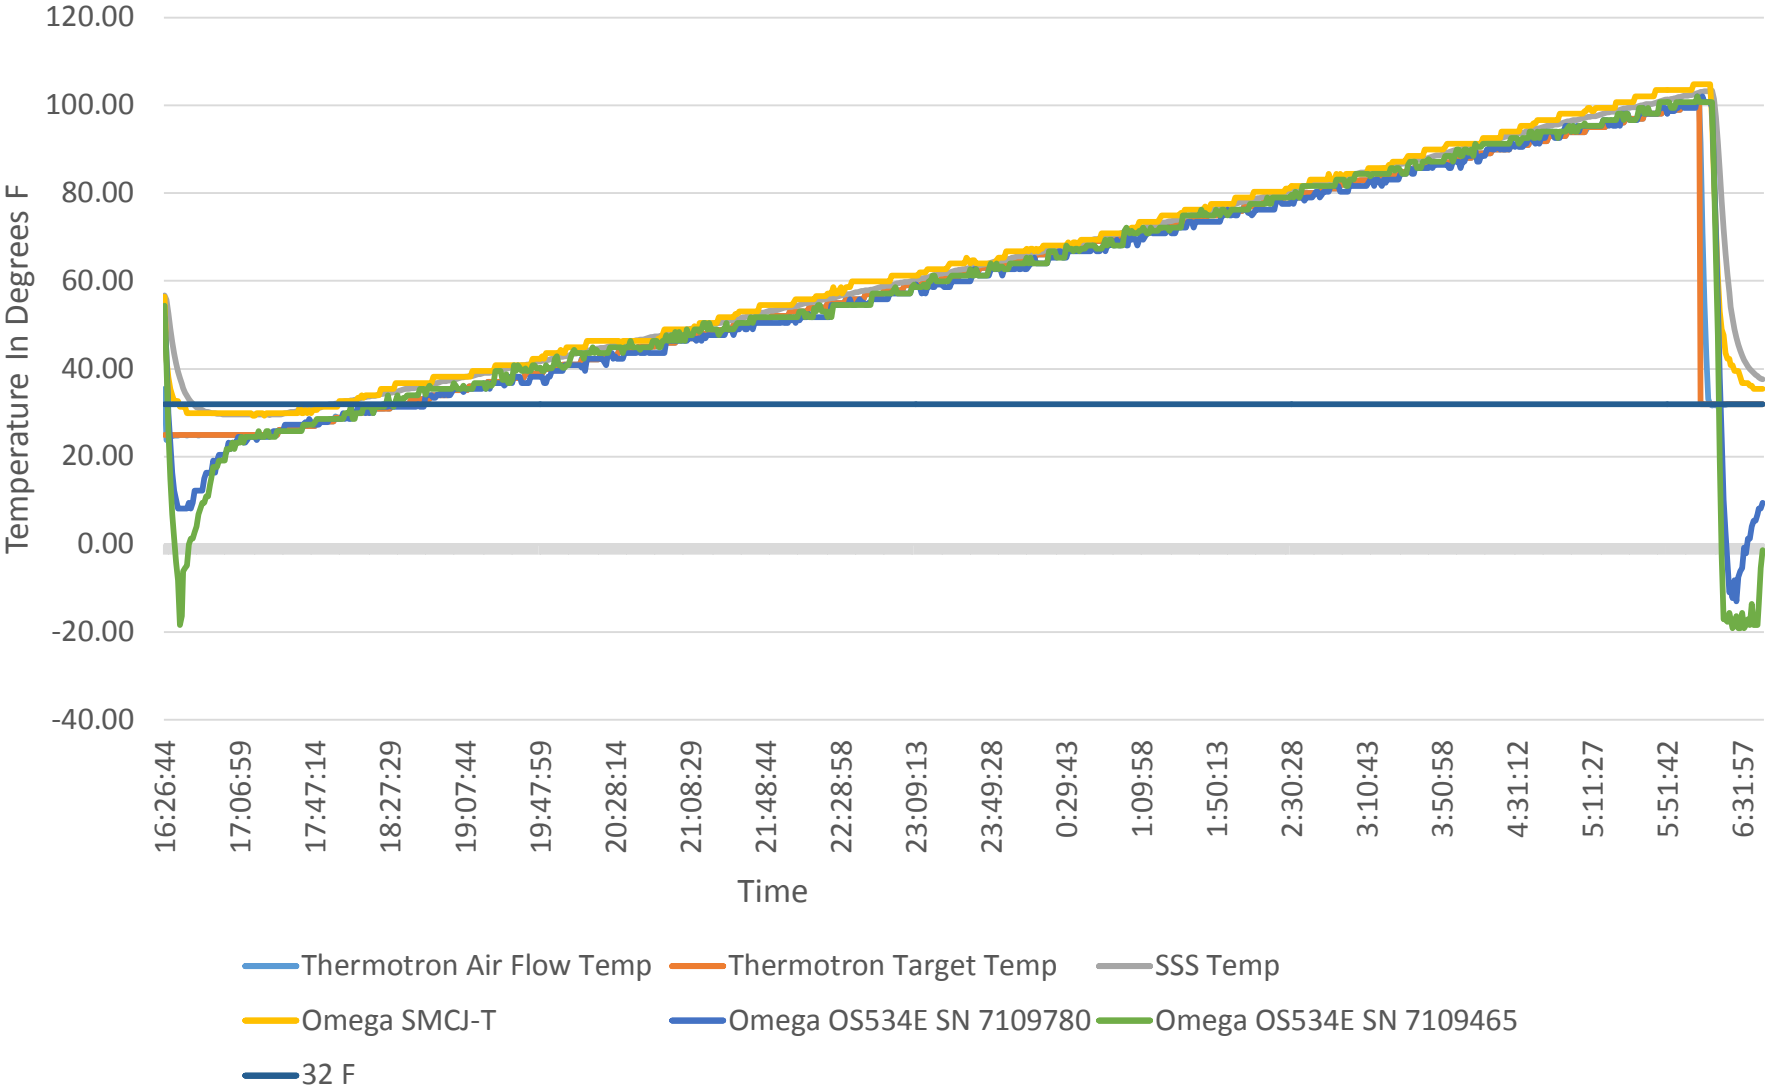
Comparison of Various Temperature Sensors In Test Chamber

- ▶ The IR comparison has limitations in that the sensor itself must be within the range of the comparator that compares the sensor to the target IR emissions or the accuracy of the measurement can be dramatically skewed.
- ▶ IR radiation from other sources can reflect off the target surface and skew the comparison.
- ▶ Water droplets or fog in the path between the target and sensor can emit IR and skew the comparison.
- ▶ The graph on the next slide shows how the Omega IR sensors reacted to large temperature changes of the target value in a short period of time and the time it took for the IR sensors to acclimatize to the change.

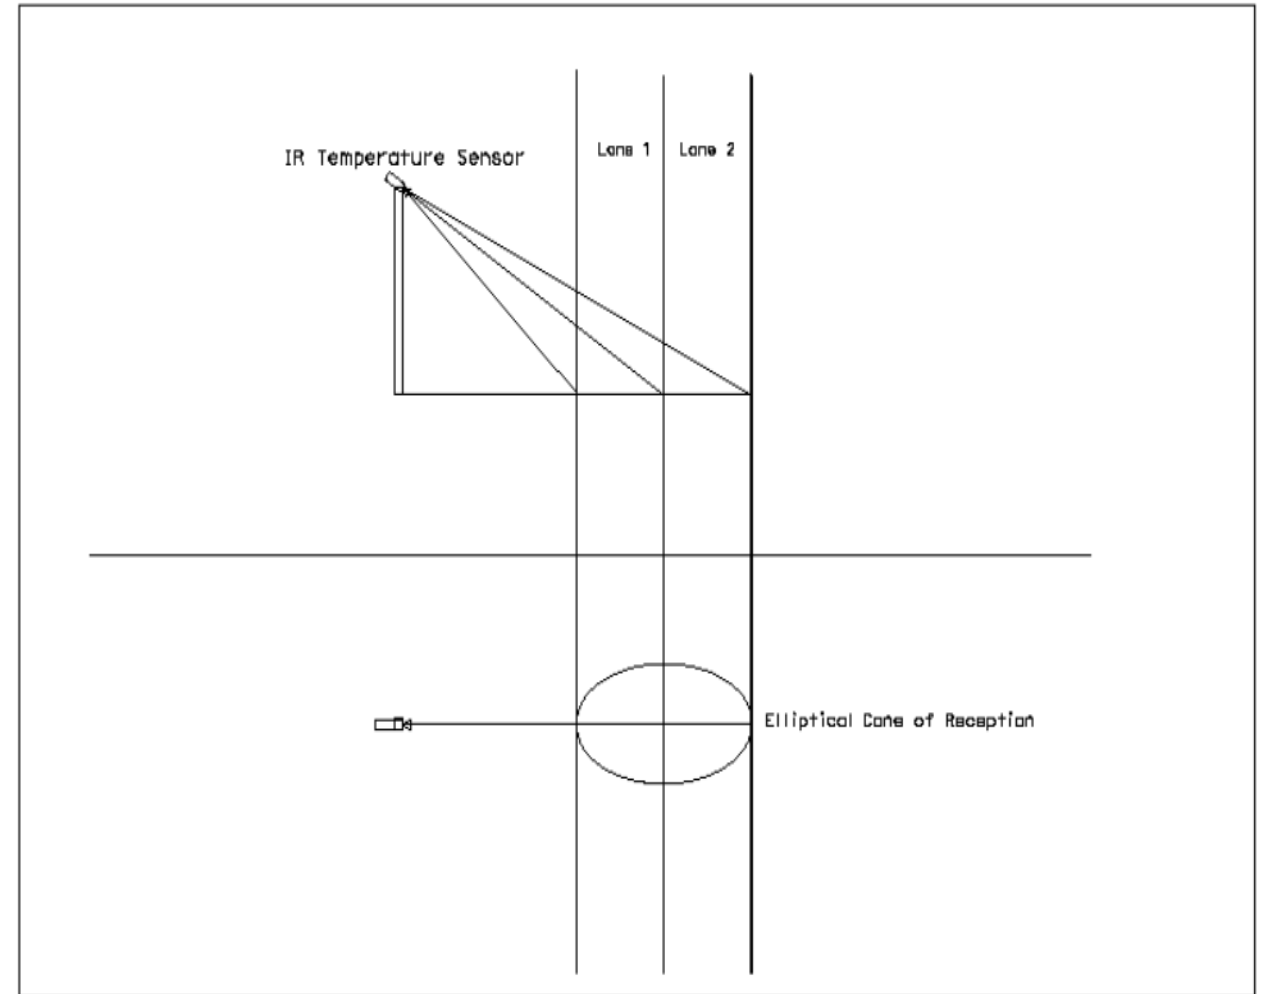
- ▶ IR temperature sensors average the temperature over large area. The sensor has a lens that focuses the IR emissions from the pavement onto the sensor. The field of view of the lens, usually measured in degrees from the centerline of view, determines the field of view of the sensor and the temperature measured is an average of the entire field of view. This in effect defines a cone of reception which becomes an ellipse when projected on the pavement surface.
- ▶ Knowing the dimensions of the cone of reception for the IR temperature sensor is critical to being sure the temperature measurement is measuring the road surface and not the shoulder or median.

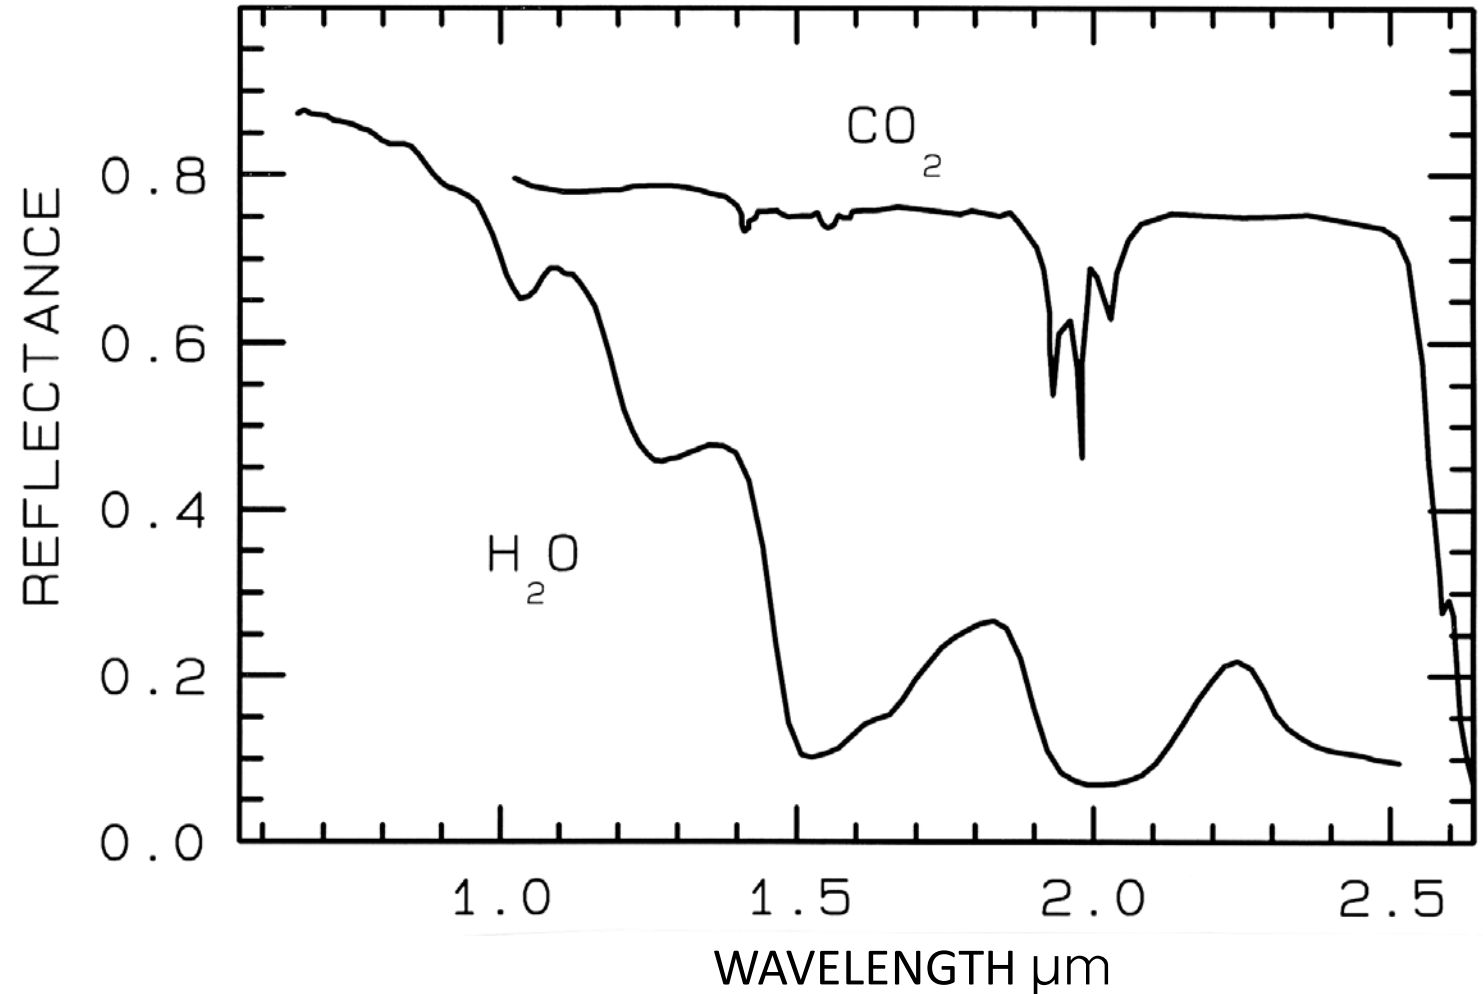
Chart of H₂O IR Absorption

At the right is a chart from the USGS website Reflectance spectra of solid carbon dioxide, CO₂, and water, H₂O, from Clark *et al.* (1986).

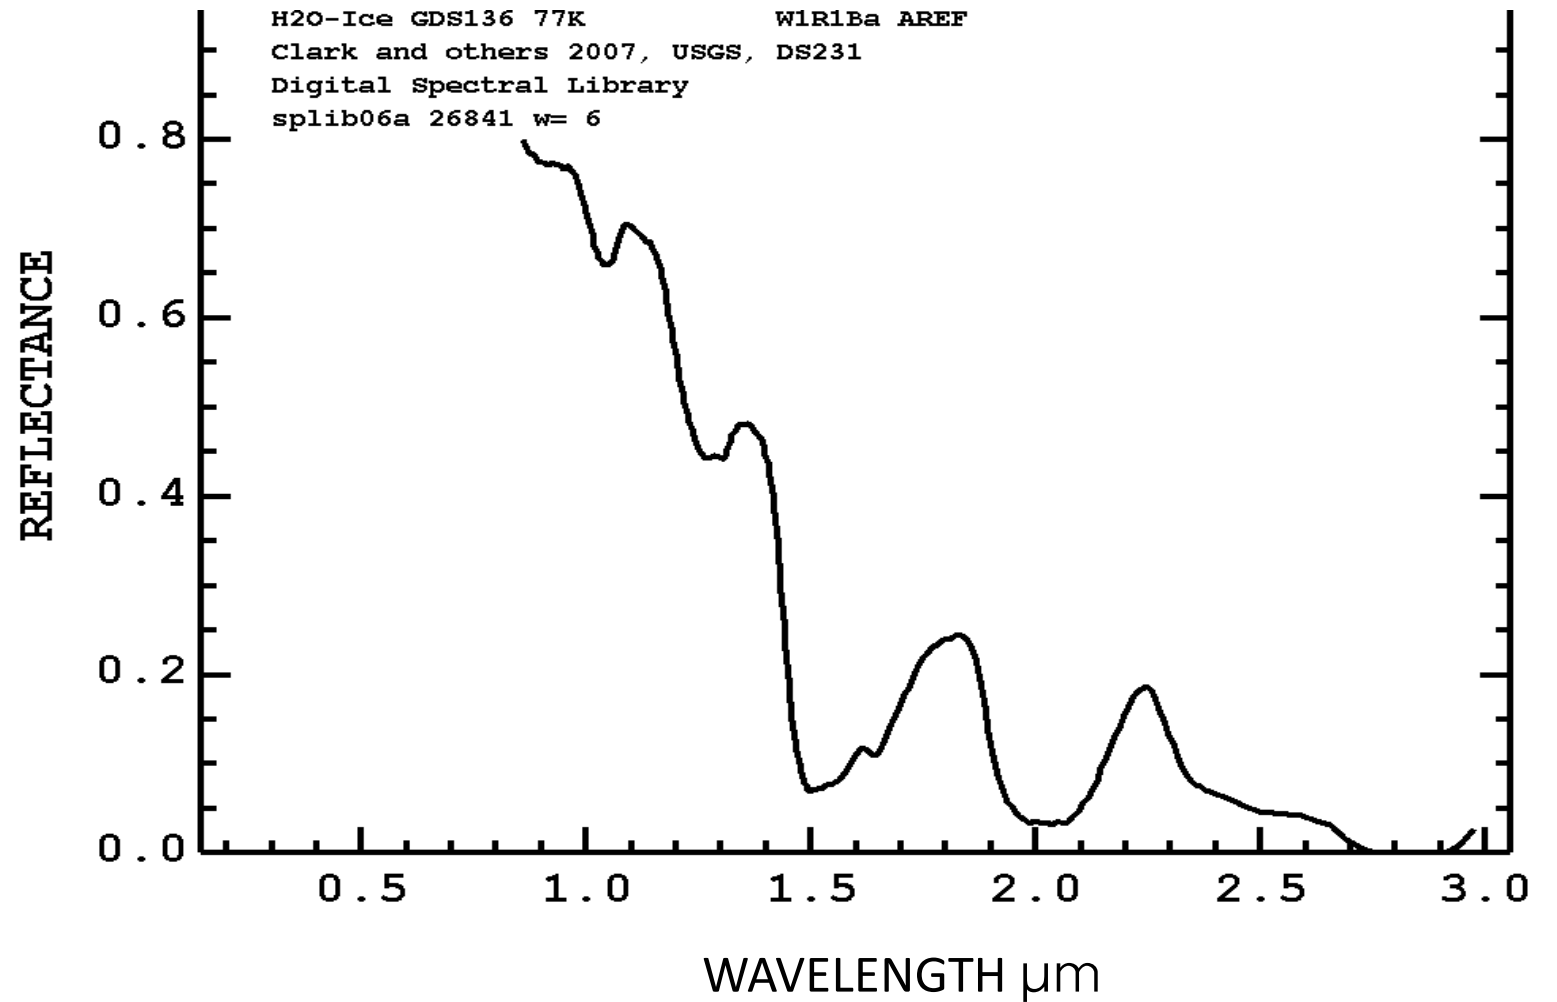
Chart of H2O Ice IR Absorption

At the right is a chart from the USGS website showing H2O ice reflectance as a function of wavelength.

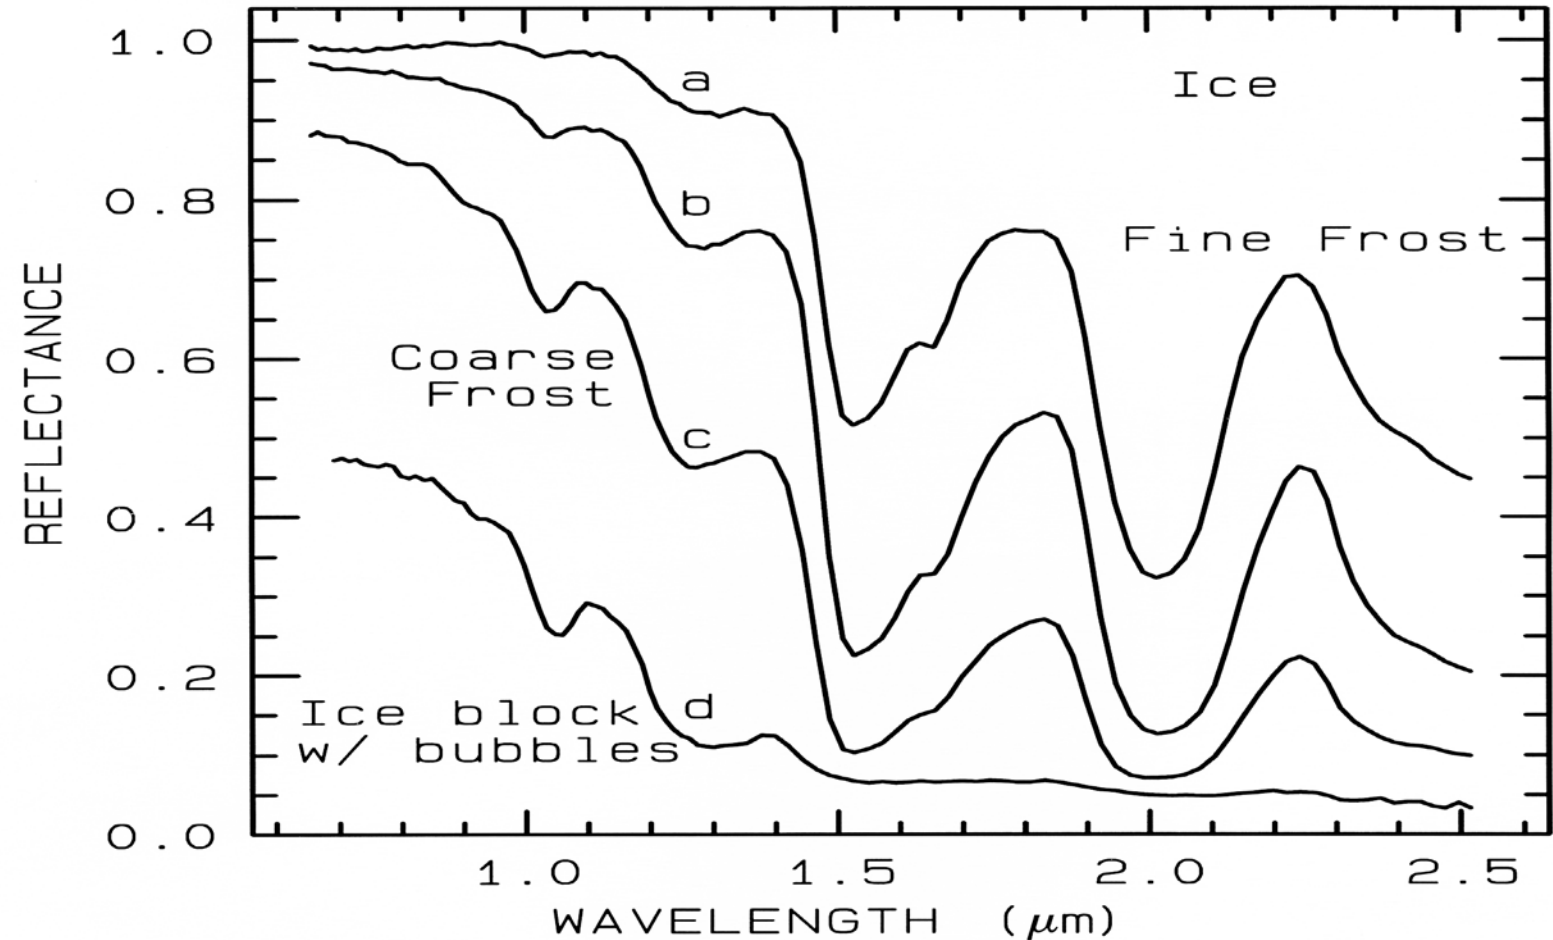
Chart of Frost IR Absorption

At the right is The near-infrared spectral reflectance of A) a fine grained ($\sim 50\text{ }\mu\text{m}$) water frost, B) medium grained ($\sim 200\text{ }\mu\text{m}$) frost, C) coarse grained ($400\text{-}2000\text{ }\mu\text{m}$) frost and D) an ice block containing abundant microbubbles. The larger the effective grain size, the greater the mean photon path that photons travel in the ice, and the deeper the absorptions become. Curve D is very low in reflectance because of the large path length in ice. The ice temperatures for these spectra are 112-140 K. From Clark *et al.* (1986).
