Comparison of In-Pavement Versus Non-Invasive Pavement Sensor Technologies

Mike Beyer ITS Engineer, Caltrans D02

June 22nd, 2016

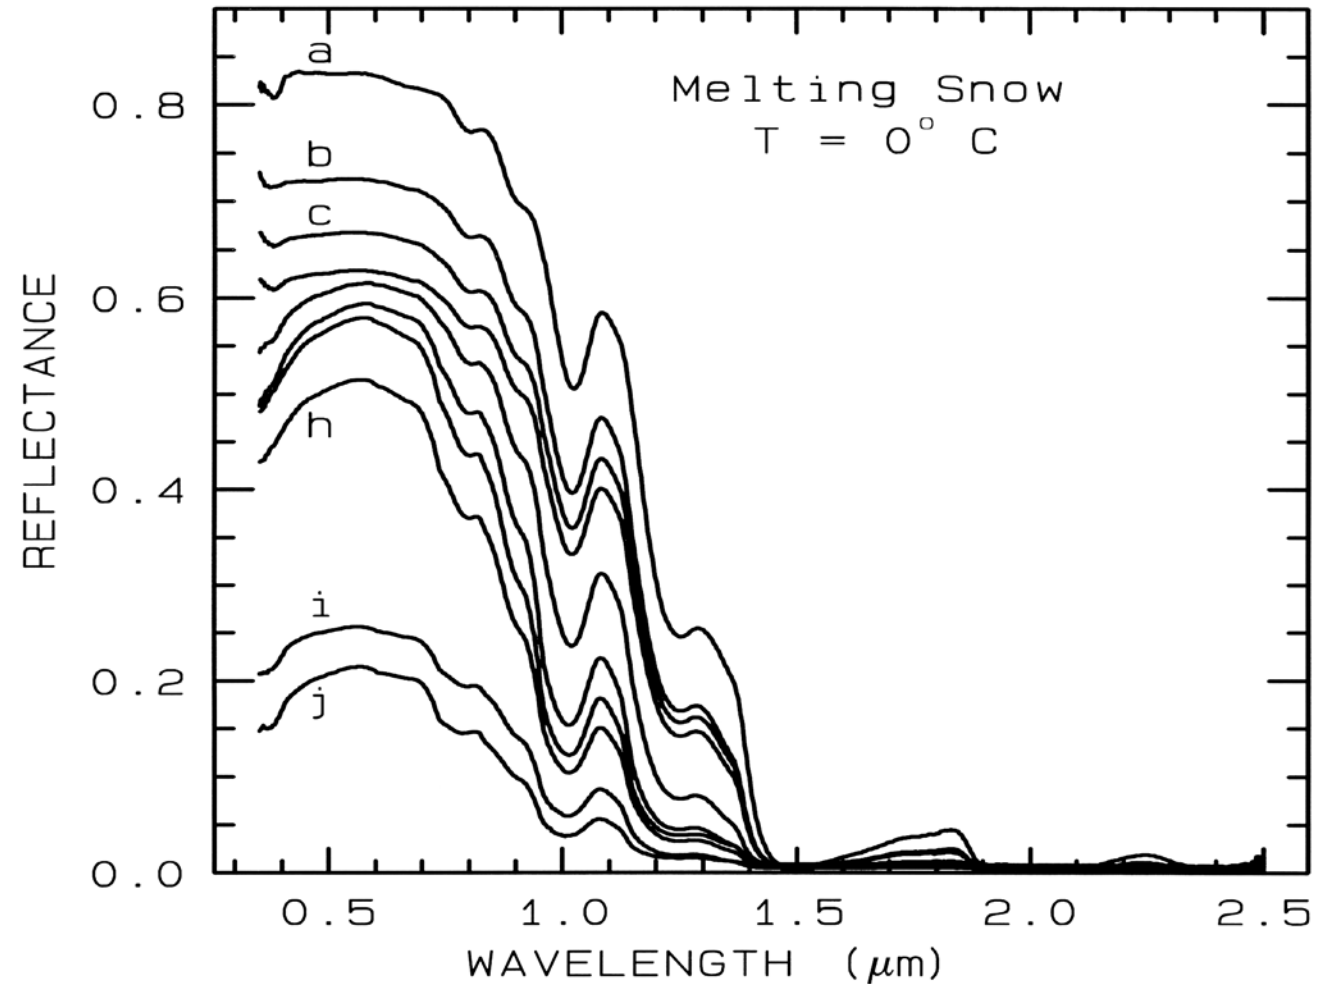
Chart of Melting Snow IR Absorption

A series of reflectance spectra of melting snow. The top curve (a) is at 0°C and has only a small amount of liquid water, whereas the lowest spectrum (j) is of a puddle of about 3 cm of water on top of the snow. Note in the top spectrum, there is no 1.65- μm band as in the ice spectra in figure 22a because of the higher temperature.. The 1.65- μm feature is temperature dependent and decreases in strength with increasing temperature (see Clark, 1981a and references therein). Note the increasing absorption at about 0.75 μm and in the short side of the 1- μm ice band, as more liquid water forms. The liquid water becomes spectrally detectable at about spectrum e, when the UV absorption increases. Spectra from Clark, King and Swayze, in preparation

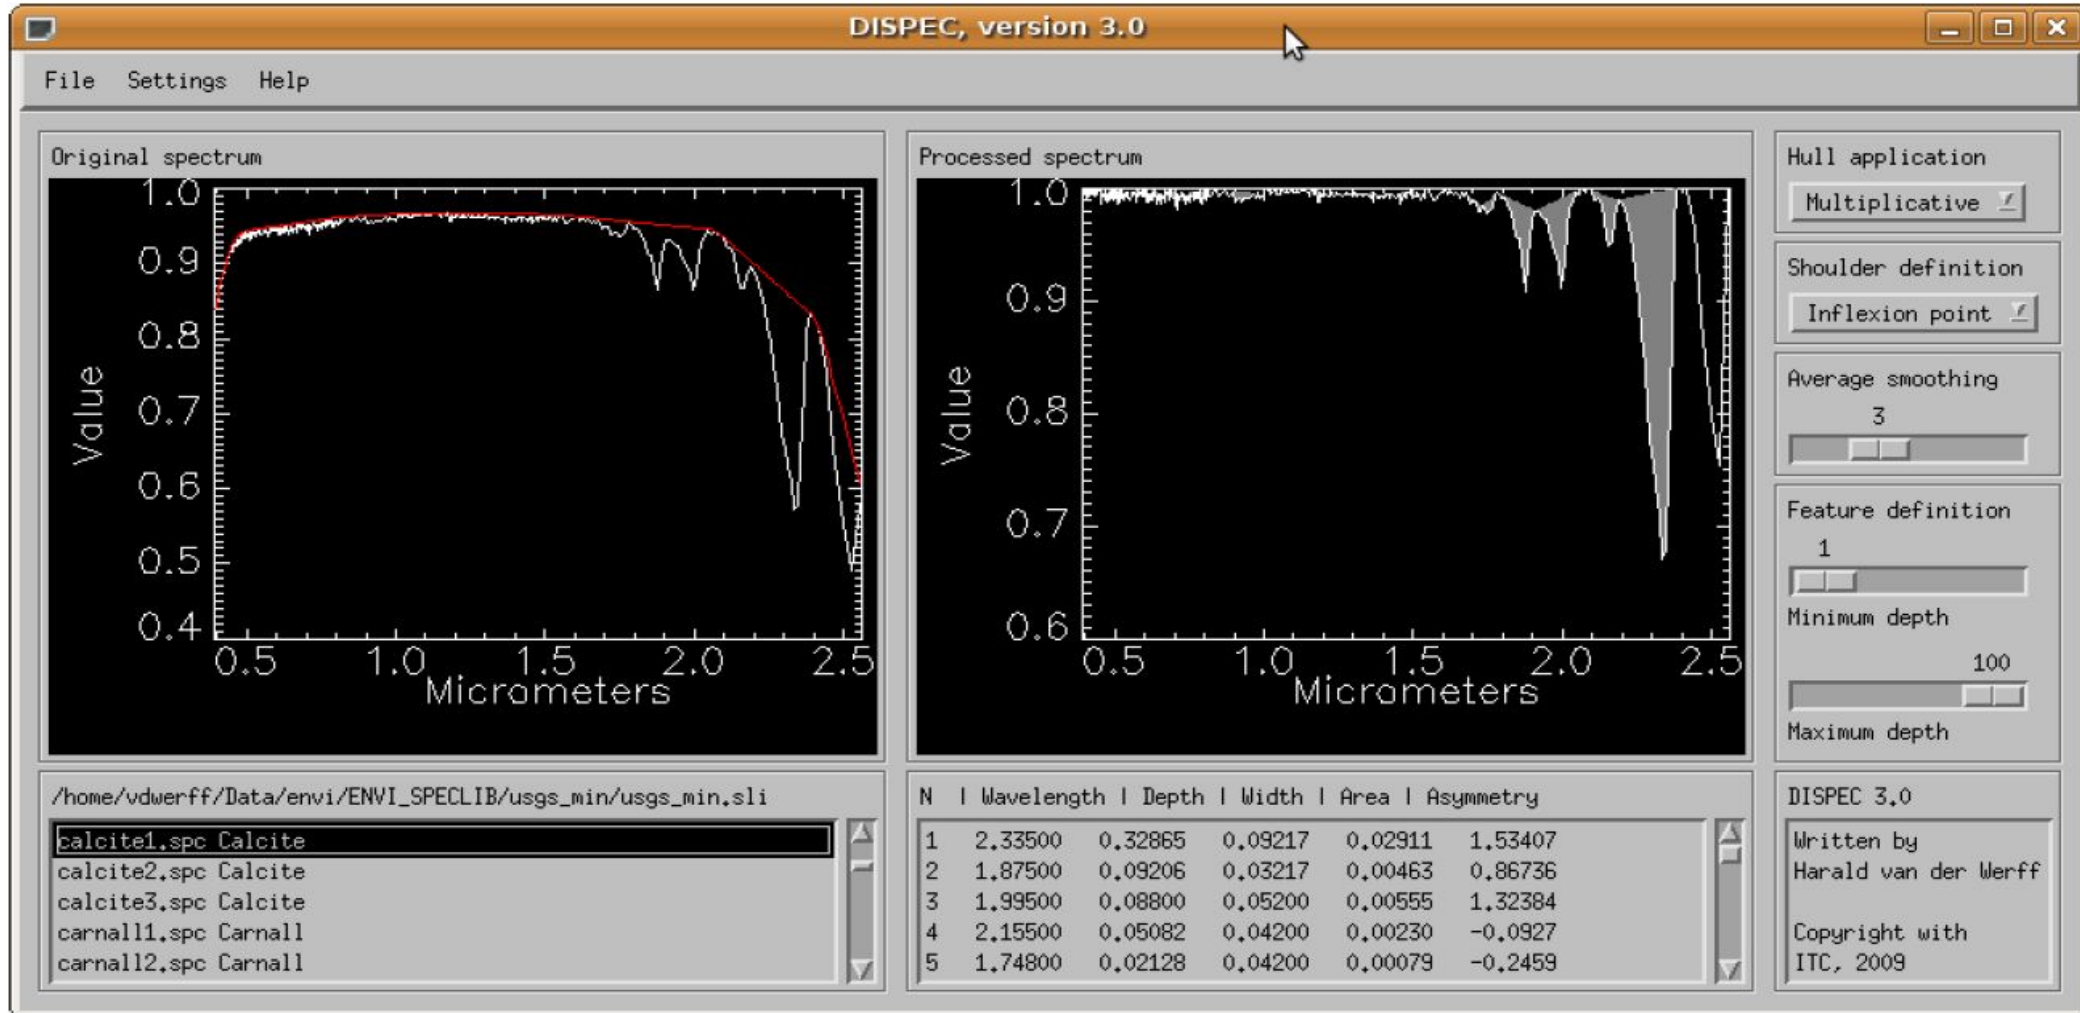
Continuum Removal is a mathematical process whereby the contour of the characteristic charts can be normalized to produce a clear spike identifying the characteristic of the material under examination. Image from [\[14\]](#)

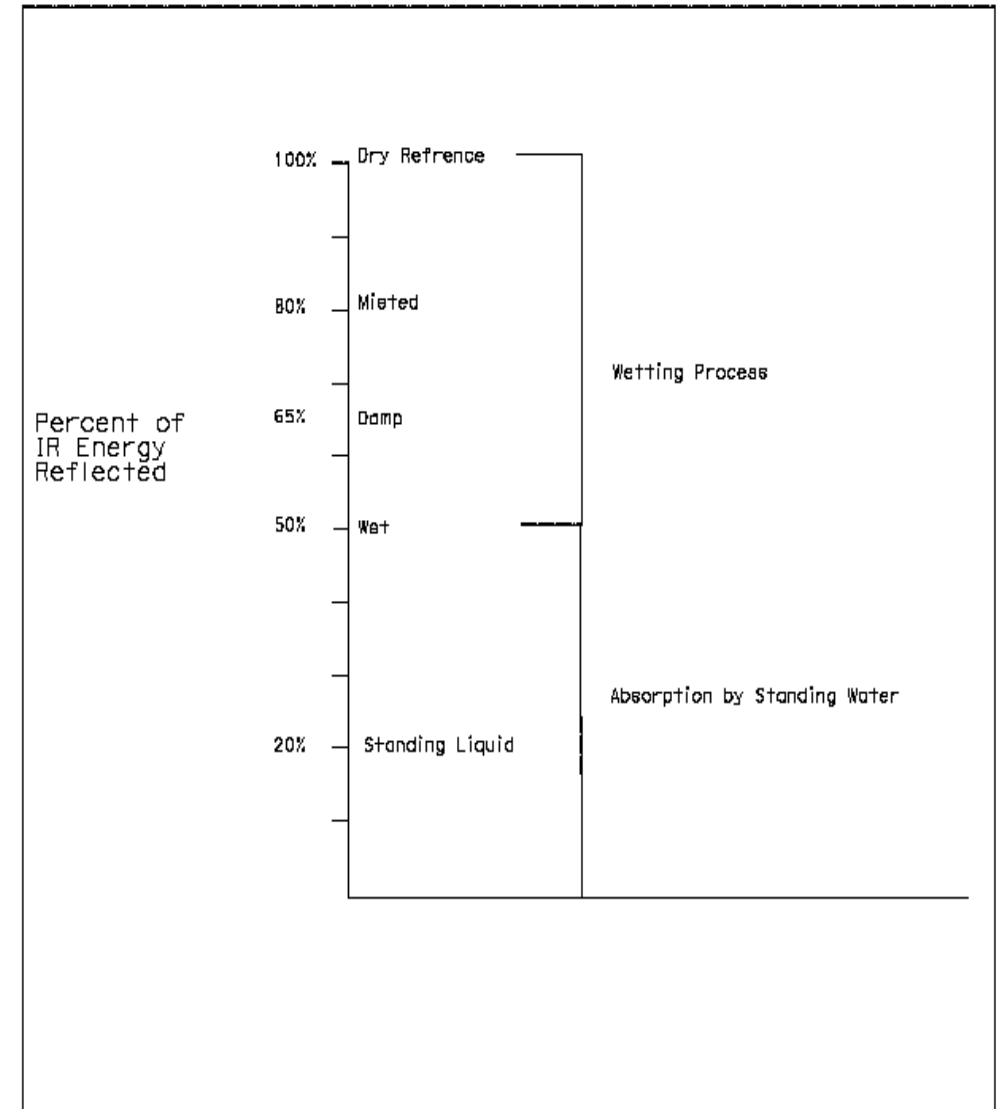
Chart of NIPS Calibration Principal

Surfaces can be classified as being “Wettable” or “Non-Wettable”. A wettable surface will soak up water at first like paper or dry concrete and is characterized as a darkening of the surface. A non-wettable surface will not absorb water such as glass or plastic the water will simply bead up or runoff. This chart describes the “wetting process” which is responsible for the trace moisture readings that can translate to either frost or trace moisture under the right circumstances. This helps in understanding how important it is that NIPS calibration be done on absolutely dry pavement.

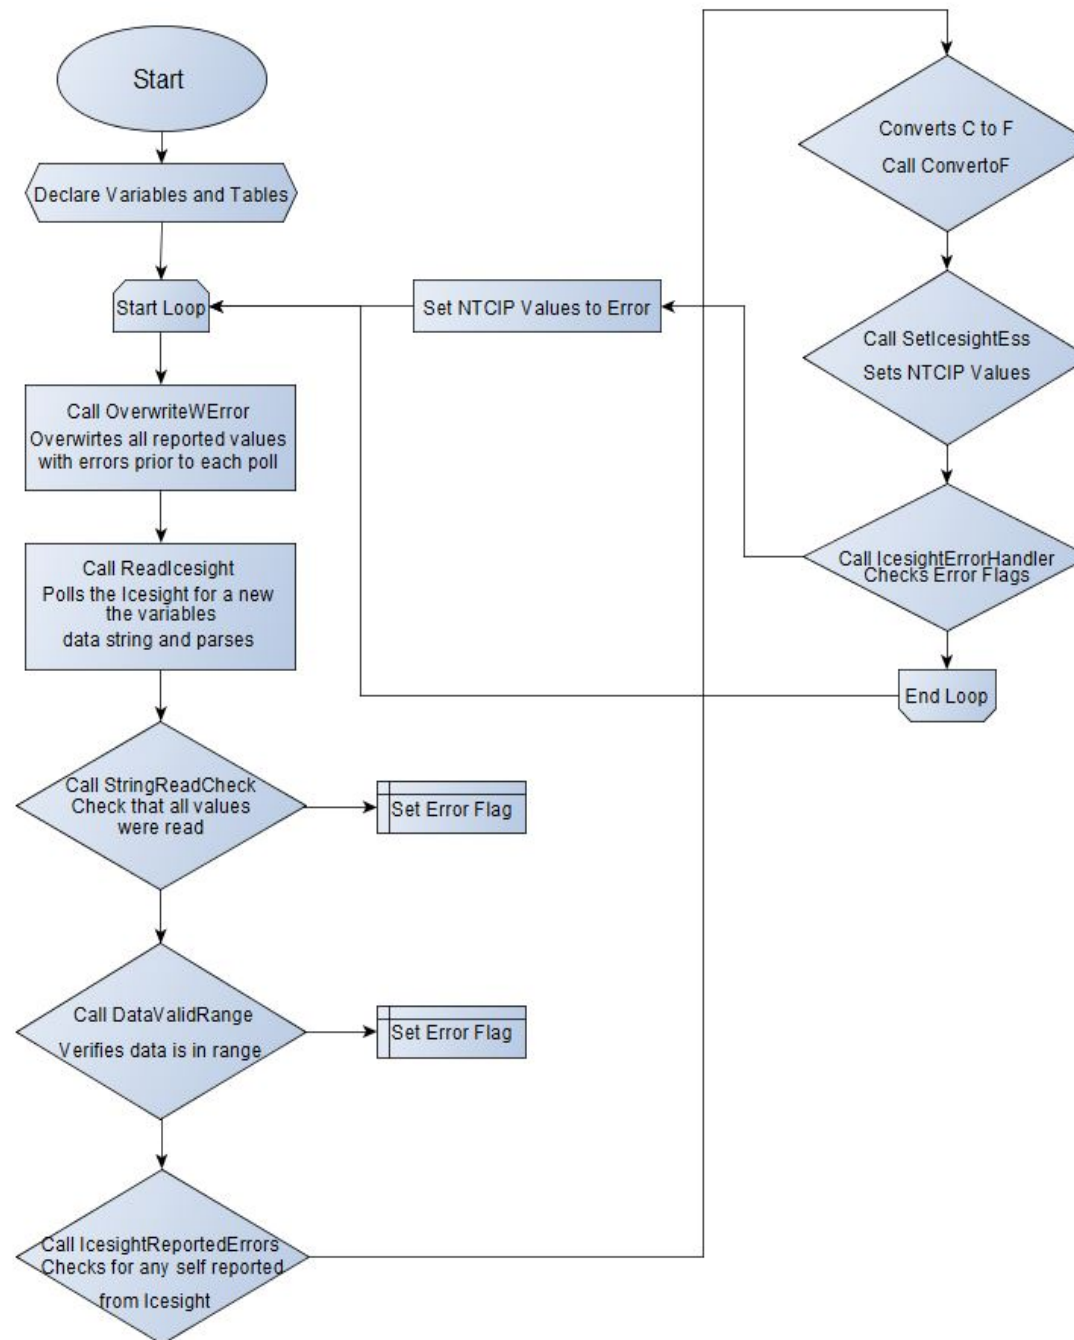
CR 1000 Code Flow Chart for the Icesight.

Note: There is
a critical wait
state in the
ReadIcesight
subroutine
that is
necessary in
the polling
process.

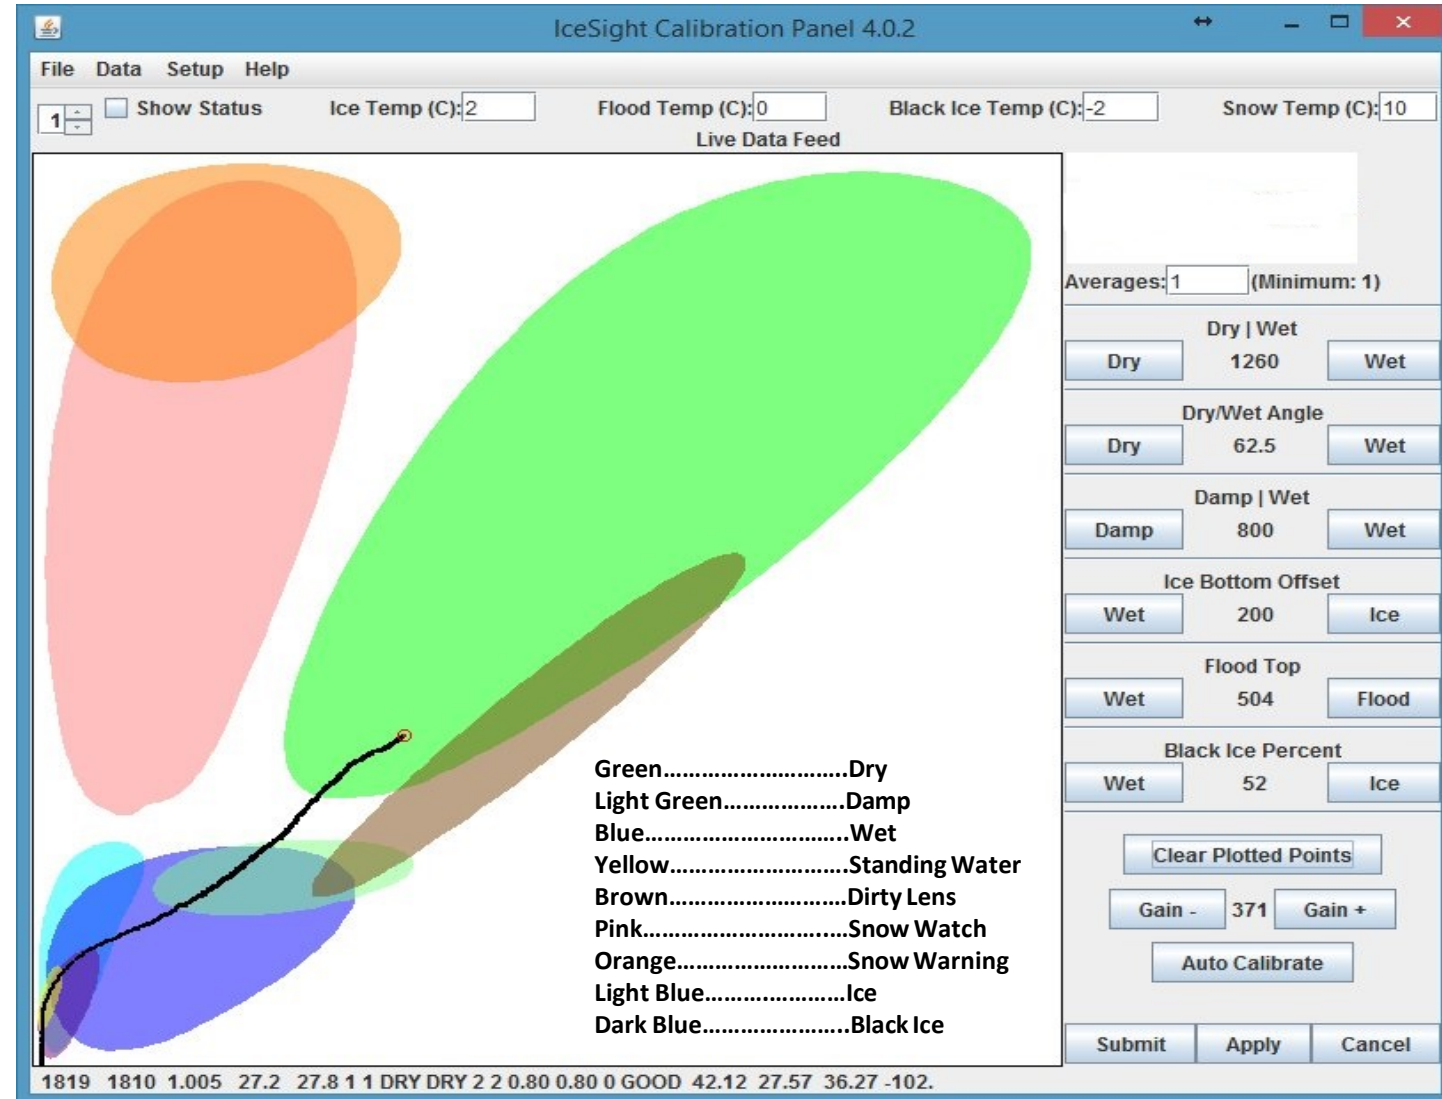
Icesight Calibration in Office

At the right is a Java window used to access live Icesight reporting from the field. This utility allows the Icesight to act as a stand alone sensor without the need for a full RWIS. This graph shows an overnight curve created in my office during code development. This curve depicts a block of concrete frozen to -20° F and covered with ice. The block was placed in the field of view and left to acclimatize to room temperature and dry overnight. The resulting curve is an ideal curve showing the transition from ice, to wet to dry.

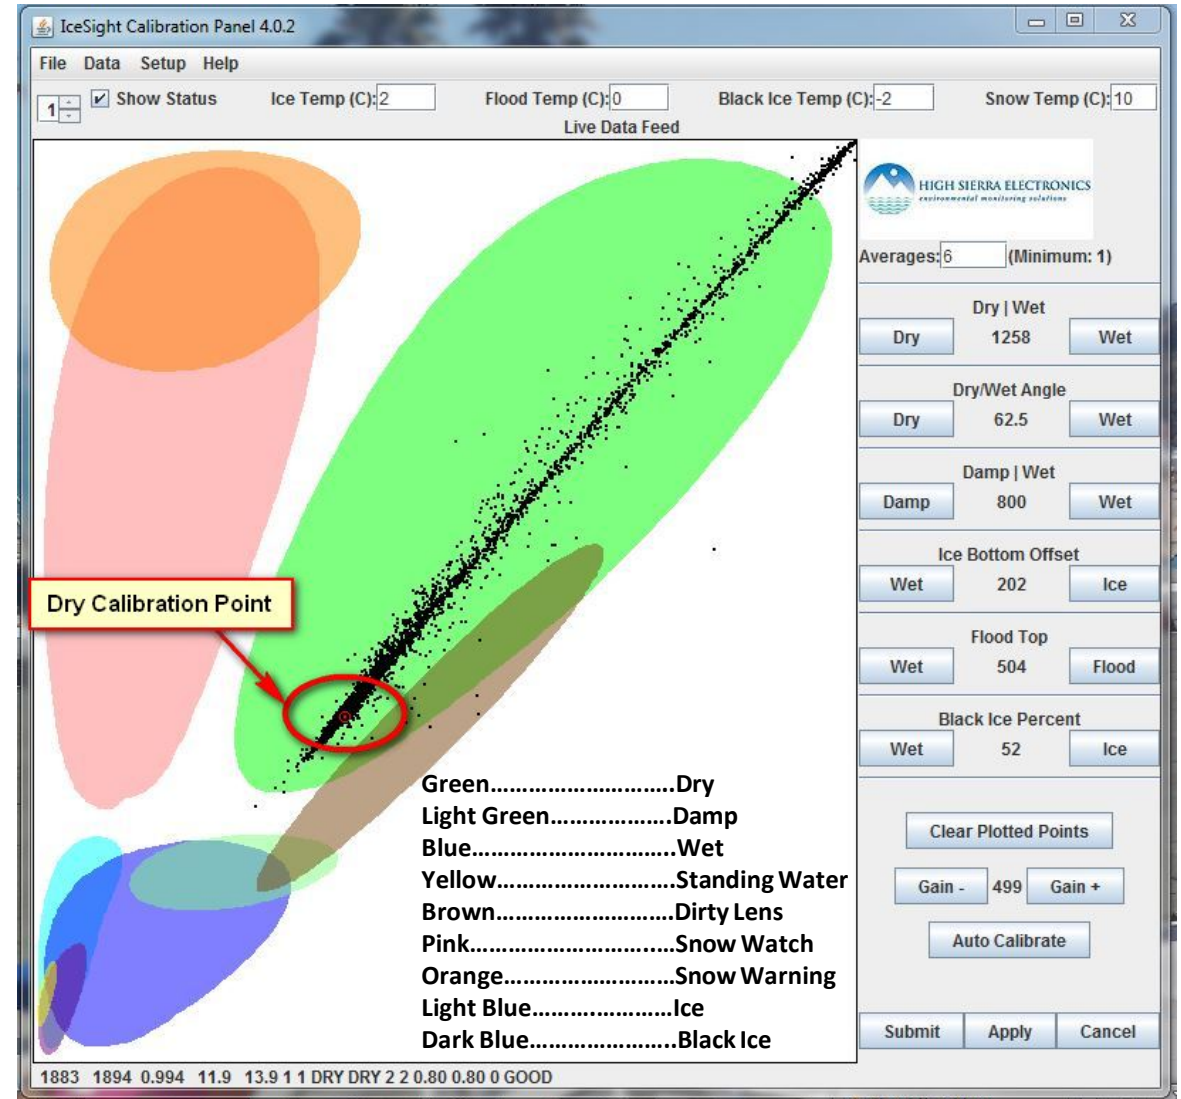
Icesight Calibration in the Field

At the right is a calibration curve created in the field at Sims road. This curve depicts the dry calibration process where the Icesight is calibrated to dry pavement in a live traffic environment. Note the grouping of reading around the dry calibration point and the line of readings projecting up to the upper right corner. The line leading to the upper right are vehicle interference reads and need to be averaged out in normal operation.

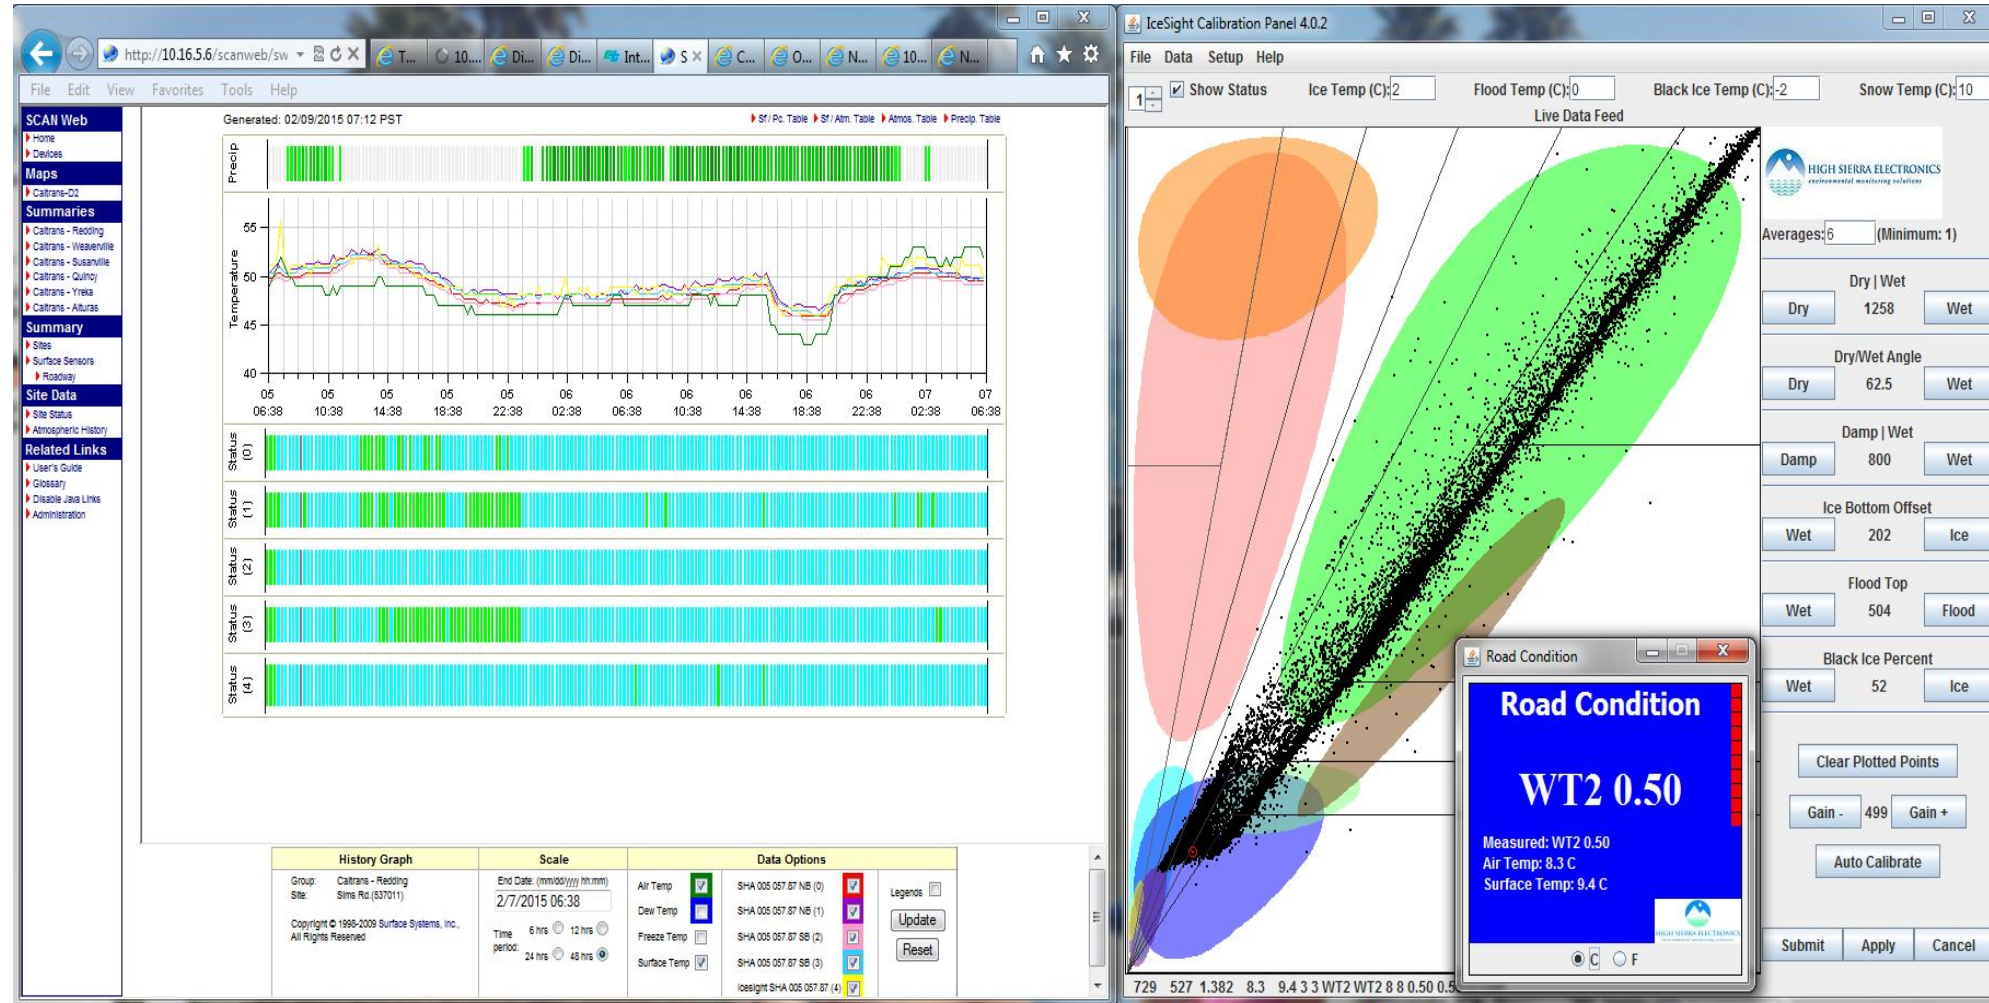
Monitoring Icesight with Live Traffic in a Storm

At the right is a long term monitoring curve created in the field at Sims road. This curve depicts a storm with live traffic. Again notice the amount of reads that need to be averaged out.

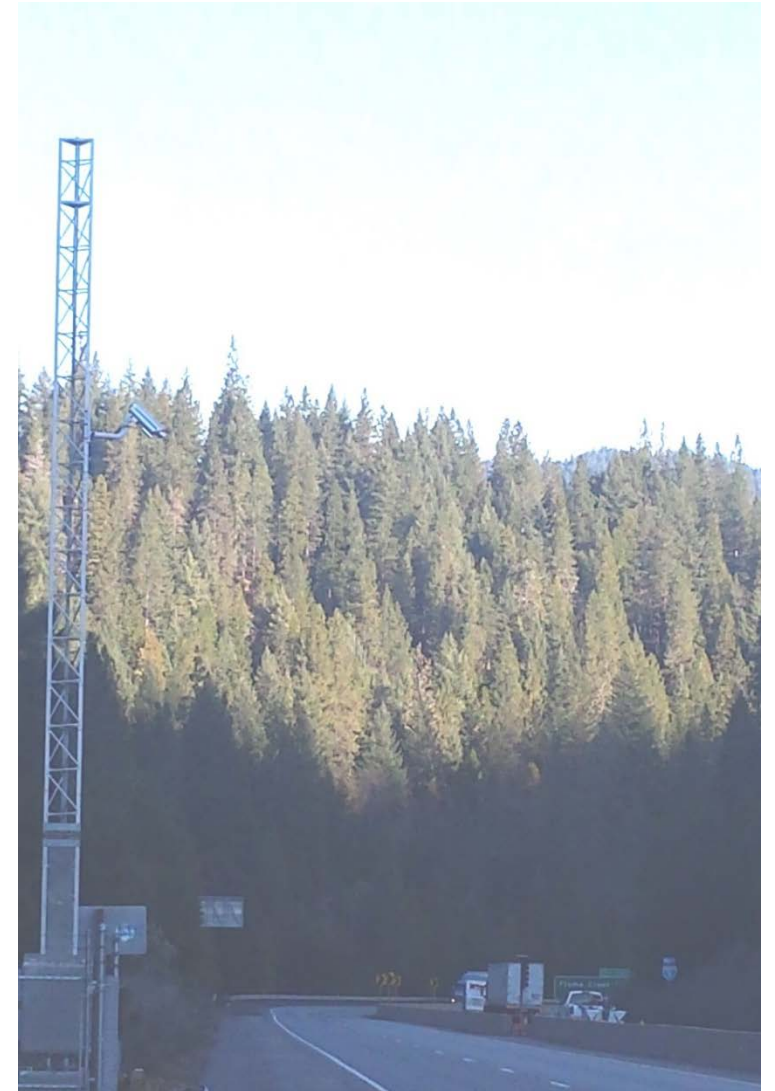
Sims Vehicle Interference Errors

Each time a vehicle is in the Icesight's line of view to the pavement the values returned by the lasers rise to a maximum, which corresponds to a pavement condition of "Error." The averaging values in the Parameters screen of the configuration utility were set too low for a live traffic environment. Researching the settings and setting up a live logging routine to monitor the error occurrences while increasing the averaging values the vehicle read errors were eliminated.

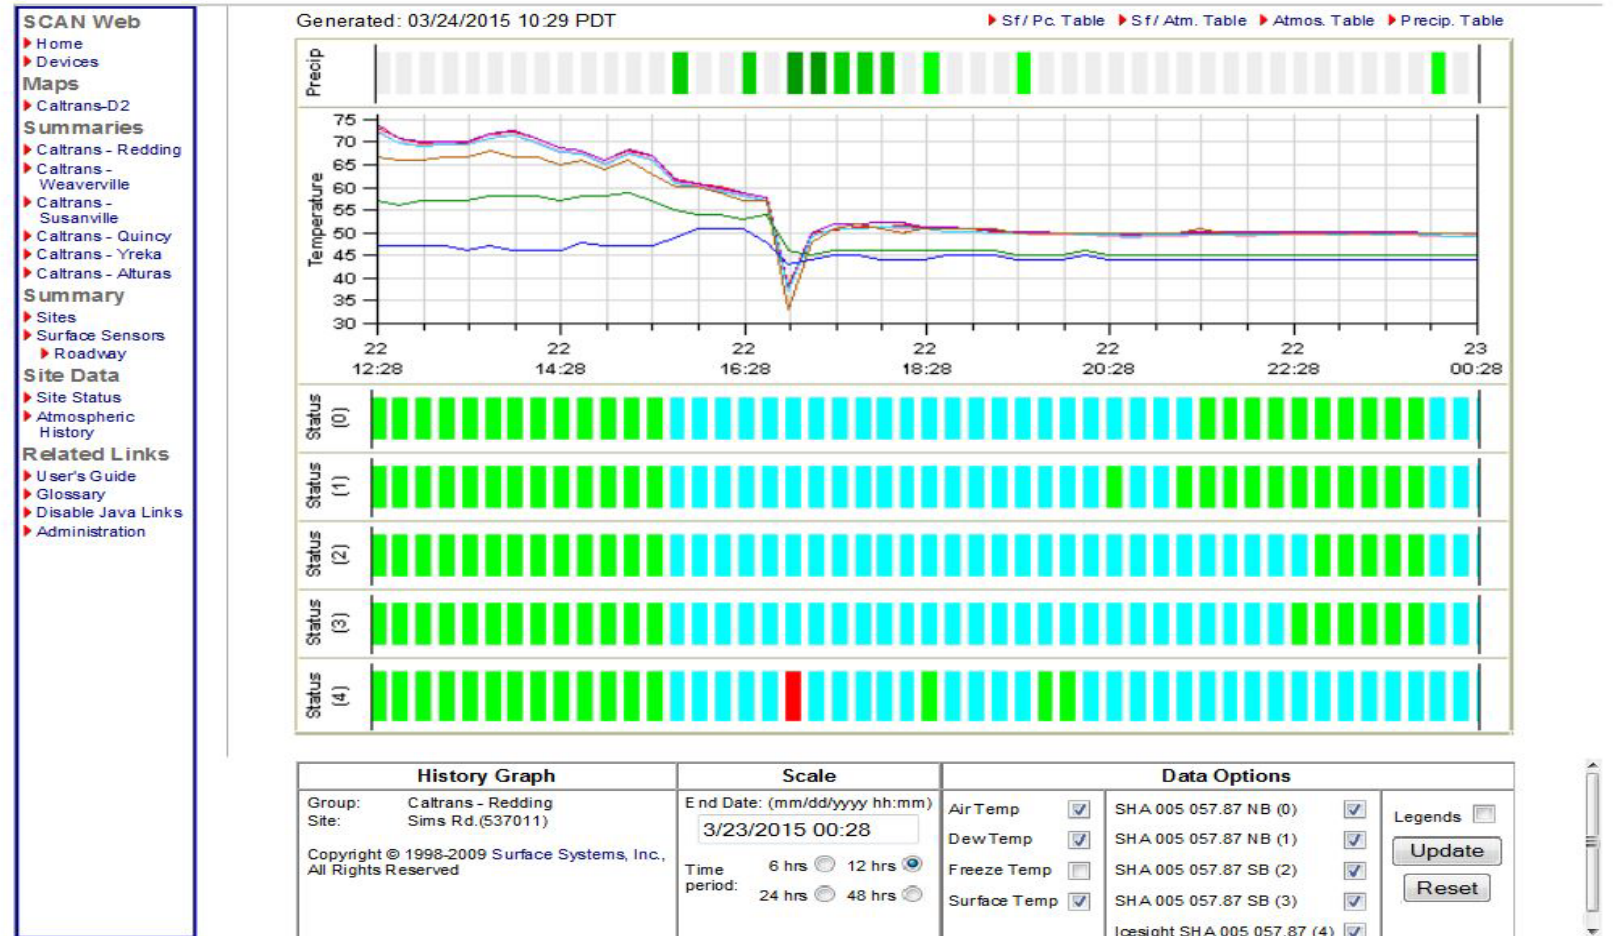
SCAN Web 5.12 - History Graph

Hailstorm Investigation

Investigation of the ice warning revealed a hailstorm as root cause. In an interview with the local truck stop owner he stated there was a significant hailstorm with what he called almond size hail, and he further reported that traffic was pulling off the freeway and waiting the storm out. So we have confirmation of the incident reported by the Icesight as a condition of Ice Warning as a significant incident impacting traffic flow. At the right is an image on the aftermath of the hailstorm showing the remnants of hail on the shoulders.

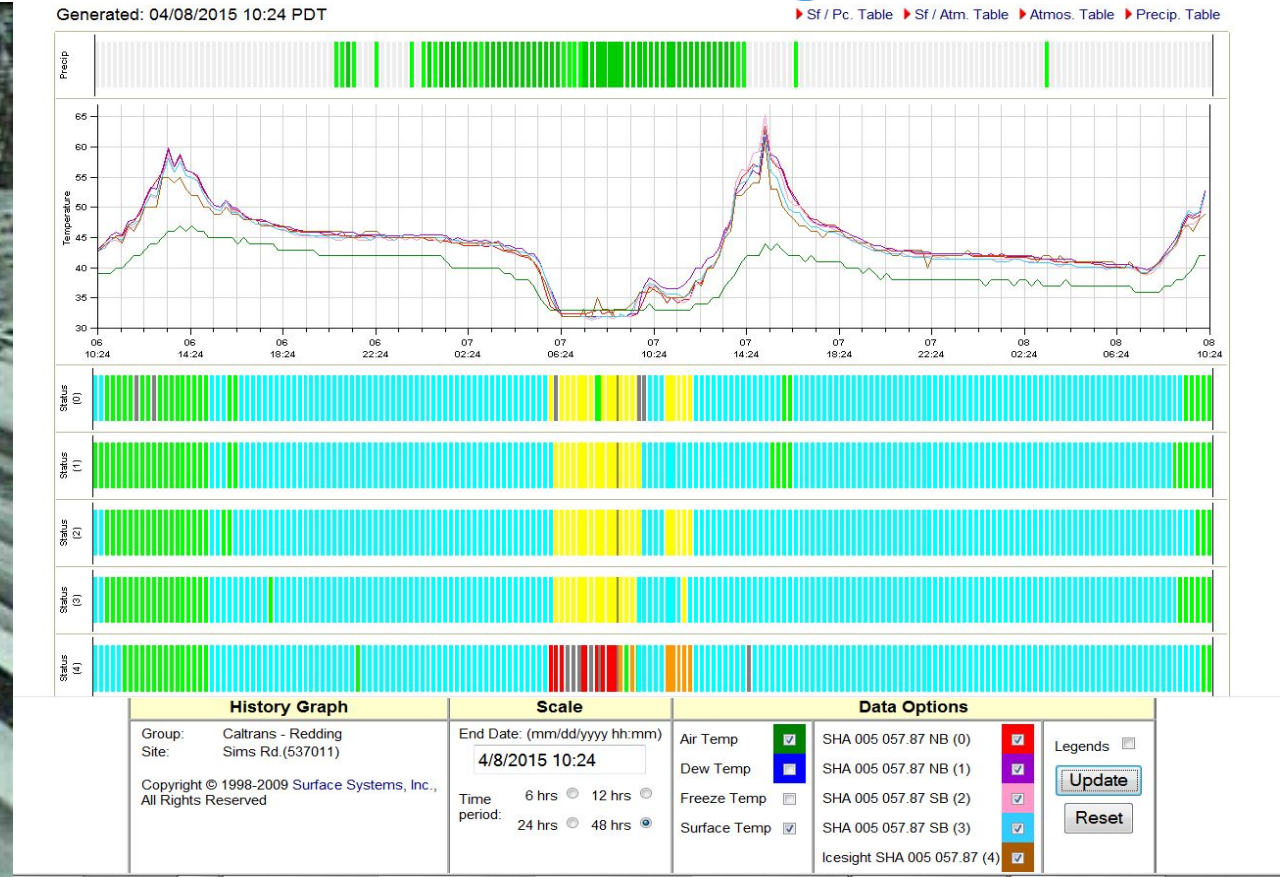
Activation of Snow Warning

At the right is the Scanweb report of the snow warning and watch in April of 2015. In this incident the IPS reported only chemically wet but the indicates a snow warning was a more correct characterization of the actual pavement condition. It is also worth noting the indications of dry and error by the Icesight may indicate fog or low visibility during the incident. Yet again this points out an image archive is indispensable in pavement condition analysis.

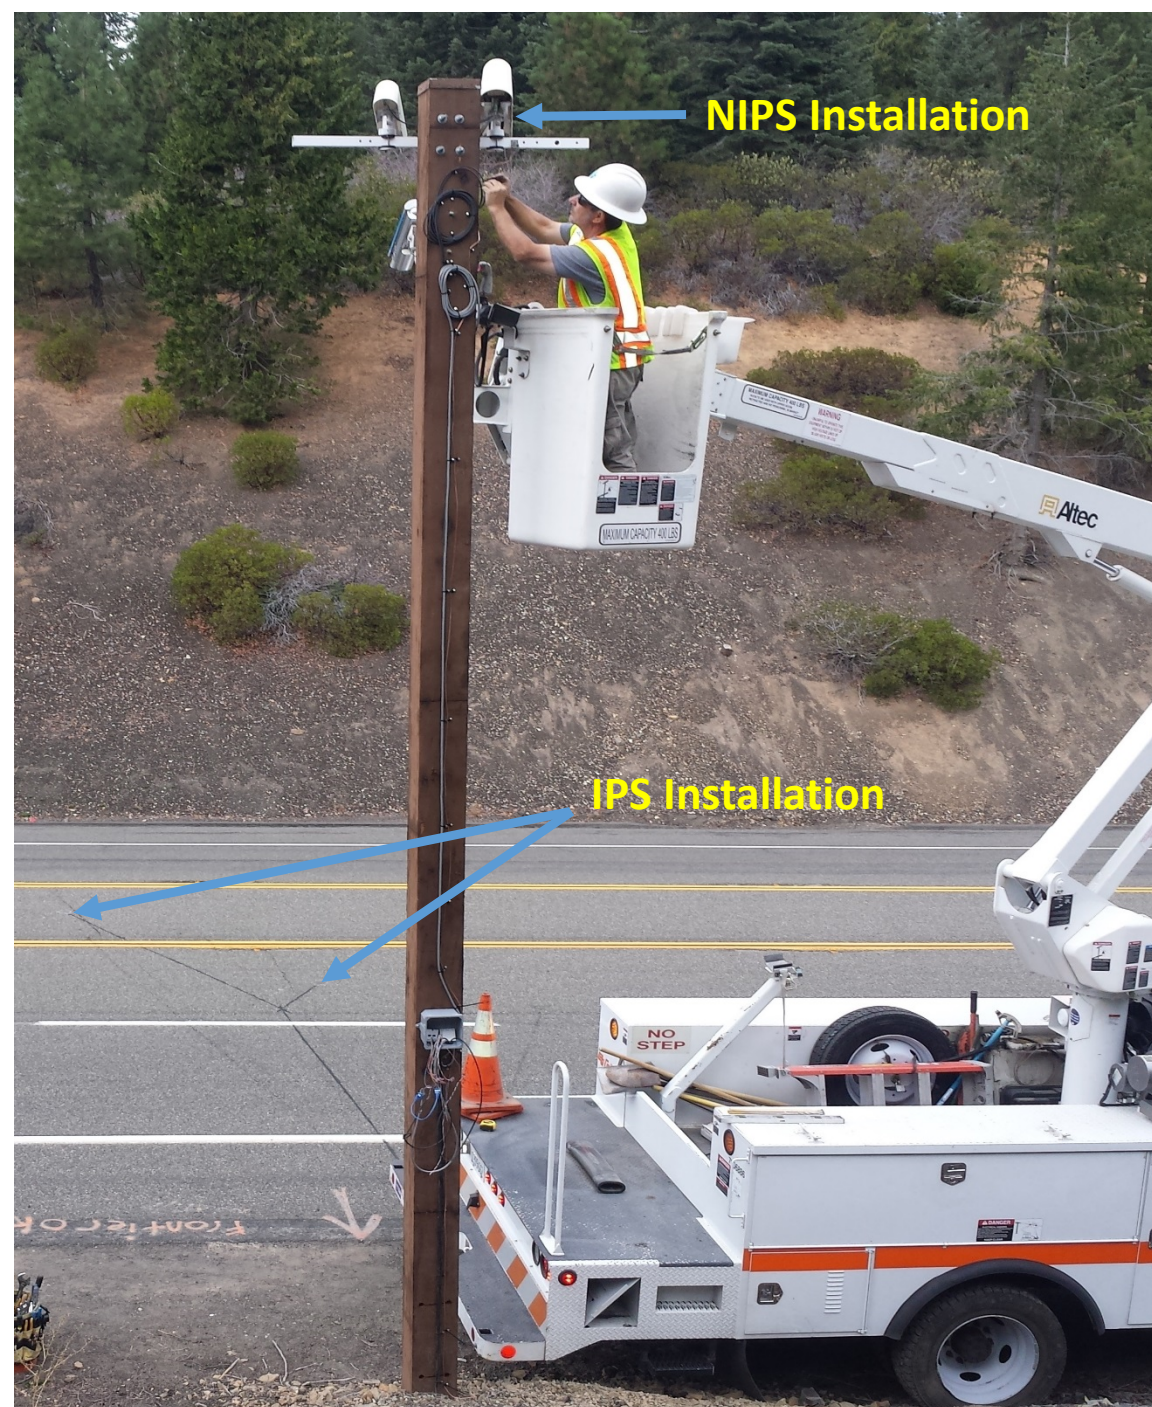
Installation of the out of pavement sensors at Snowman Summit with in pavement FP2000 sensors in the road below. The NIPS were installed 20' up and 25' from ETW on a wood box beam sign post. Note one of the IPS is in the soft median.

- ▶ Proper aiming of the NIPS was observed to include the lanes only in the IR temperature sensors cone of view.
- ▶ Setting IR spectral surface sensors to not interfere with each other. Care was taken to aim each of the NIPS about 8 feet on each side of the in pavement sensors to ensure the laser emissions from one NIPS would not interfere with the other NIPS.
- ▶ The look angle of sensors from the pavement up to the NIPS was calculated to be approximately 40° elevation well within the manufacturers specifications.

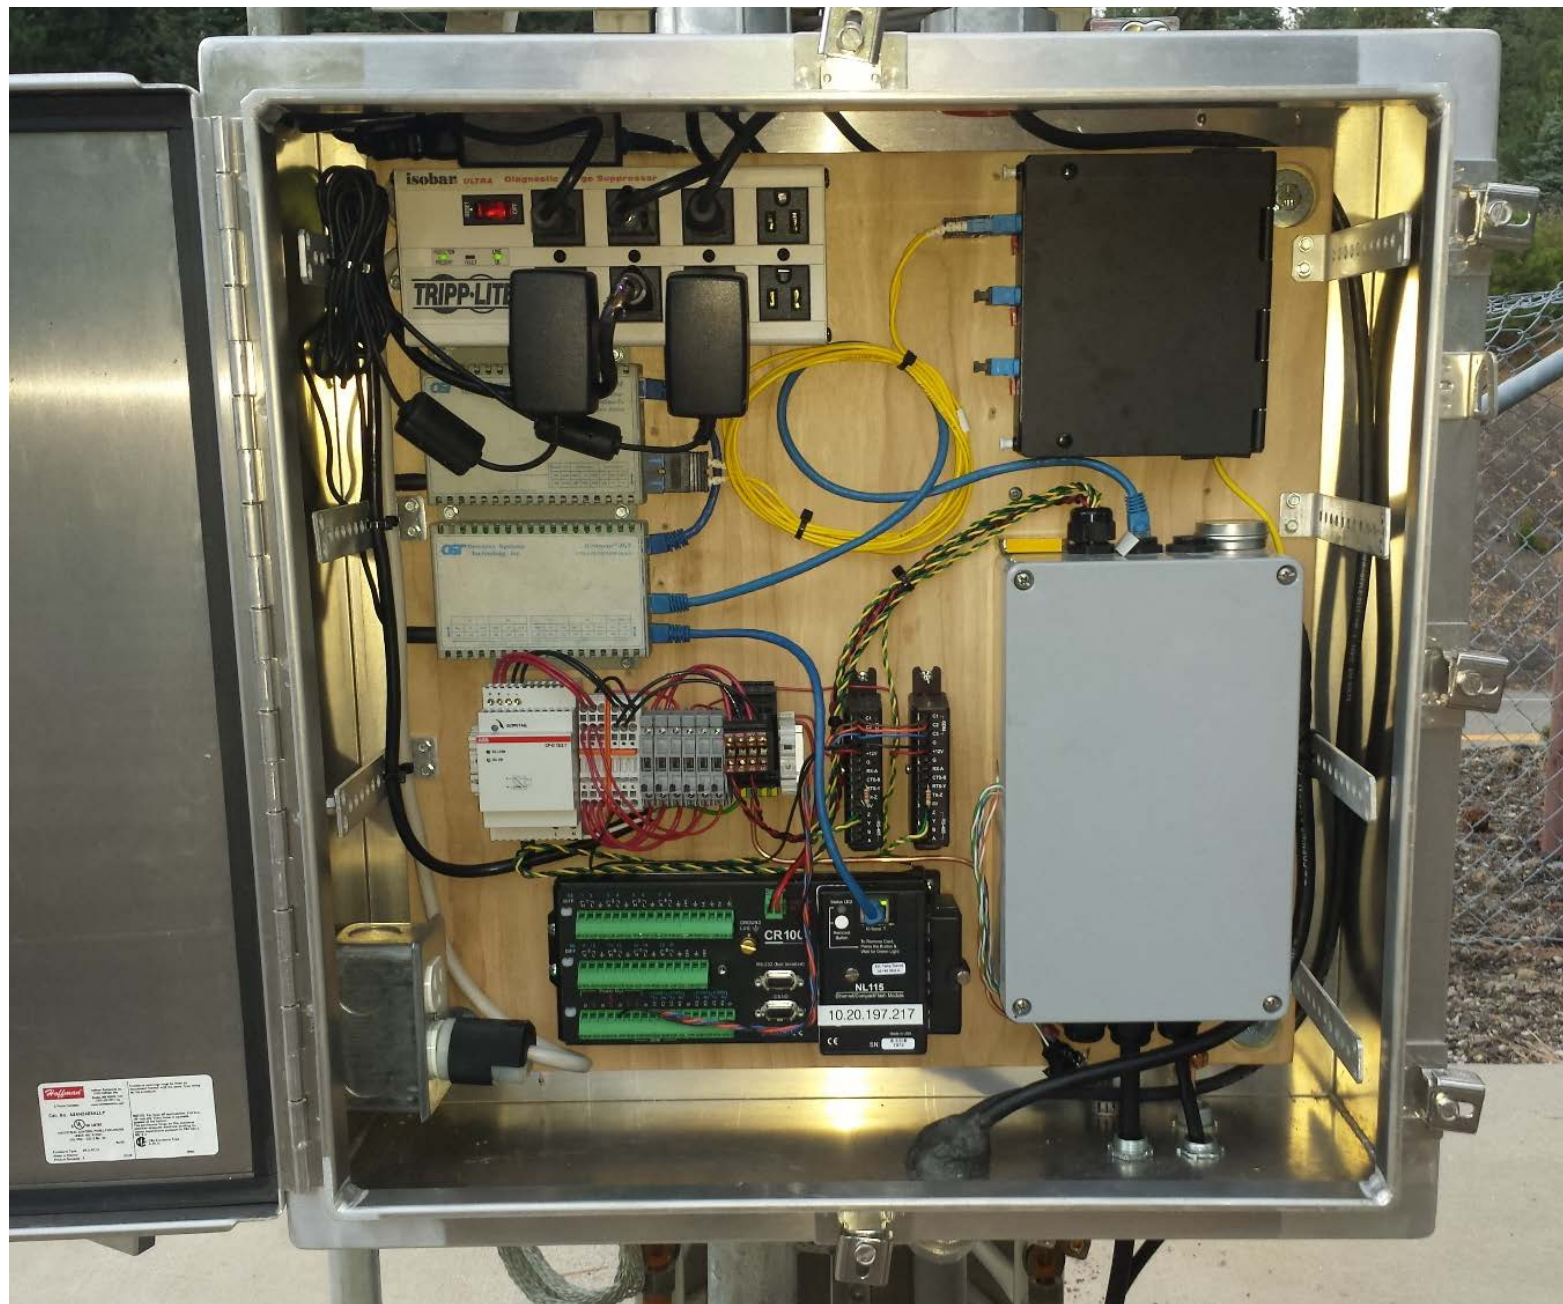
A separate datalogger had to be installed at the Snowman site as this site has a SSI RWIS that would not support the NIPS. This meant we had to have two instances of ESS at the Snowman location in Scanweb. So when we see images of Scanweb captures later in the presentation they are compilation's of the two instances of the ESS Scanweb at the Snowman location.

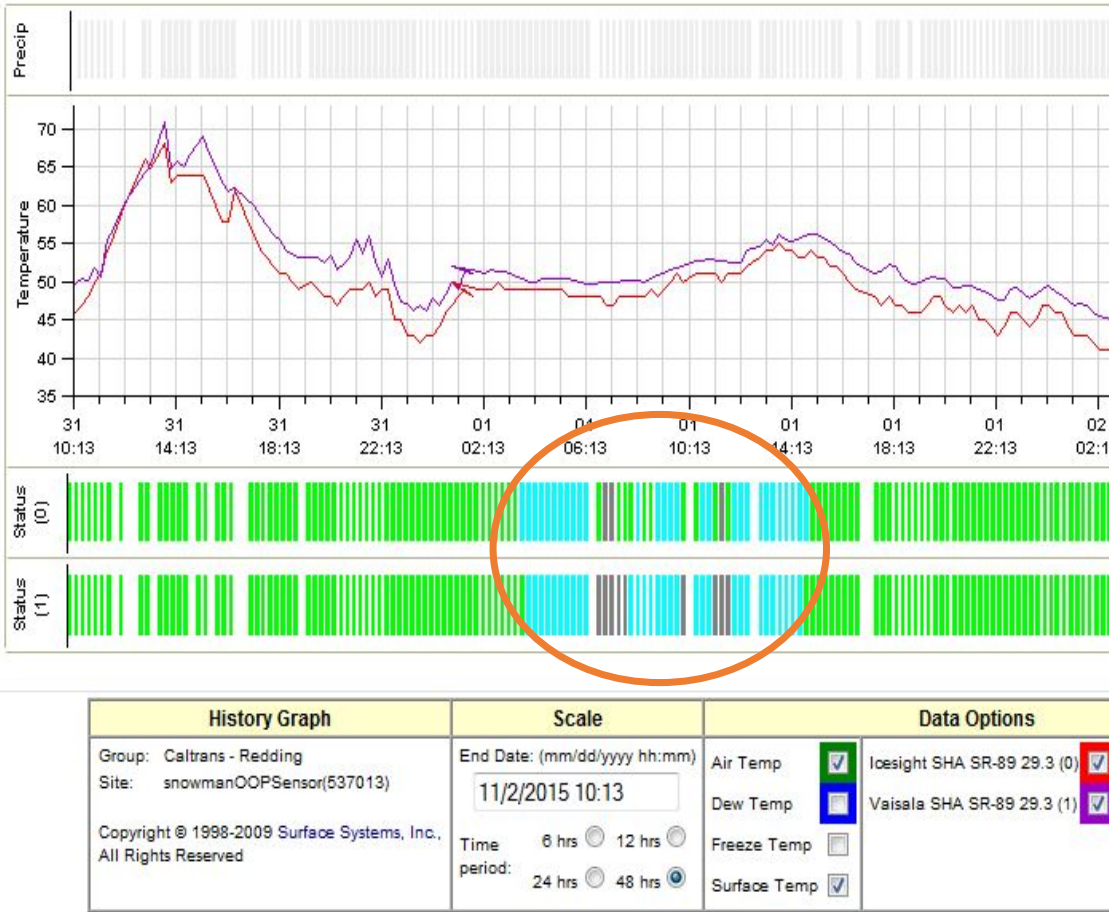
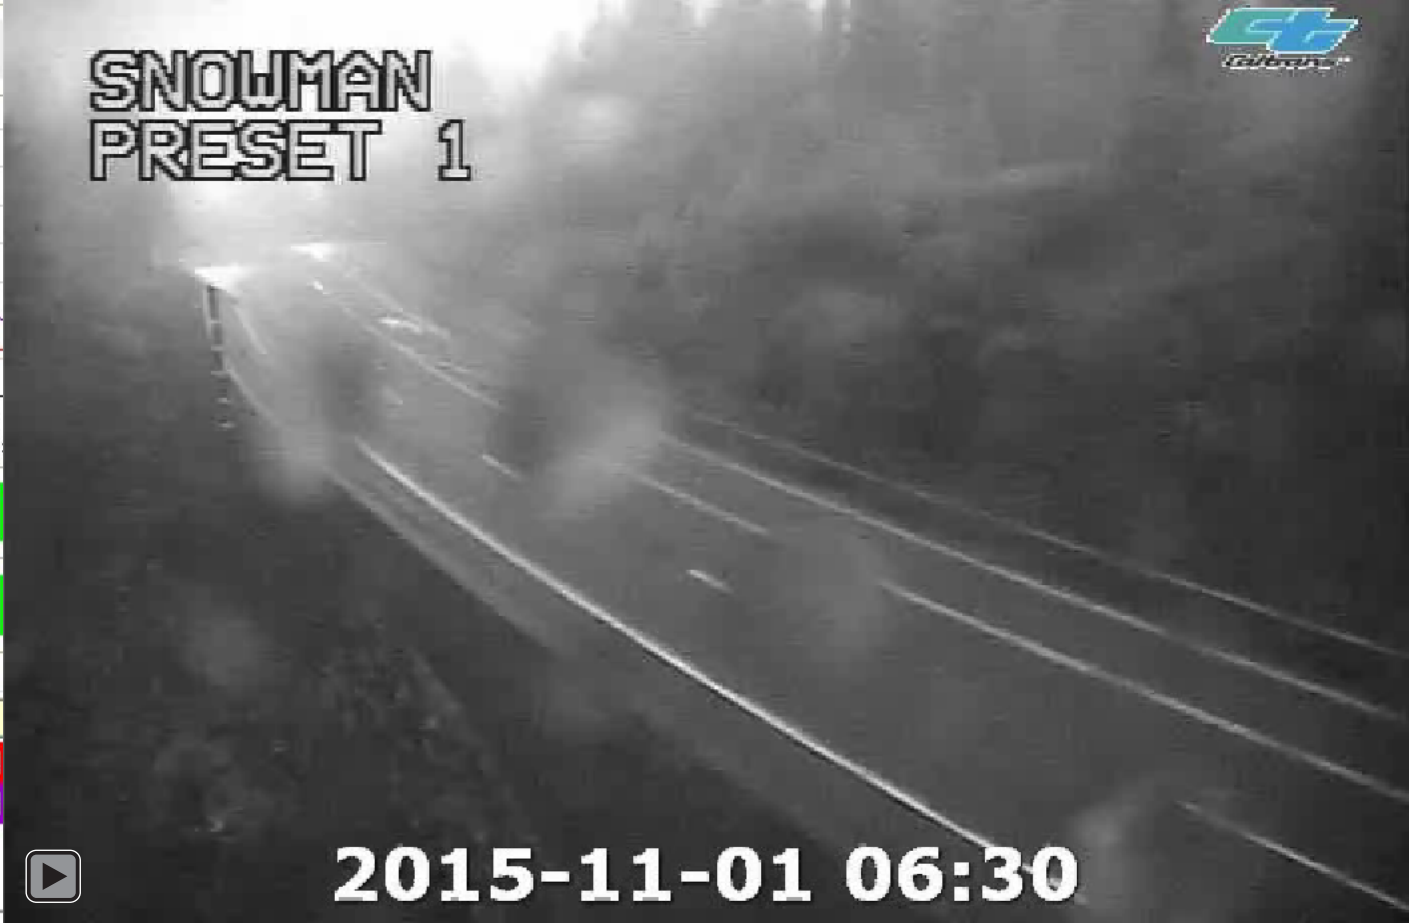
Interesting Event Due to Fog November 1, 2015

The video shows the visibility conditions during error and erroneous dry reports from the NIPS sensors. This fog incident lead me to contact both vendors which resulted in both vendors coming up with methods to report this condition as either fog or low visibility. By the time we got the updates it was too late in the test cycle to fully evaluate the updates. In addition the Vaisala product can be ordered with a visibility option which will report this condition without modification.
