Comparison of In-Pavement Versus Non-Invasive Pavement Sensor Technologies

Mike Beyer ITS Engineer, Caltrans D02

June 22nd, 2016

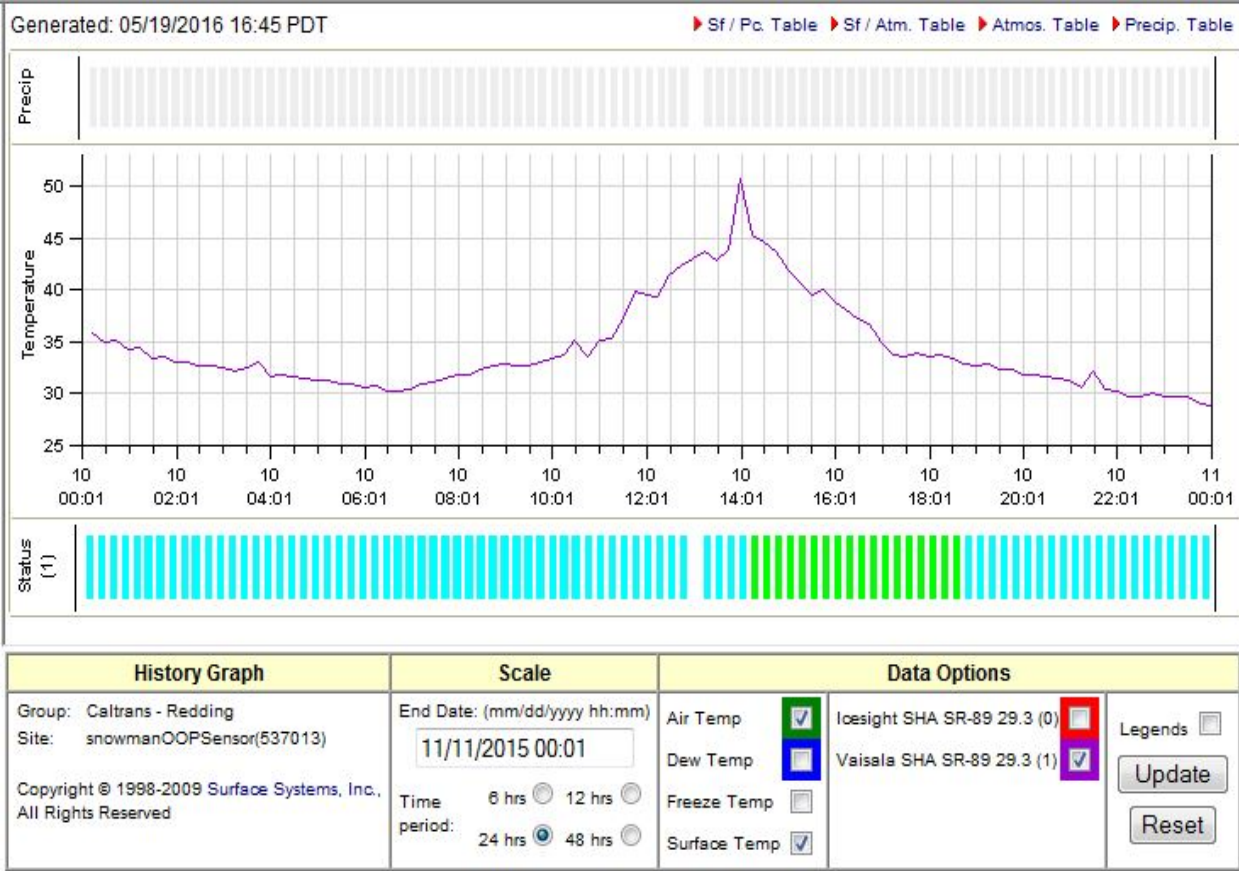
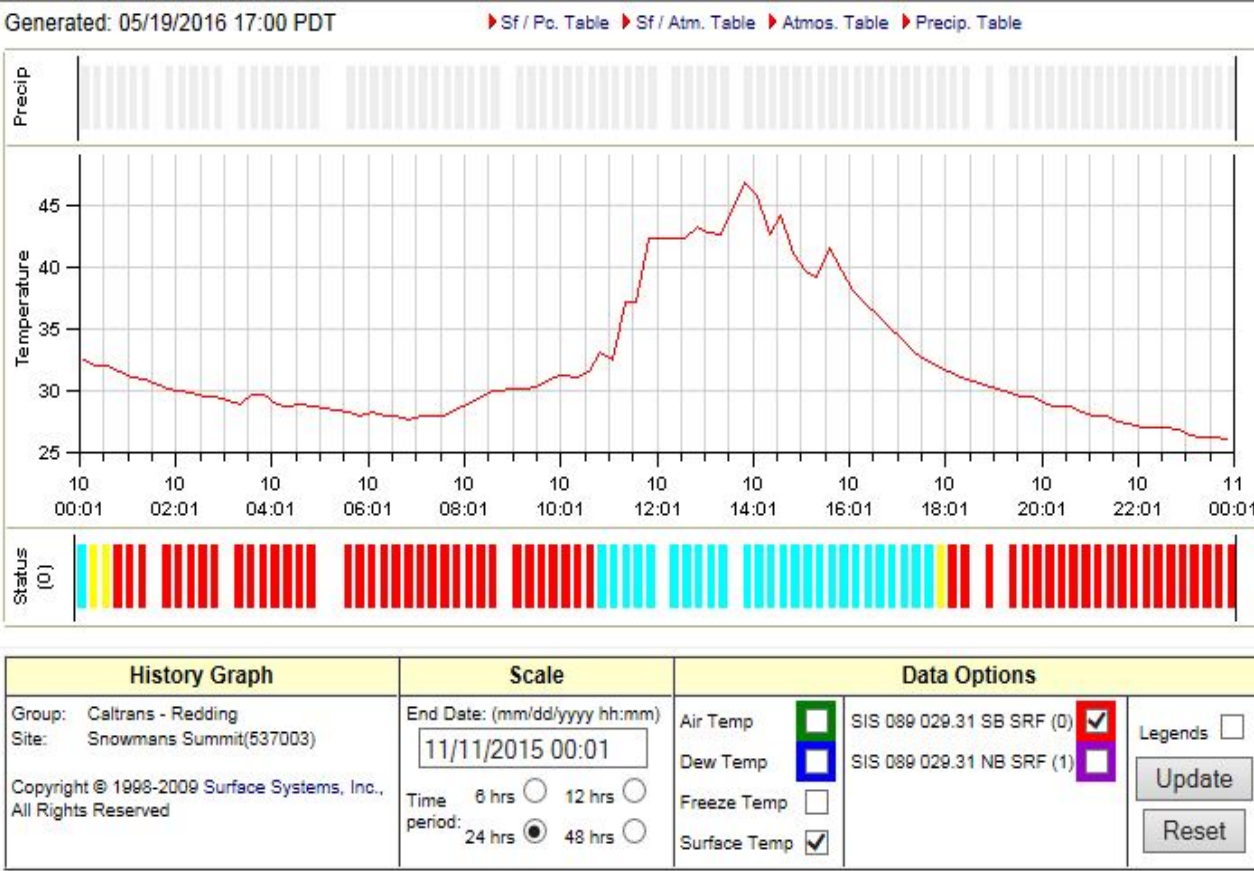
Interesting Event Nov. 10th 2015 IPS Reports Ice NIPS Trace Moisture

The right Scanweb report shows the IPS where the Vaisals NIPS is aimed. The left Scanweb report shows the Vaisala NIPS. See next slides for graphs and video of the conflicting reports.

This video covering the daylight hours of November 10th 2016 we compare conflicting reports from the IPS and NIPS. From 1:00 A.M. till 10:20 A.M. the IPS reports ice warning while the NIPS reports trace moisture. It appears the ice warning from 8:30 from on is incorrect.

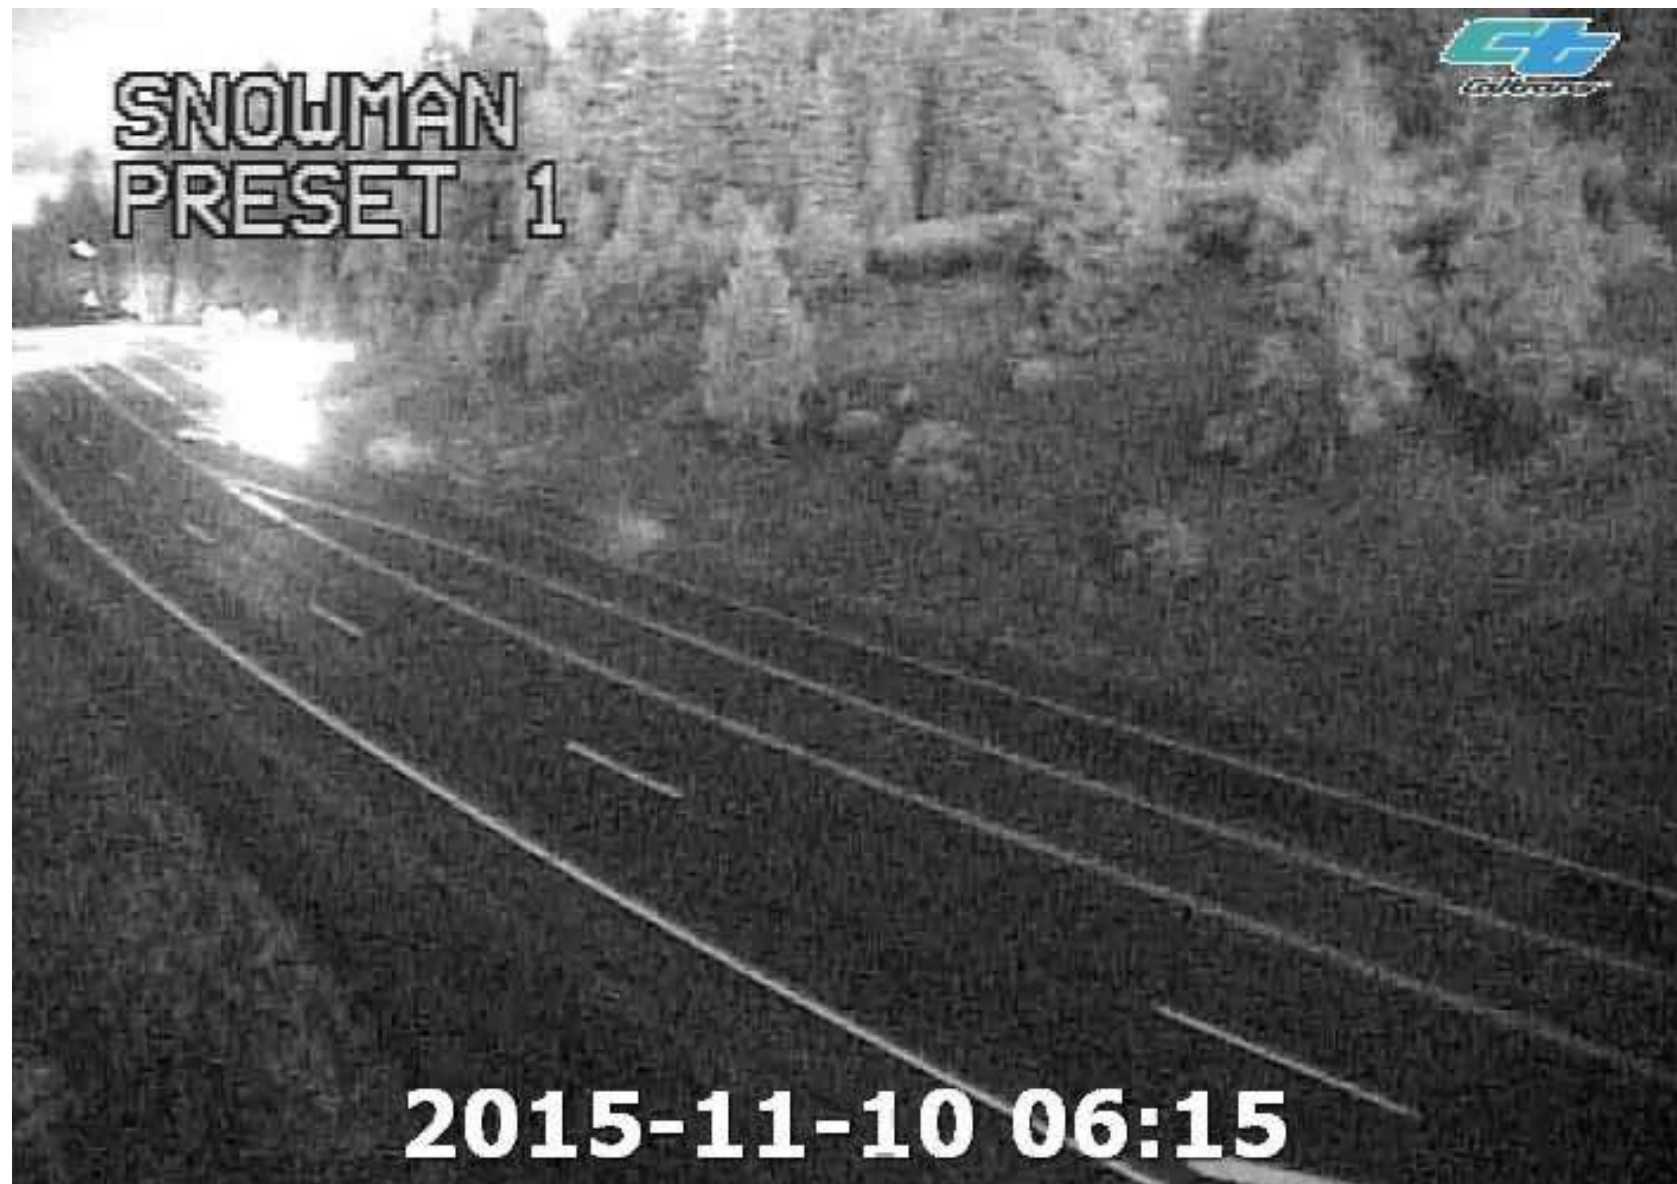
NIPS Moist Vs. IPS Frost Data Evaluation

At the right is a graph of the surface covering reported in the Vaisala data logs. Which shows an extremely shallow layer of snow on the pavement 1/100th of a mm which Vaisala has chosen to report as moist. On the next slide for comparison is a similar graph showing a incident where the Vaisala NIPS transitioned through snow, to ice, to snow to wet and finally to moist.

For further analysis we look at the raw data from the Vaisala on the following slides.

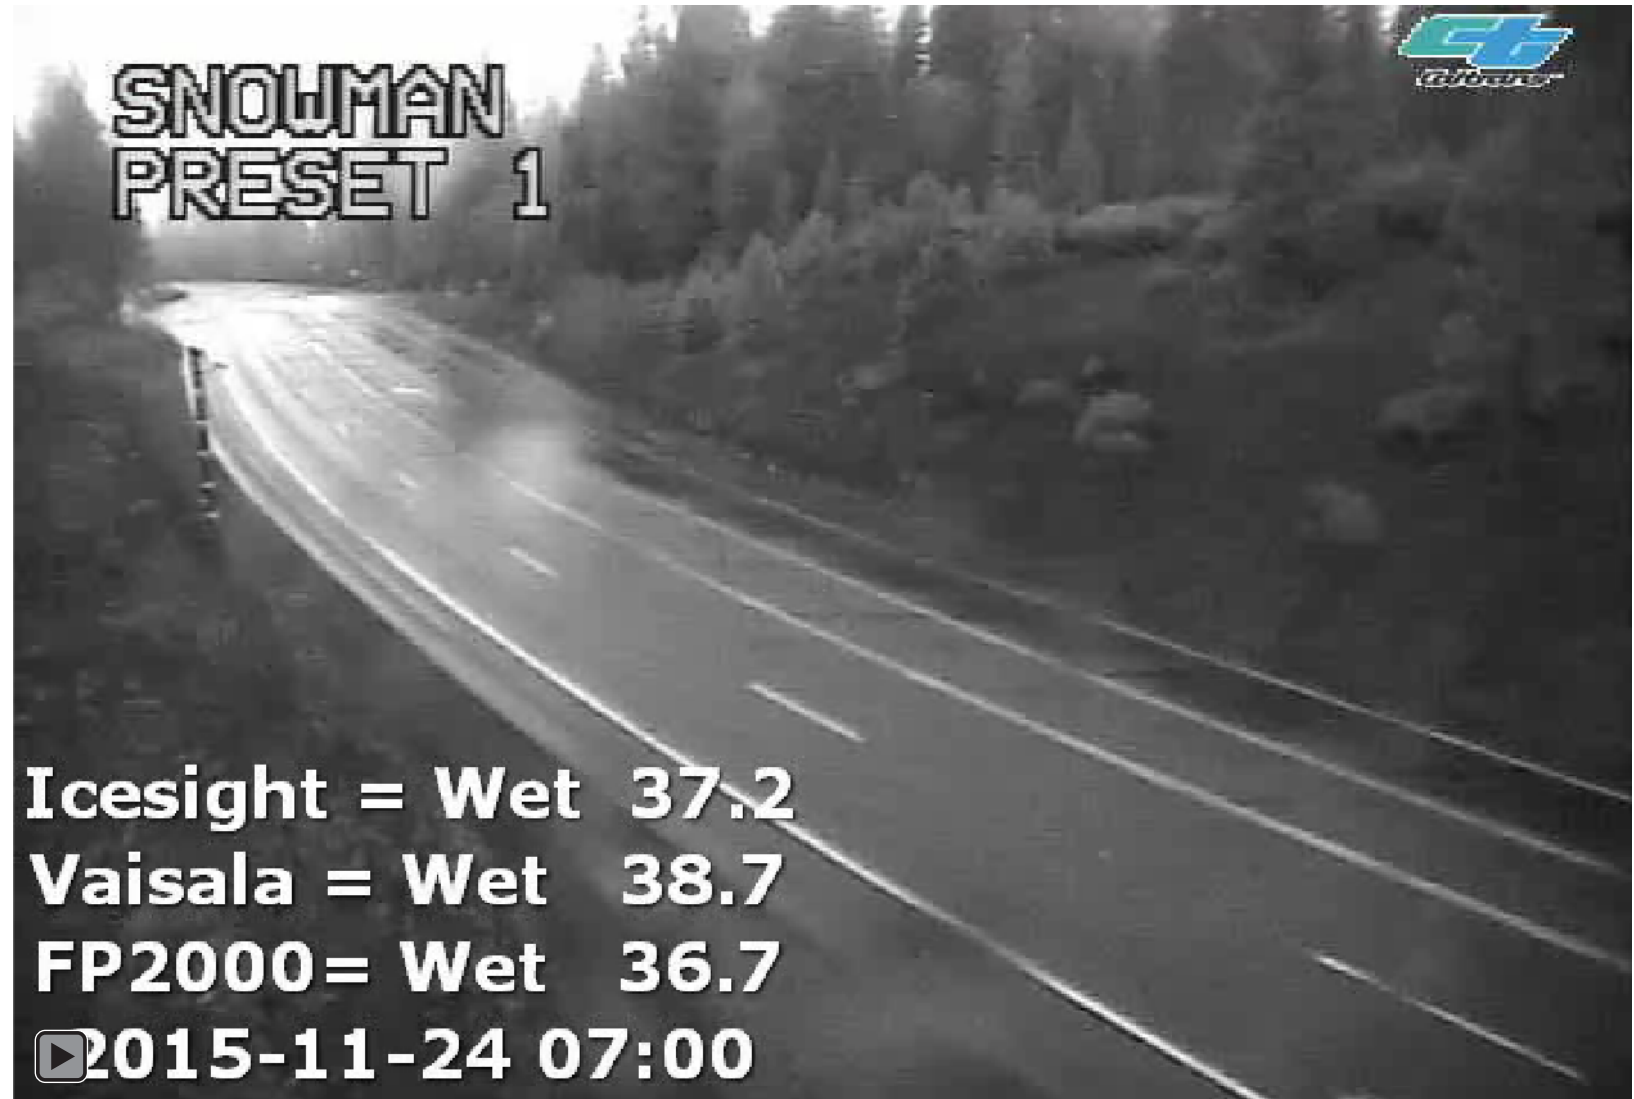
Snow Event At Snowman Summit Nov. 24th 2015.

Also note the dry and error reports from the NIPS. This points out that in some locations where fog is a common occurrence IPS or a combination of IPS and NIPS may be a preferred solution.

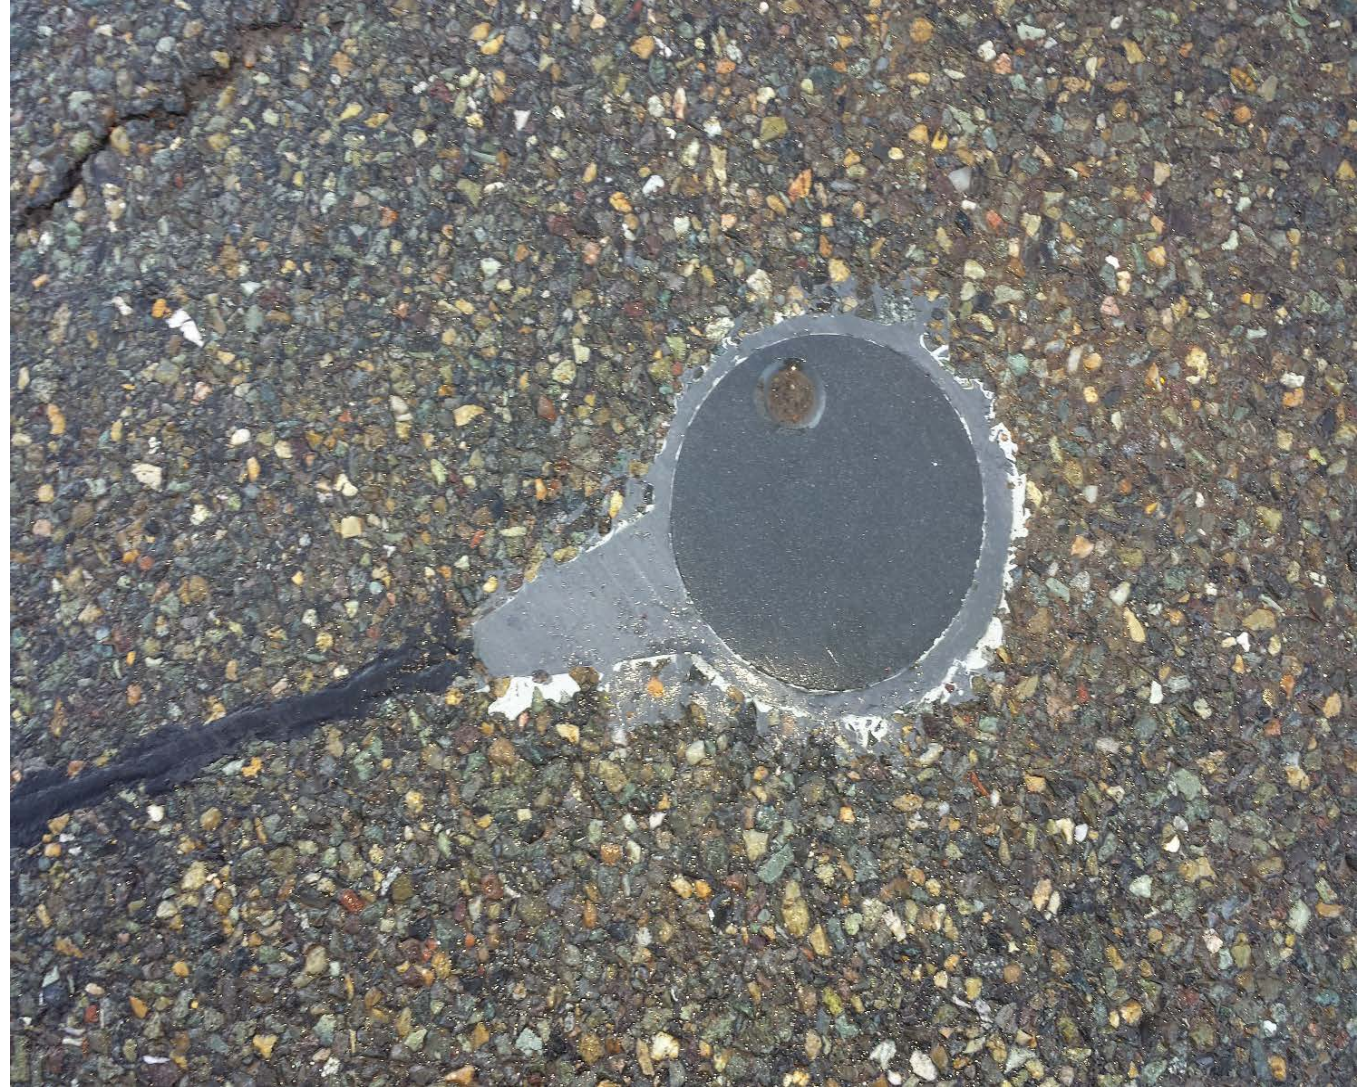
Images of Cinder, Salt and Water mixture in IPS Well

This depicts a failure mode that has been observed numerous times in our evaluation and noted other evaluations where the well remains full of material that is not representative of the pavement in general. I made several trips to the site during these events and confirmed that the well in the IPS was full of a paste mixture of cinders, salt and water. With several onsite observations confirming this and collecting data from the maintenance logs on when de-icing chemicals were applied this failure mode was confirmed under certain conditions to persist for prolonged periods.

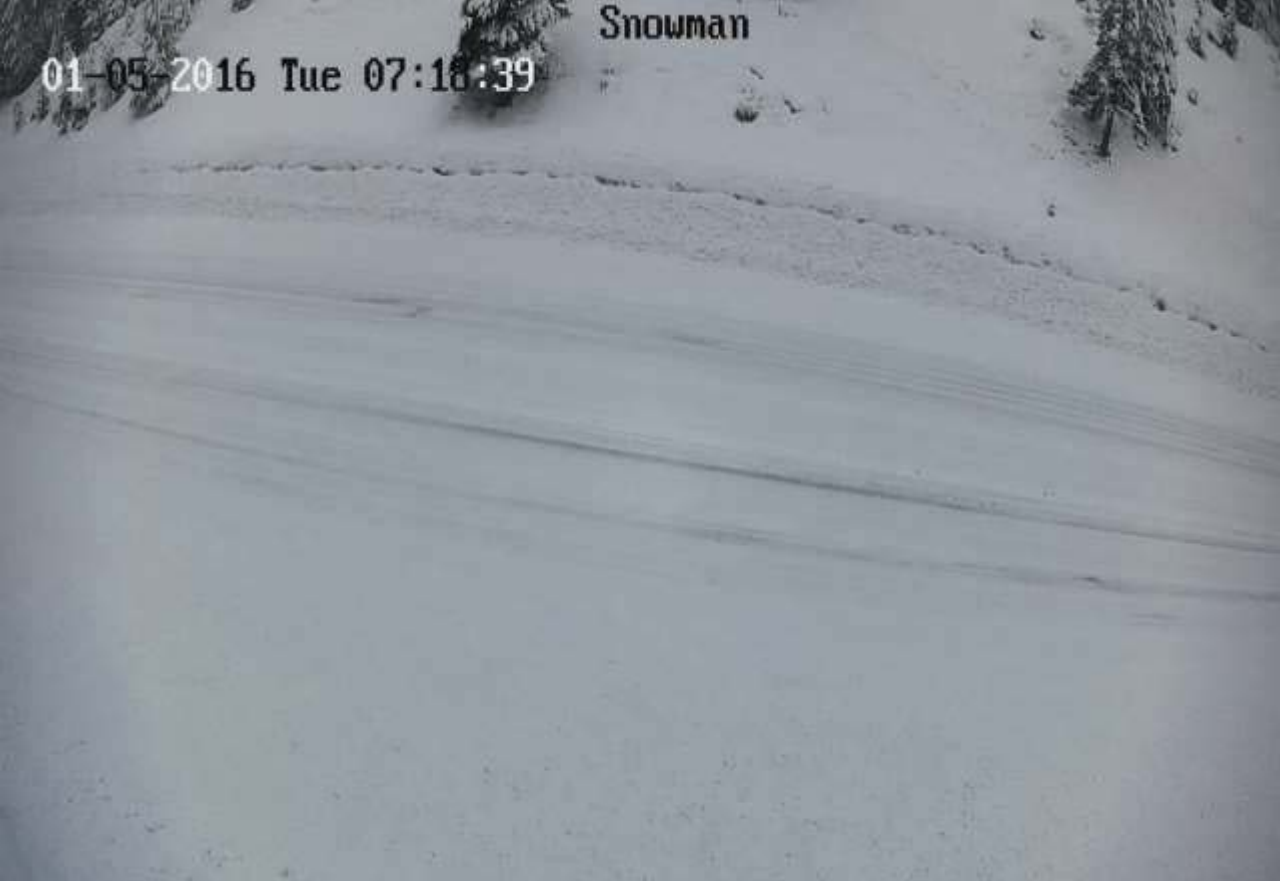
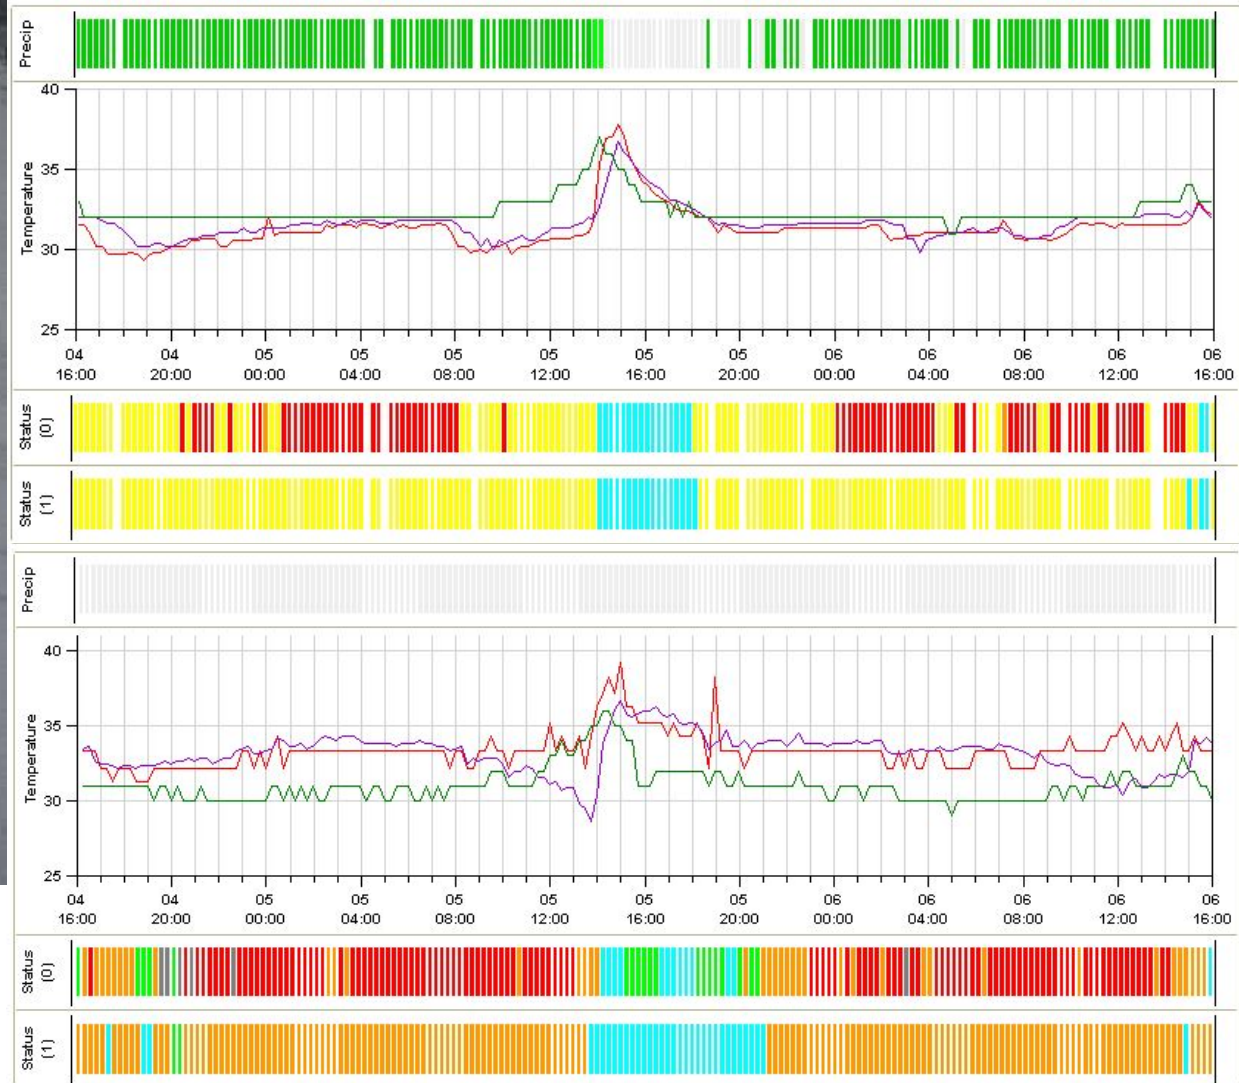
The above video taken with the HD camera installed on the same post as the NIPS shows a snow incident where the IPS is reporting chemically wet, the NIPS is showing snow watch or snow warning and in this case there is no doubt the snow watch/warning is correct. This also points out the value of the HD camera in arbitrating the actual surface condition

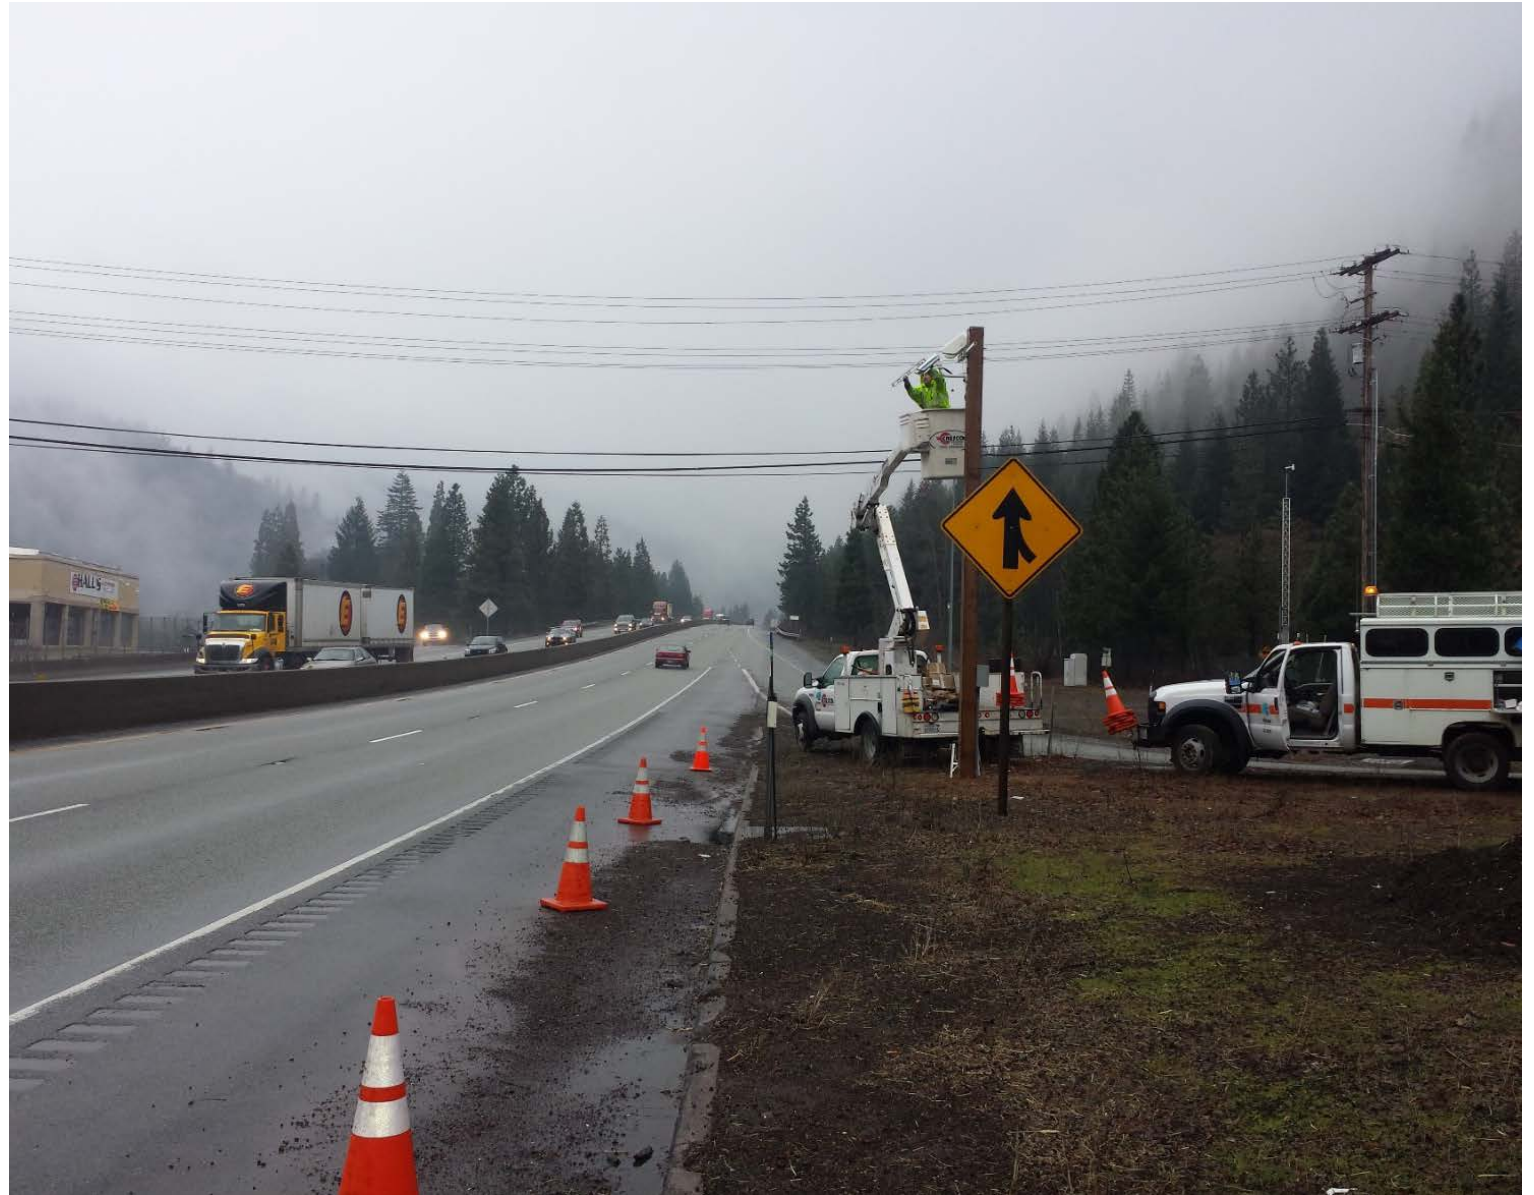
Installing the NIPS at Dunsmuir
Installed 20' up on a wood box
beam sign post 26' from ETW.
With Lufft IRS31 Pro in the lane.

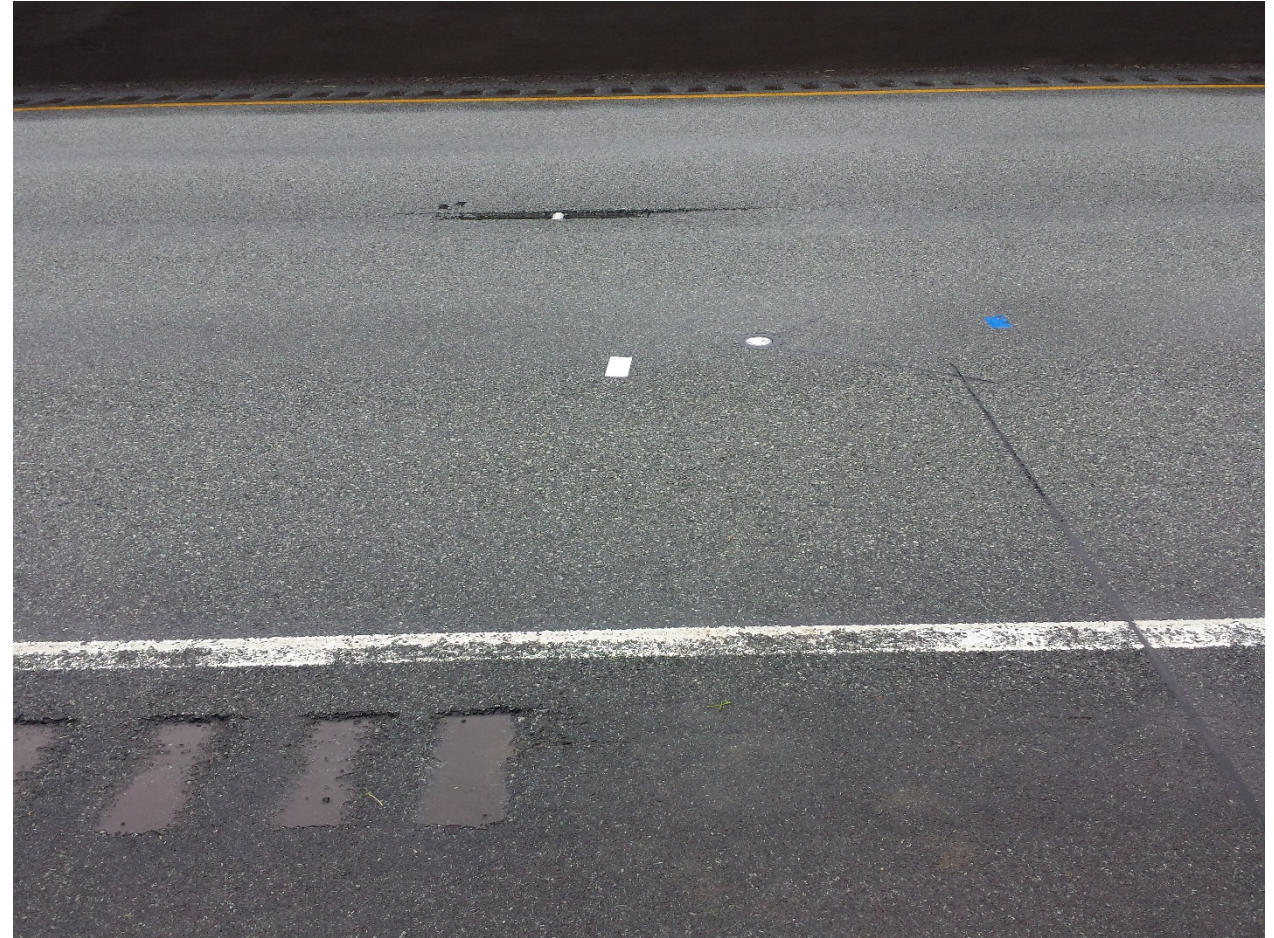
I-5 SB at Dunsmuir CA

Aiming the NIPS near the IPS, at this site we aimed the NIPS much closer to the IPS as further investigation of the principals of operation and discussions with the vendors identified the cone of reception for the IR sensing component to be much smaller than first anticipated.

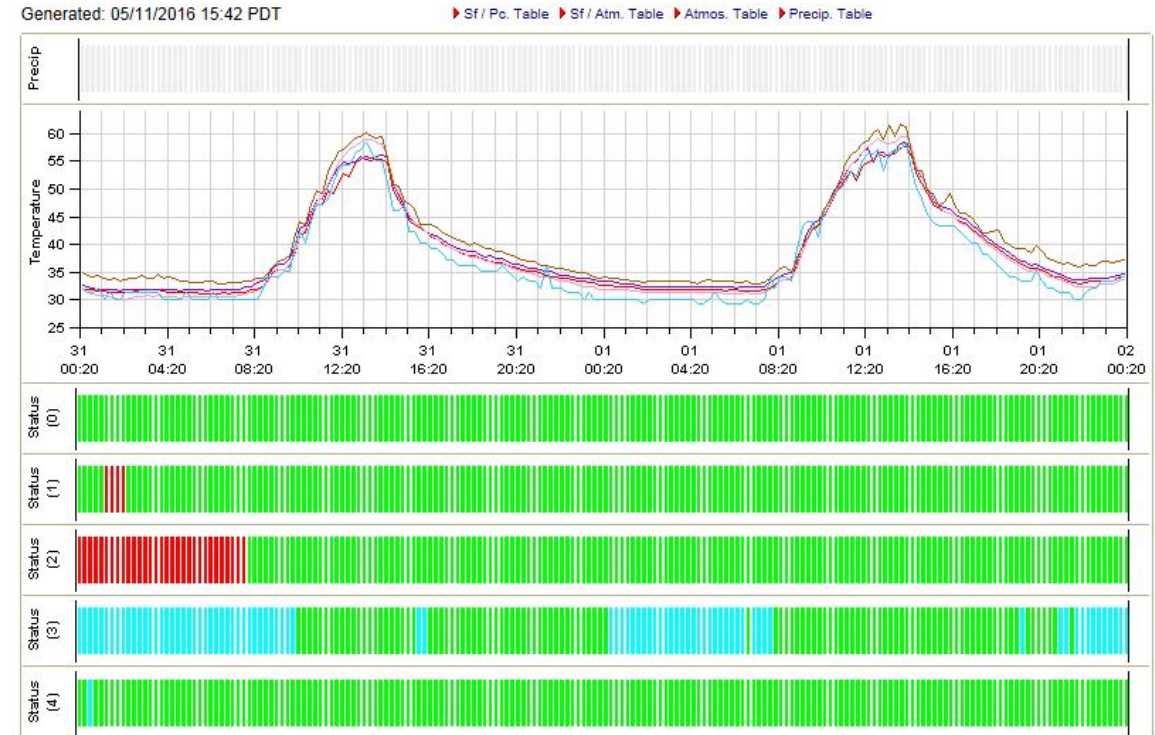
Interesting Event At Dunsmuir January 31st

At the right is a Scanweb presentation of an event where the IPS is showing Ice Warning through 8:30AM and one NIPS is showing trace moisture and the other is showing dry. In this case the videos on the following slide show trace moisture was the most correct. The interesting thing to note is the IPS was reporting the correct response for the general atmospheric conditions not the pavement conditions as shown by the wide shot video showing the roadside. Note the logs from the Vaisala DSC showed no water, ice or snow during this period.

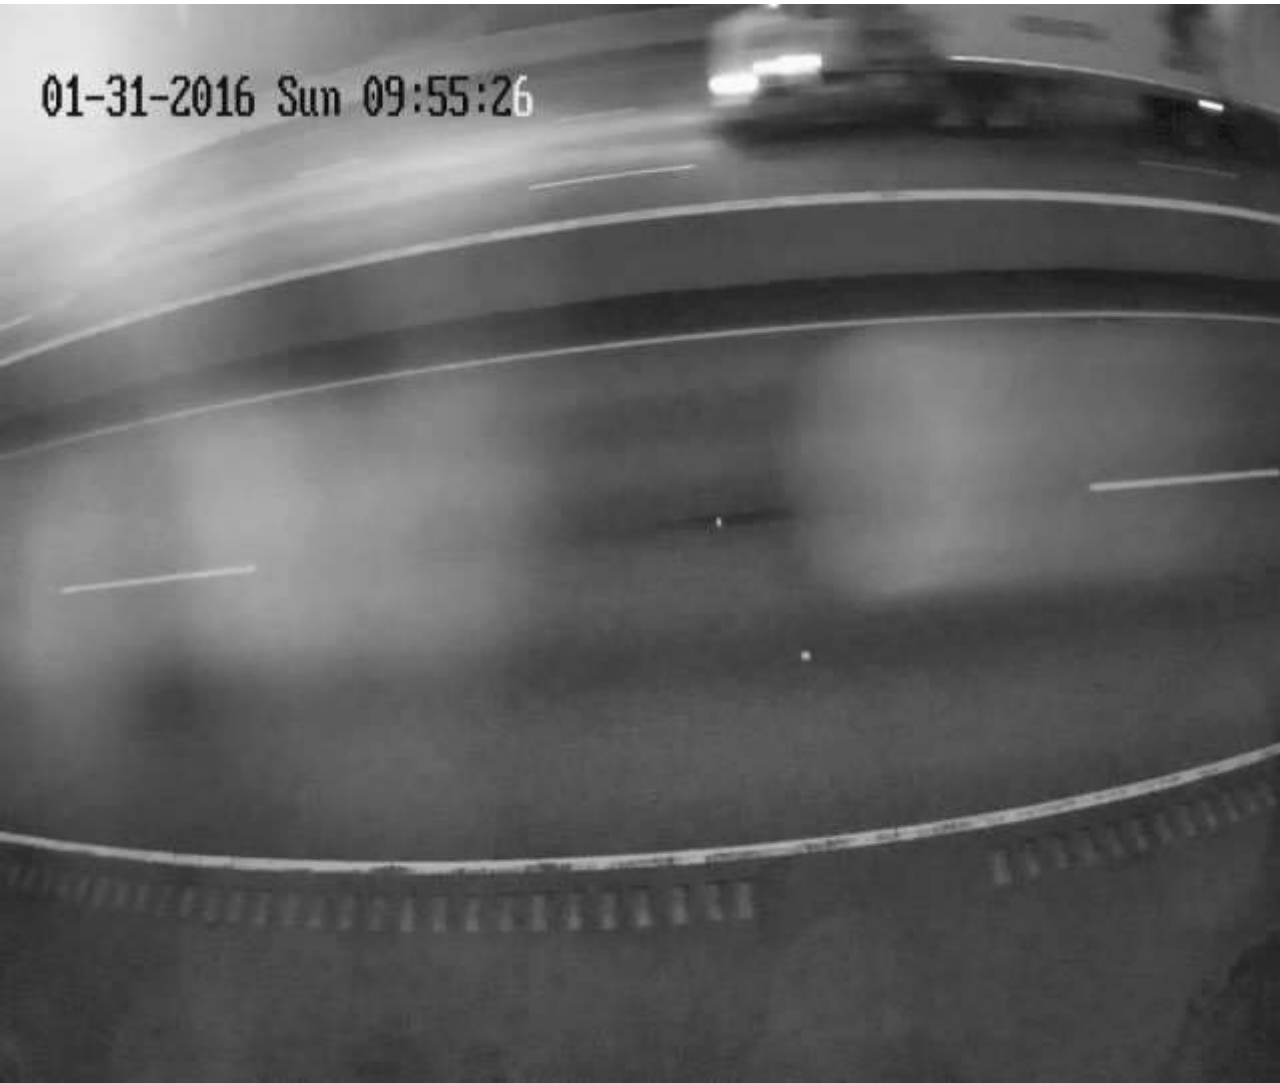
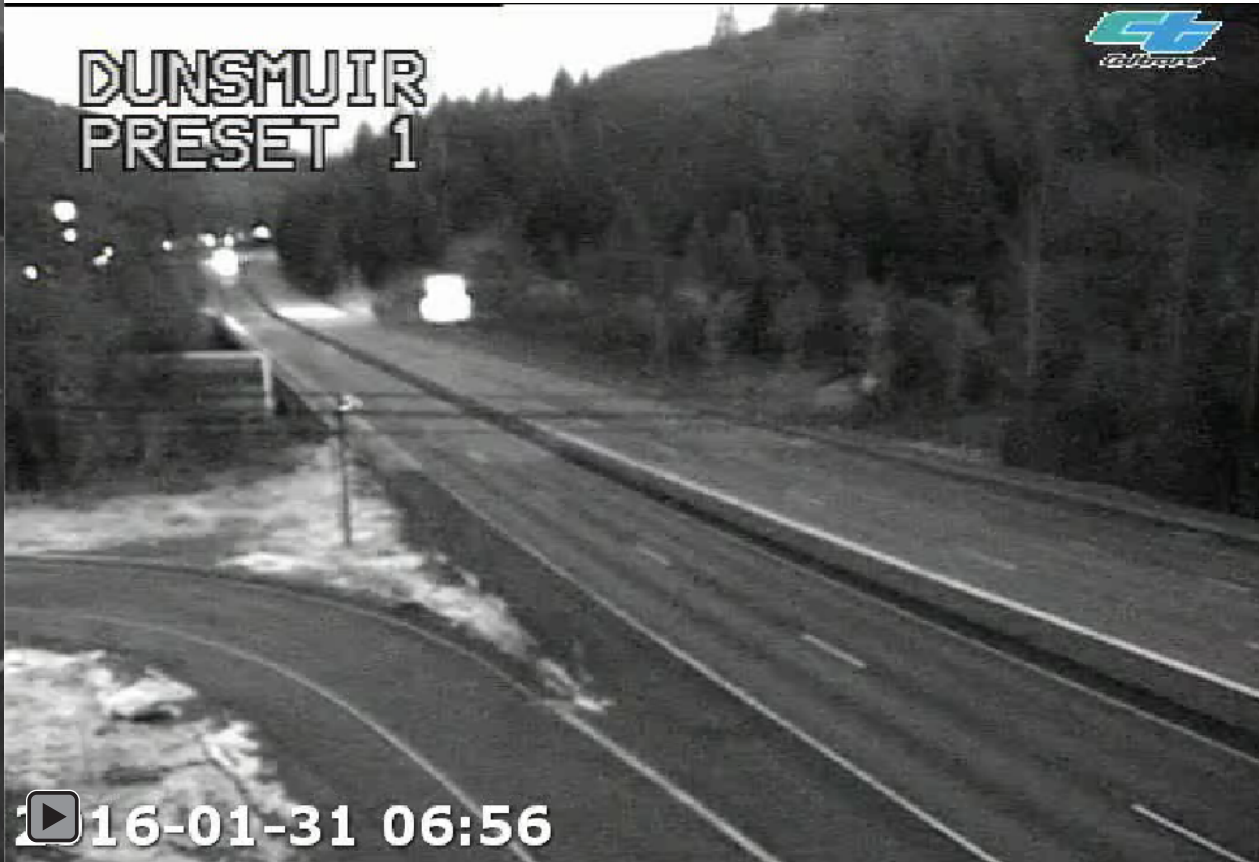
Interesting Event At Dunsmuir January 31st

Note the embedded time stamp in the video to the left reverted to eastern time when moved from Snowman to Dunsmuir.

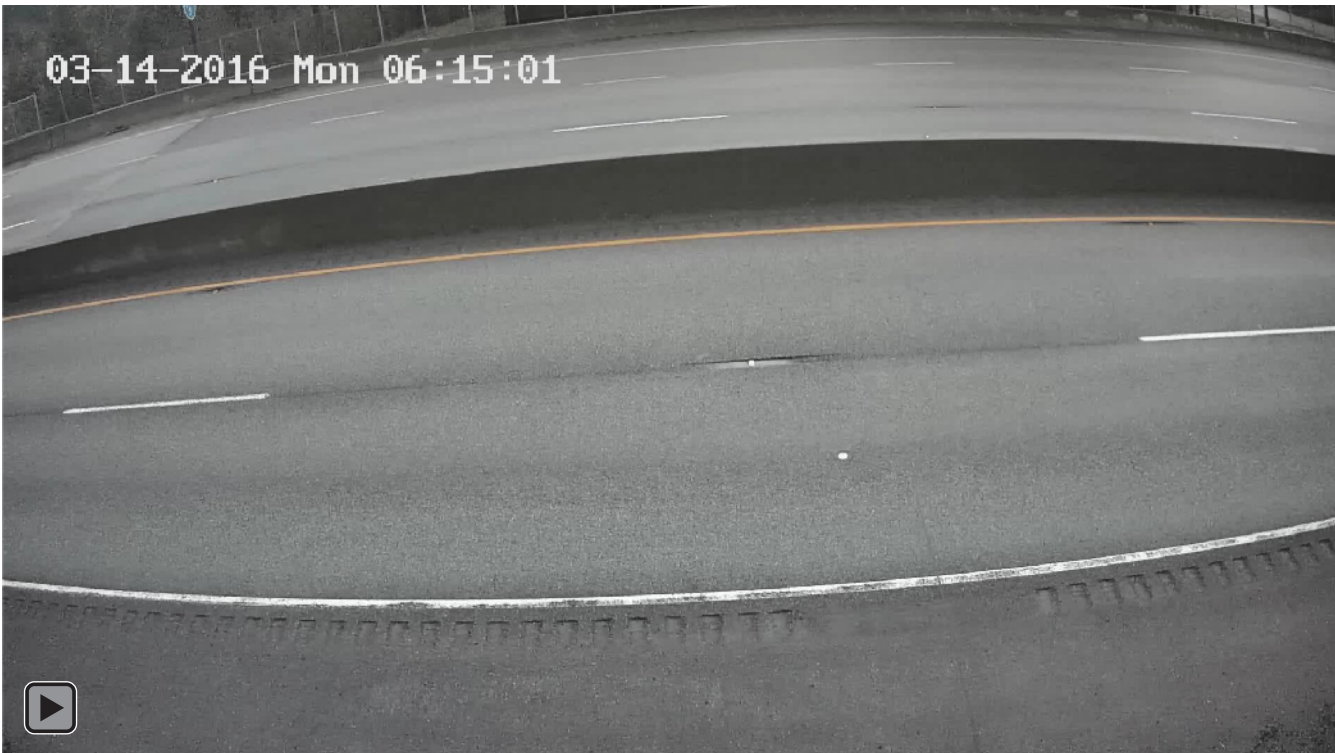
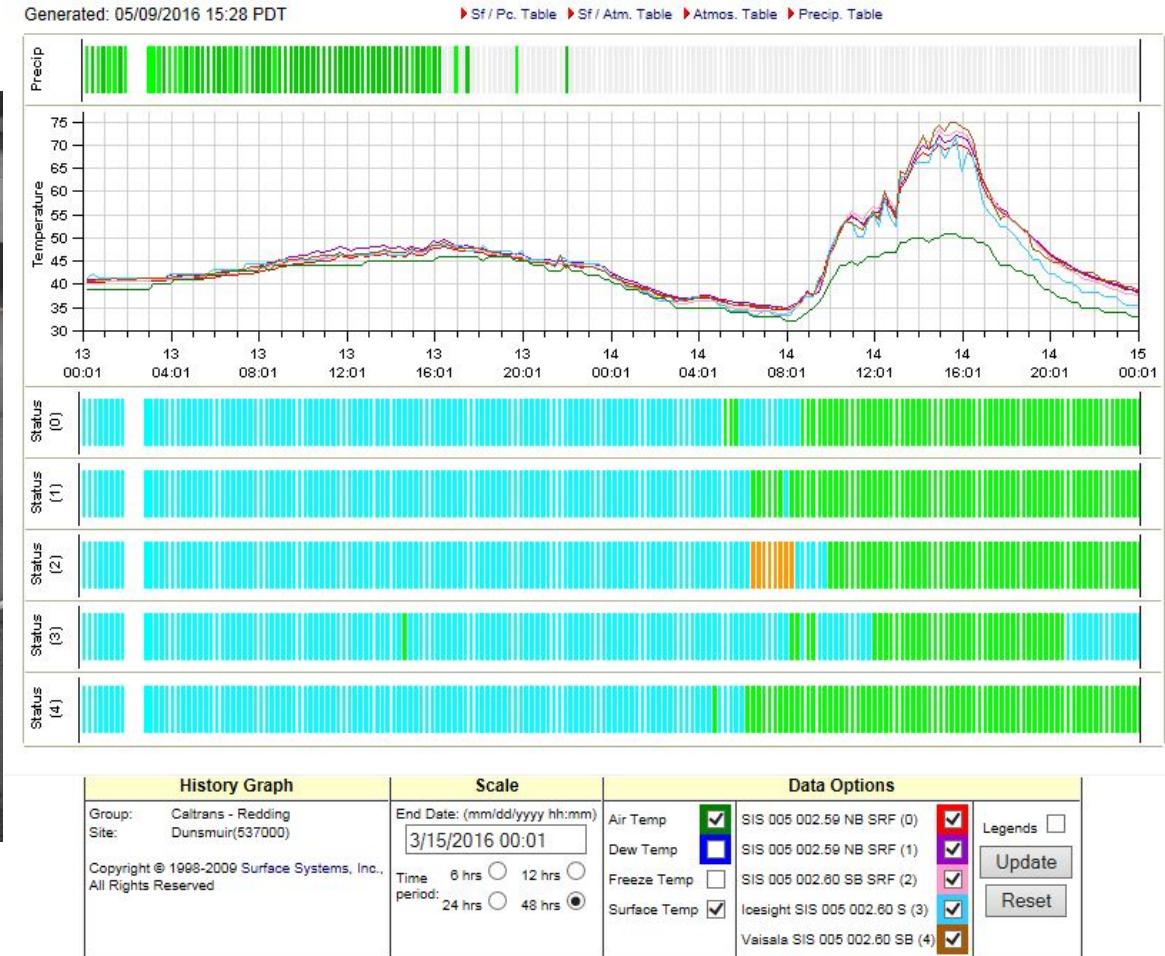
Interesting Event At Dunsmuir March 14th, 2016

In this case the IPS in the lane with the NIPS was showing Snow Watch while all other sensors were showing dry or trace moisture. In this case the video shows the trace moisture was more correct. Looking at the temperature readings from the IPS reveals this puck was reading a temperature down to 33.8° F while the other pucks were reading over 34° F. This is a good example of how important the accuracy of temperature measurements are; a few tenths of a degree make the difference between a correct and an incorrect status report. In a automated system this could be a critical error and again points to the need for multiple sensors in an automated system.

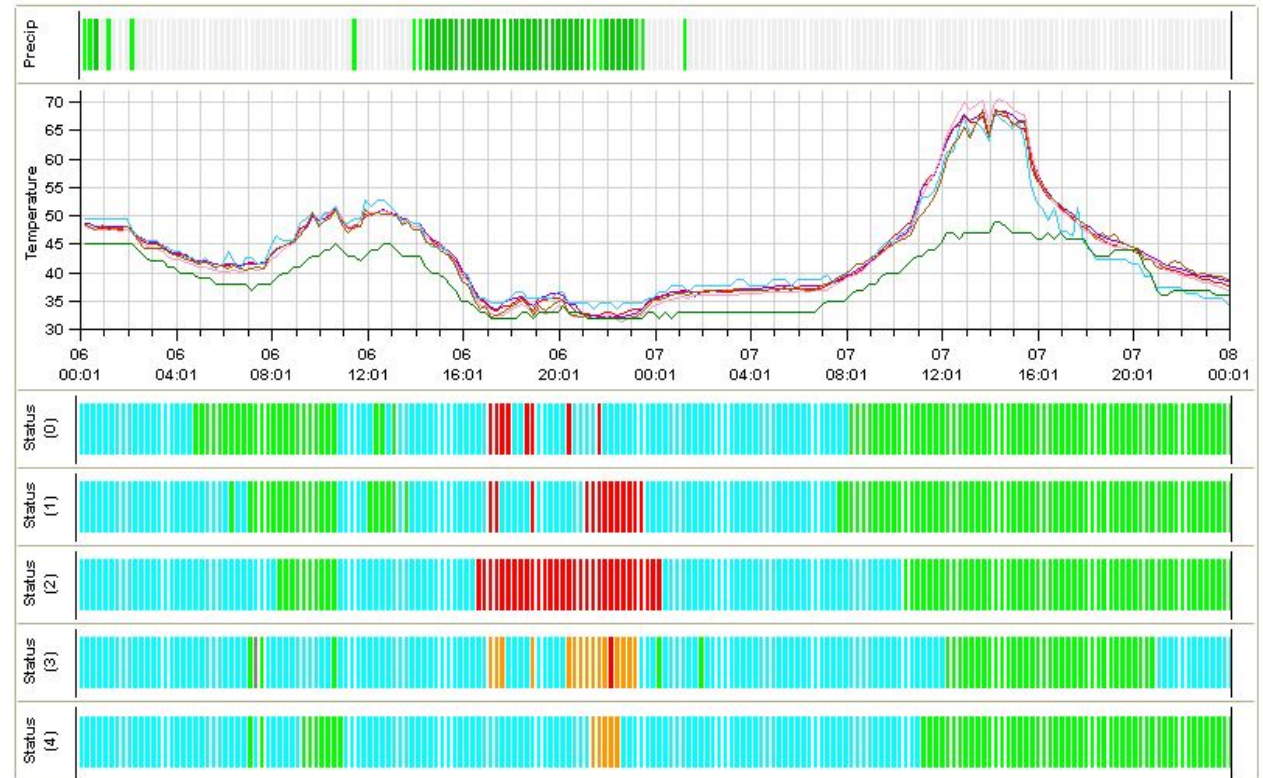
The Scanweb capture to the right shows an incident that we were not able to arbitrate. The incident was in the evening and there was not sufficient lighting for the camera images to be useful. So in this case we take the general trend between 4:00 P.M. and midnight to be there was an agreement between the sensor classes there was in fact a snow incident. This points out a reason a single sensor should not be relied upon; even among similar or even the same model of sensor the variability in pavement conditions even over a few feet and the variability of the calibrations contribute to a level of uncertainty that characterizes the state of the art. Thus again the lesser of two evils.

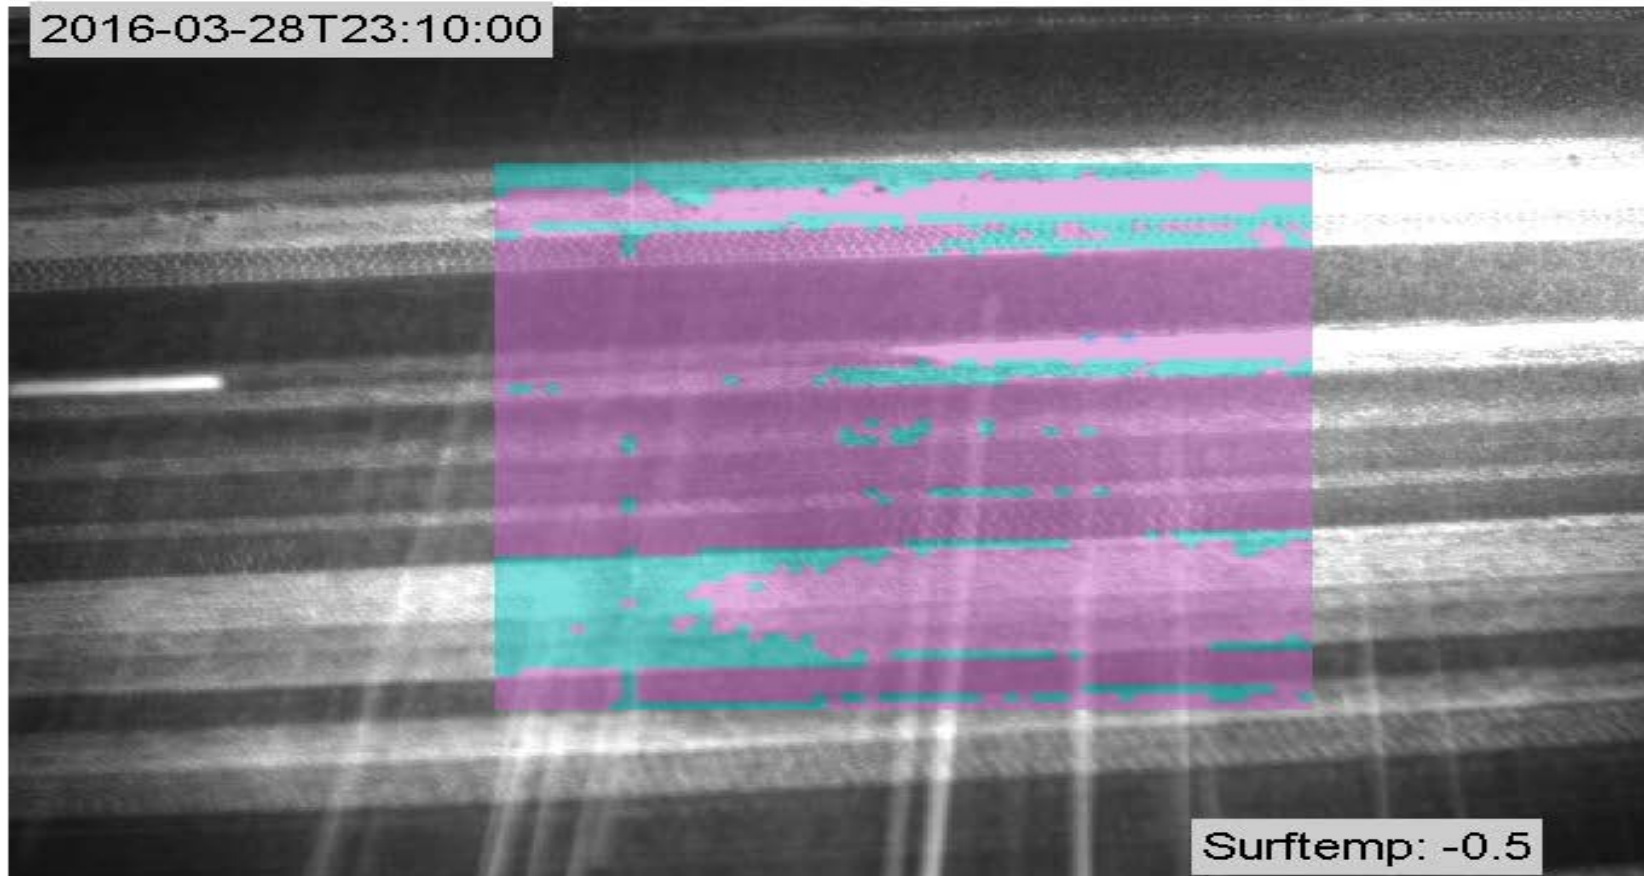
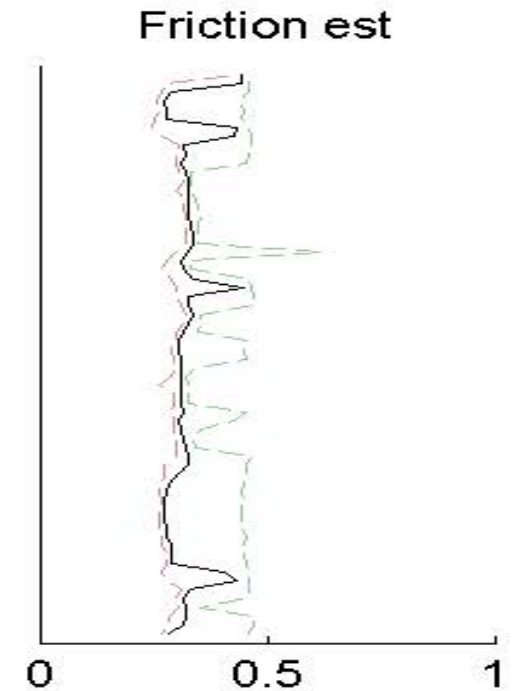
Full Roadway Sensor Images

Images of a 2D pavement surface sensor with Friction as a function of lane position. 2DRoad road temperature sensor, a world first for road temperature classification, which has been manufactured for fixed and mobile installations to monitor road condition over a 6x6m area, providing the road user with a detailed visualization of the road condition.
