Deterrence and Detection of Wrong-Way Drivers on California Highways

California Department of
Transportation

Western States Rural
Transportation
Technology Implementers
Forum

October 5th, 2021

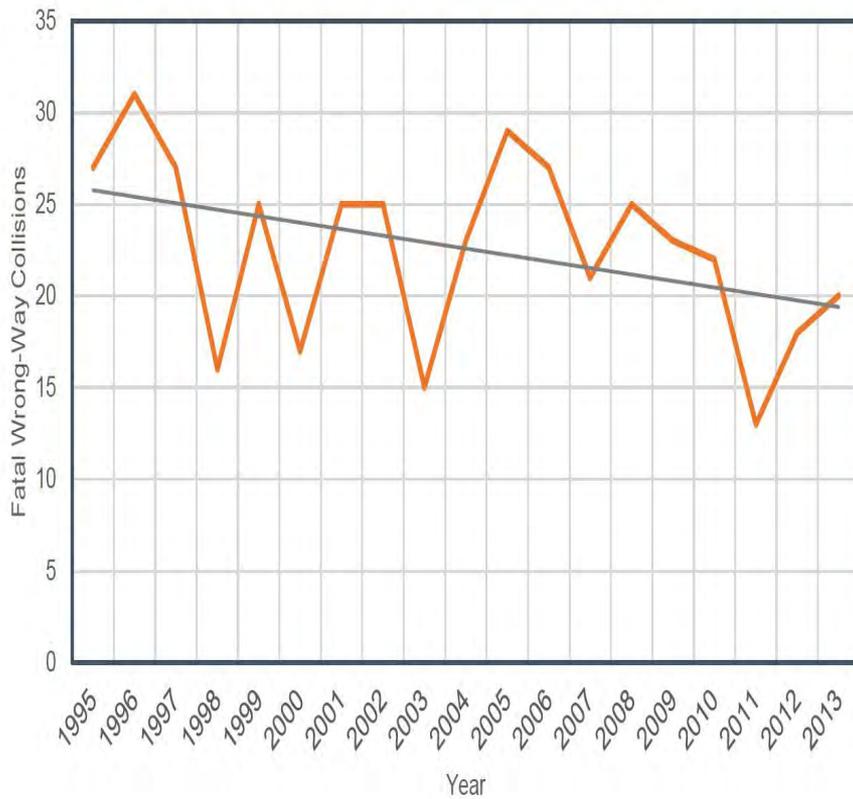
Comparison between Total Number and Rate of Fatal Wrong-Way Collisions on California Freeways and Expressways

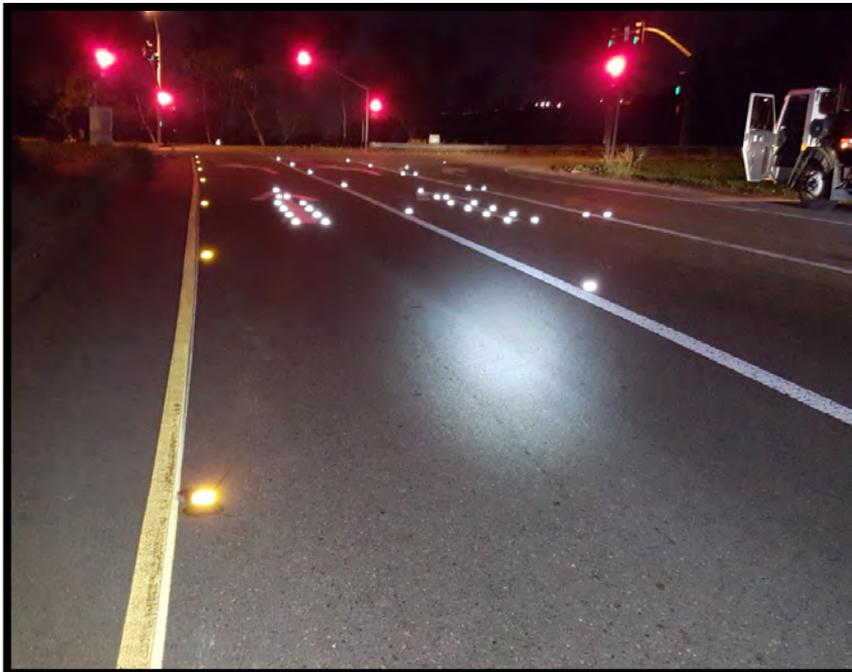
Right-Way Driver View

Two-Way Retro-Reflective Pavement Markers

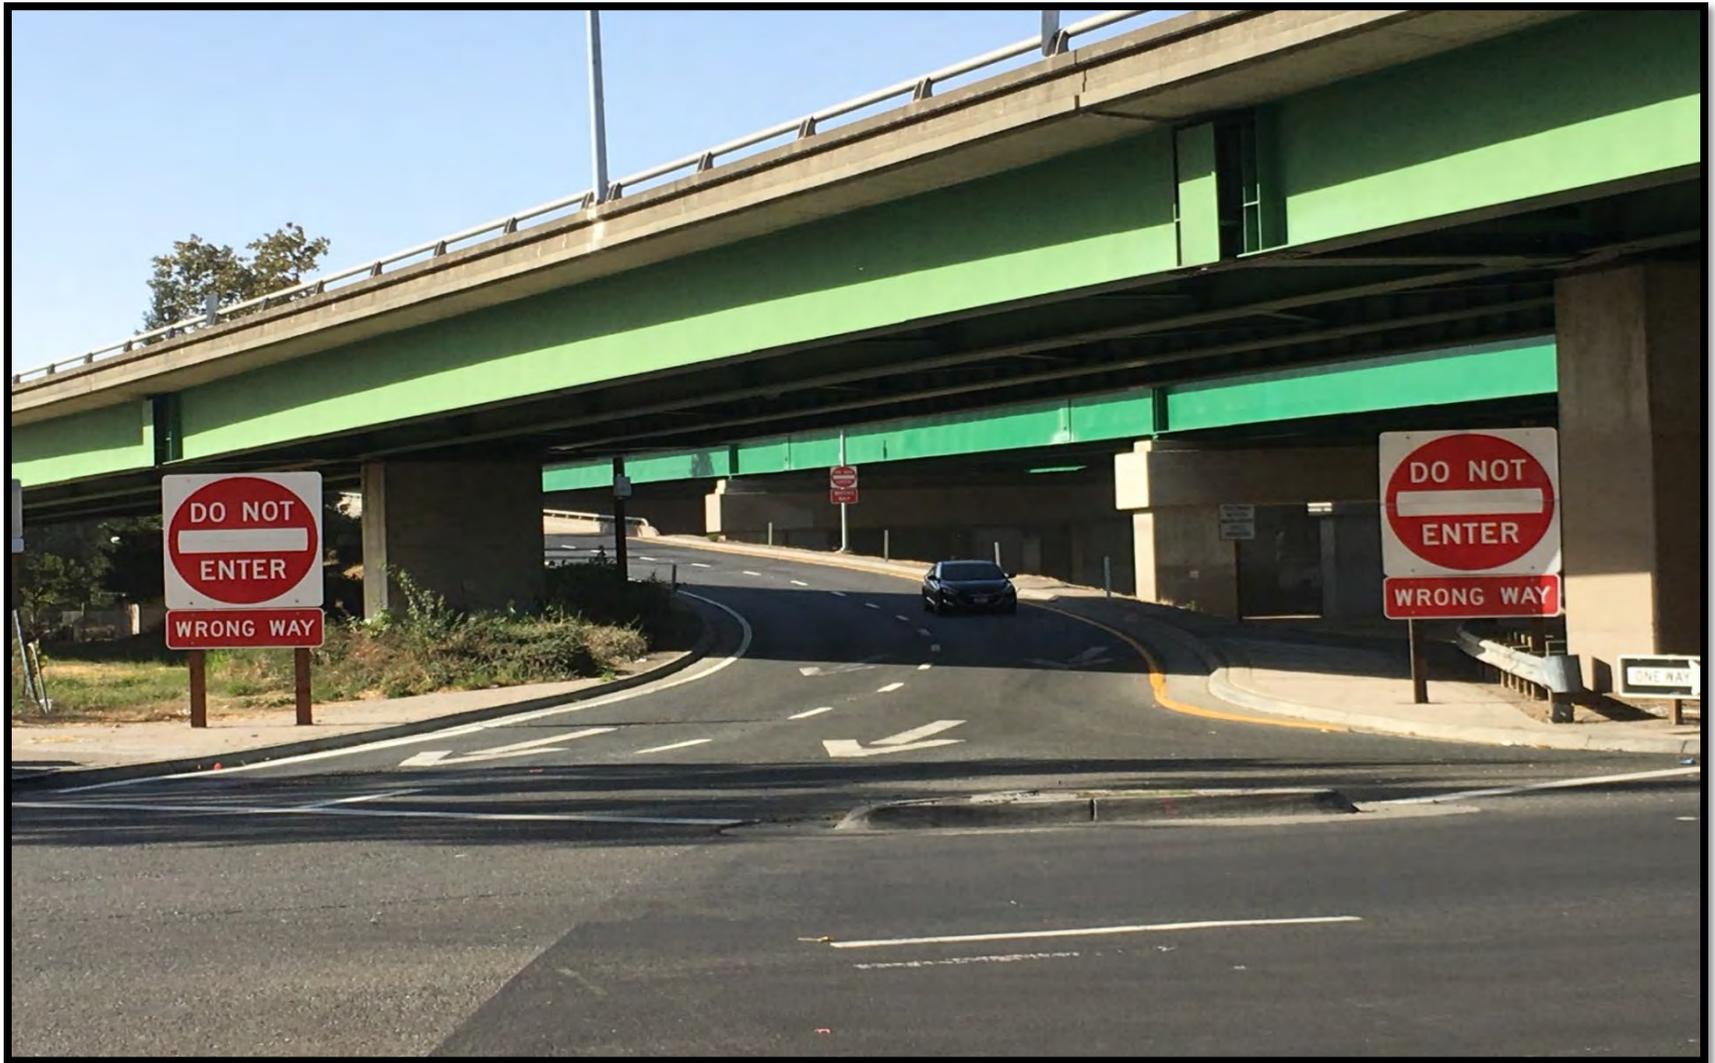
Enlarged Do Not Enter/Wrong Way Signs

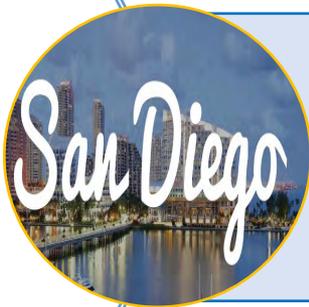
6 Ramps: Signage with TAPCO detection and alerting systems

Radar-based Active Detection and Alerting Systems were installed on a subset of exit ramps.

4 Ramps: Signage with TAPCO detection and alerting systems

2 Ramps: Signage with TraffiCalm detection and alerting systems

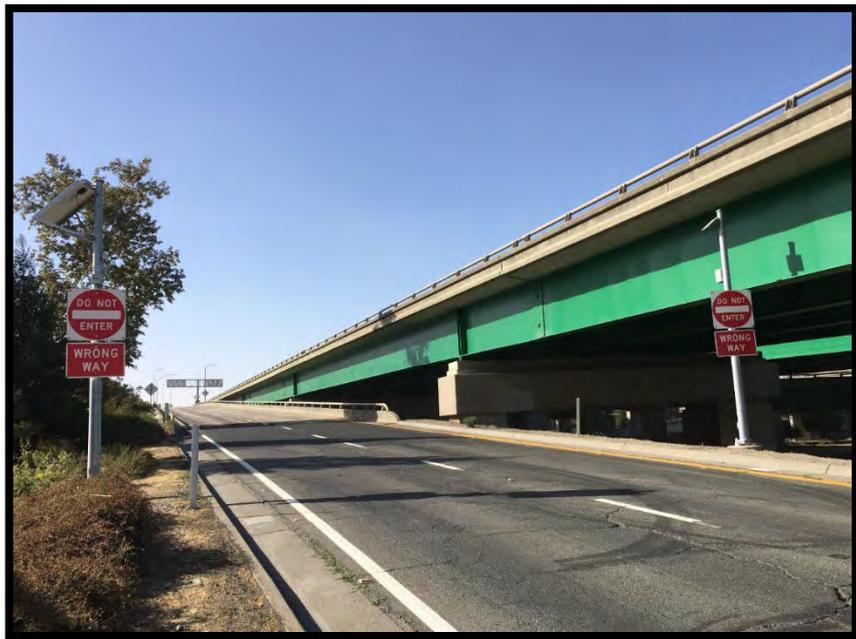
TAPCO System at Jefferson Blvd & WB US 50 in District 3

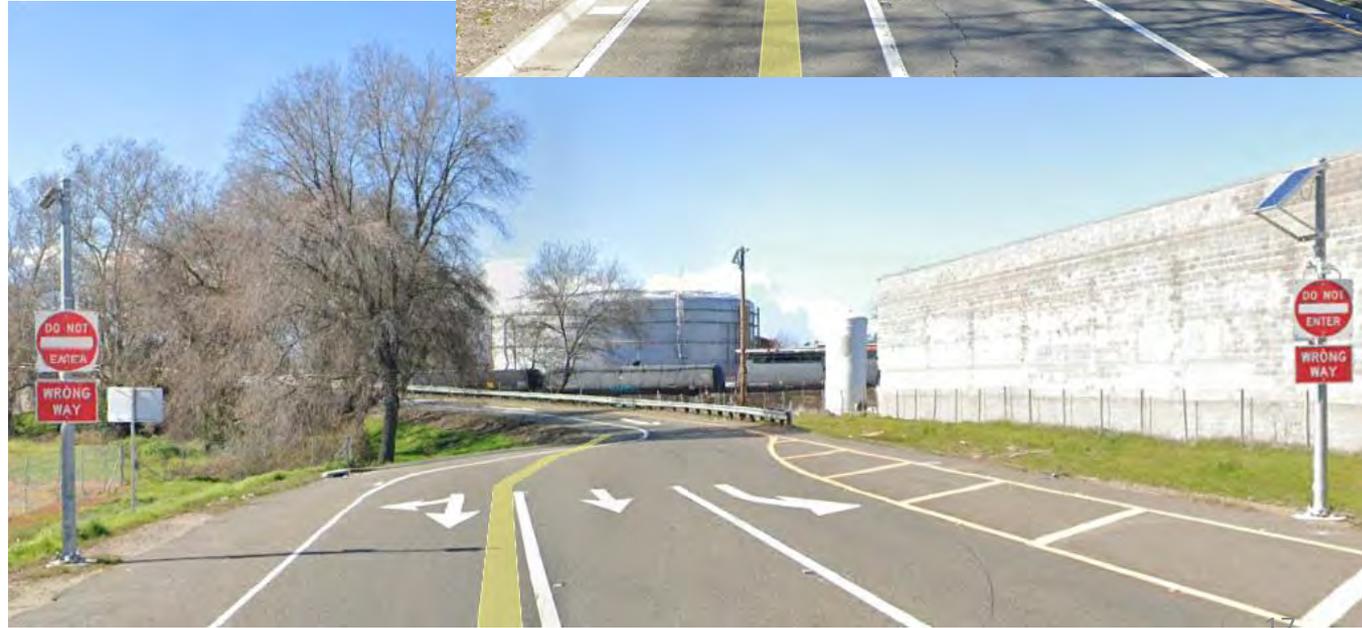
TAPCO System at 5th Street & EB US 50 in District 3

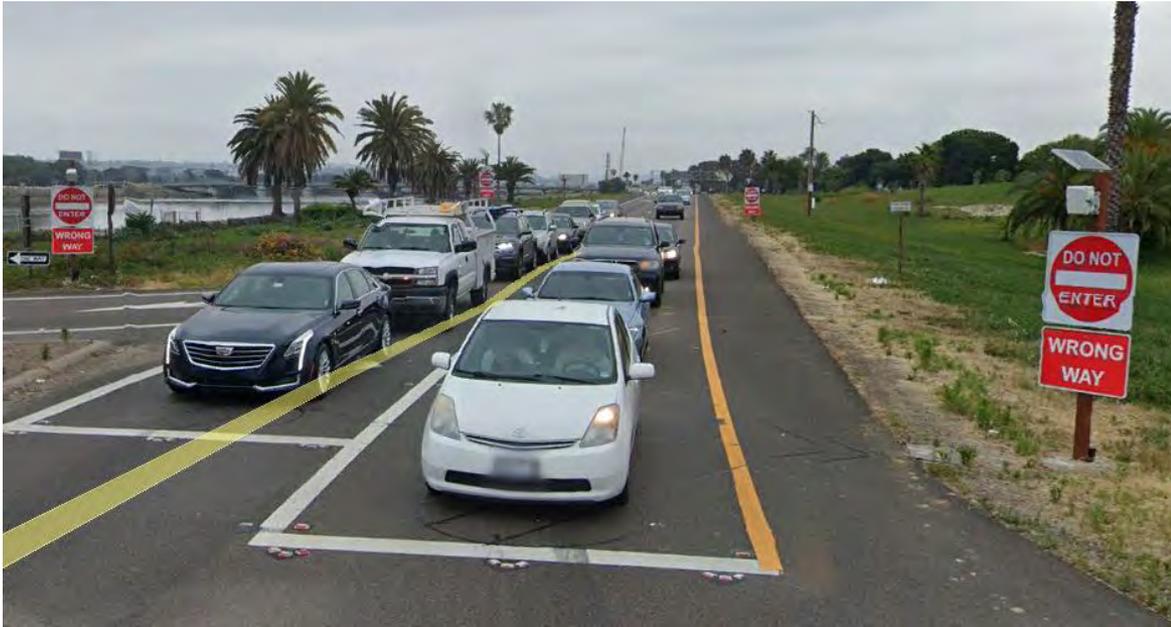
TAPCO System at South River Road & WB US 50 in District 3 >

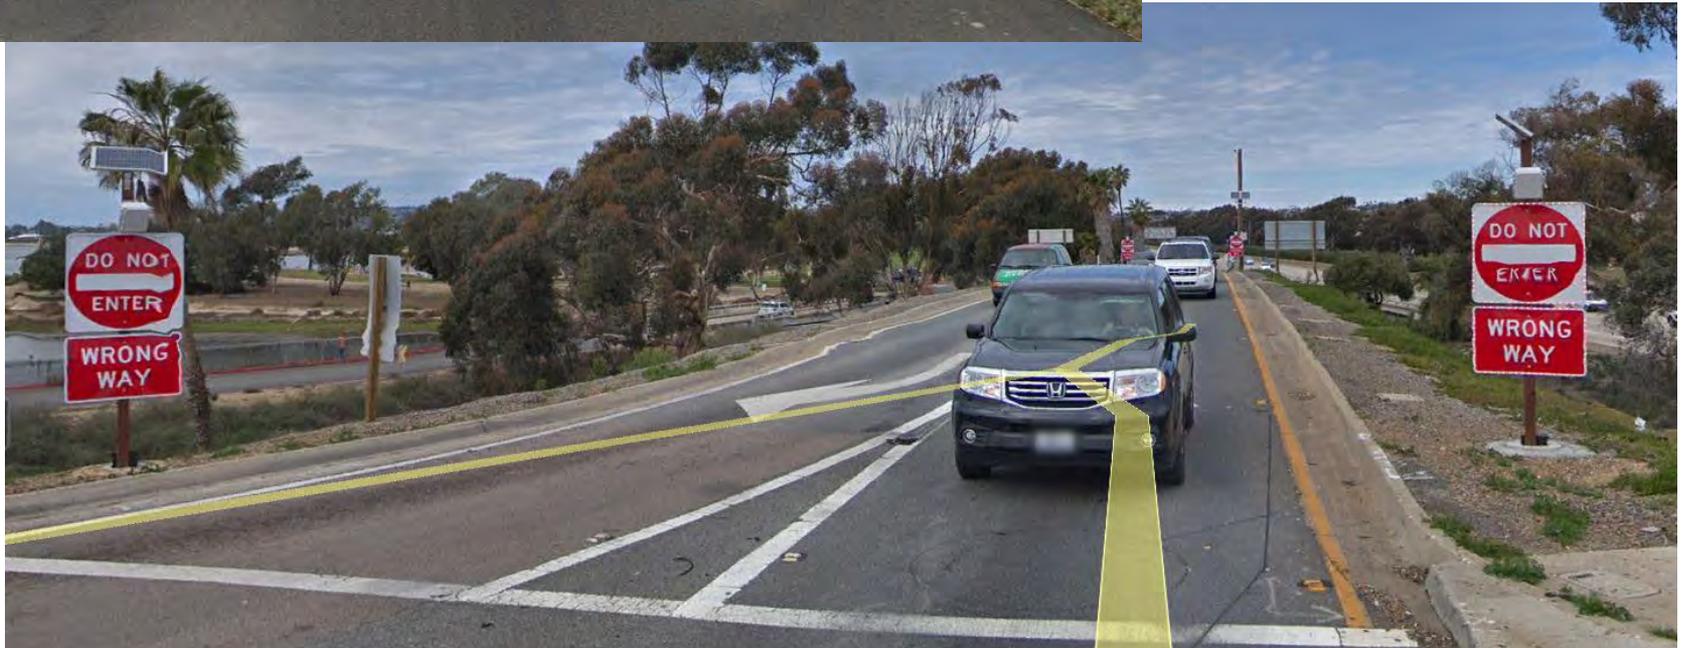
**TraffiCalm System at
Sunset Cliffs Blvd &
WB I-8 in District 11**

**TraffiCalm System
at Sea World Drive &
SB I-5 in District 11**

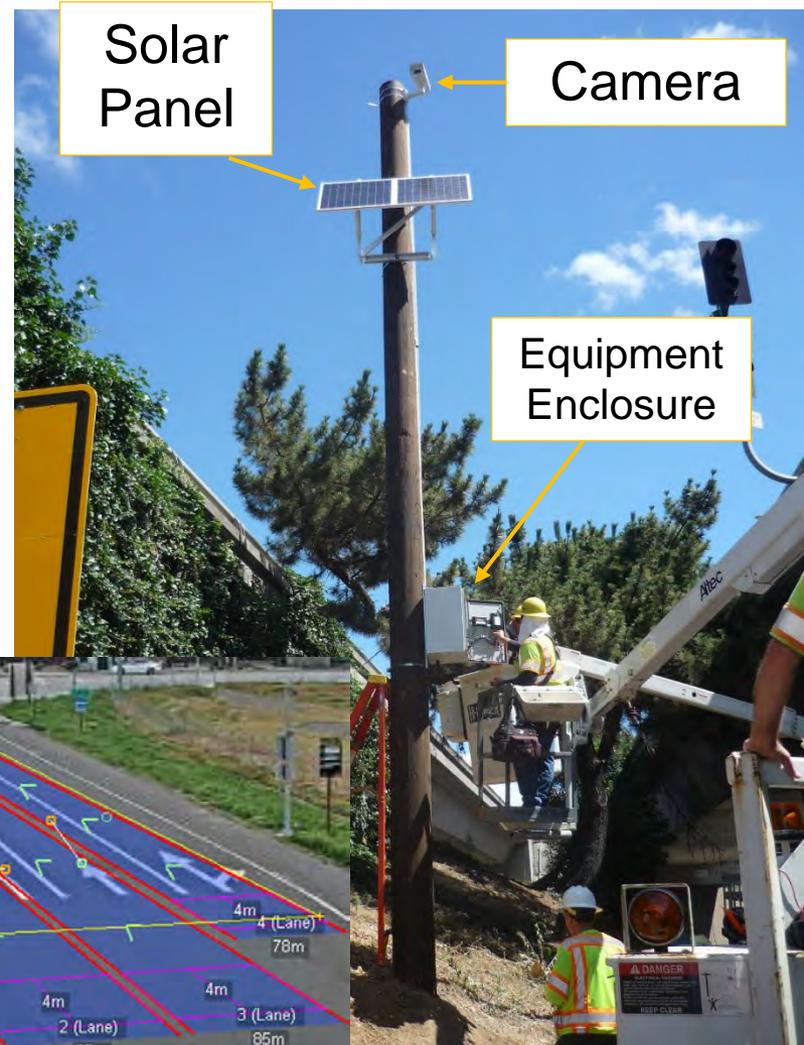
The AHMCT researchers developed and installed zone-triggered video-based site monitoring (VBSM) systems at 8 off-ramps on which active detection and alerting systems were later installed.

4 more of VBSMs were installed at control off-ramps not receiving enhancements.

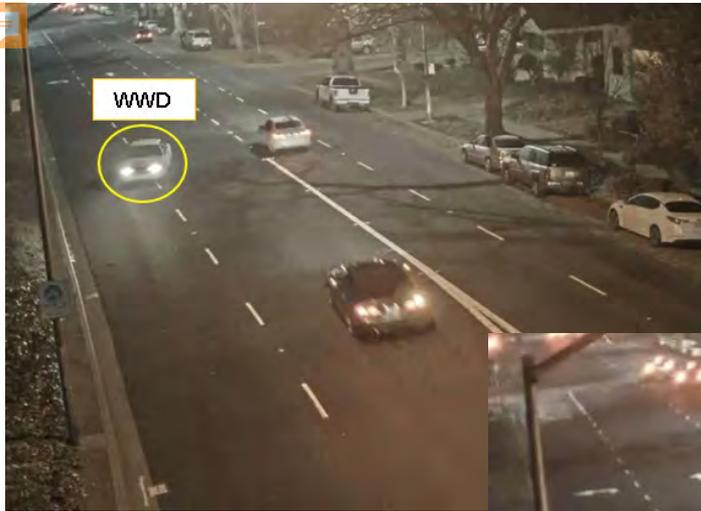
A Particularly Dangerous WWD Trajectory was Captured on 10th Street & WB US 50 Off-Ramp.

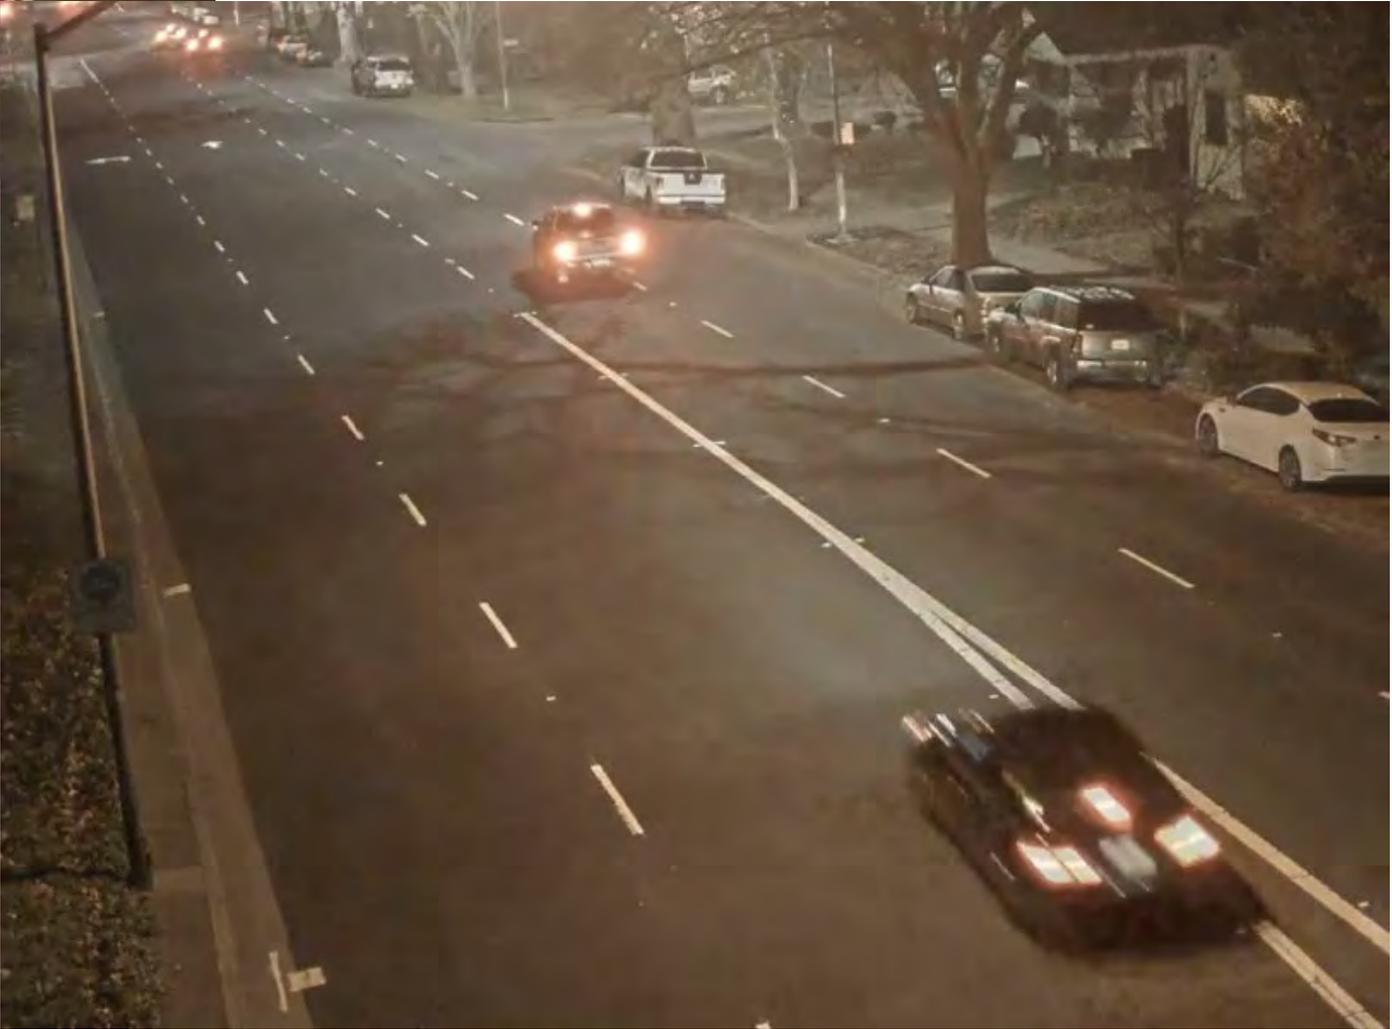
35.3% of WWD events were drivers entering an exit-ramp while travelling the wrong way on a municipal one-way street.

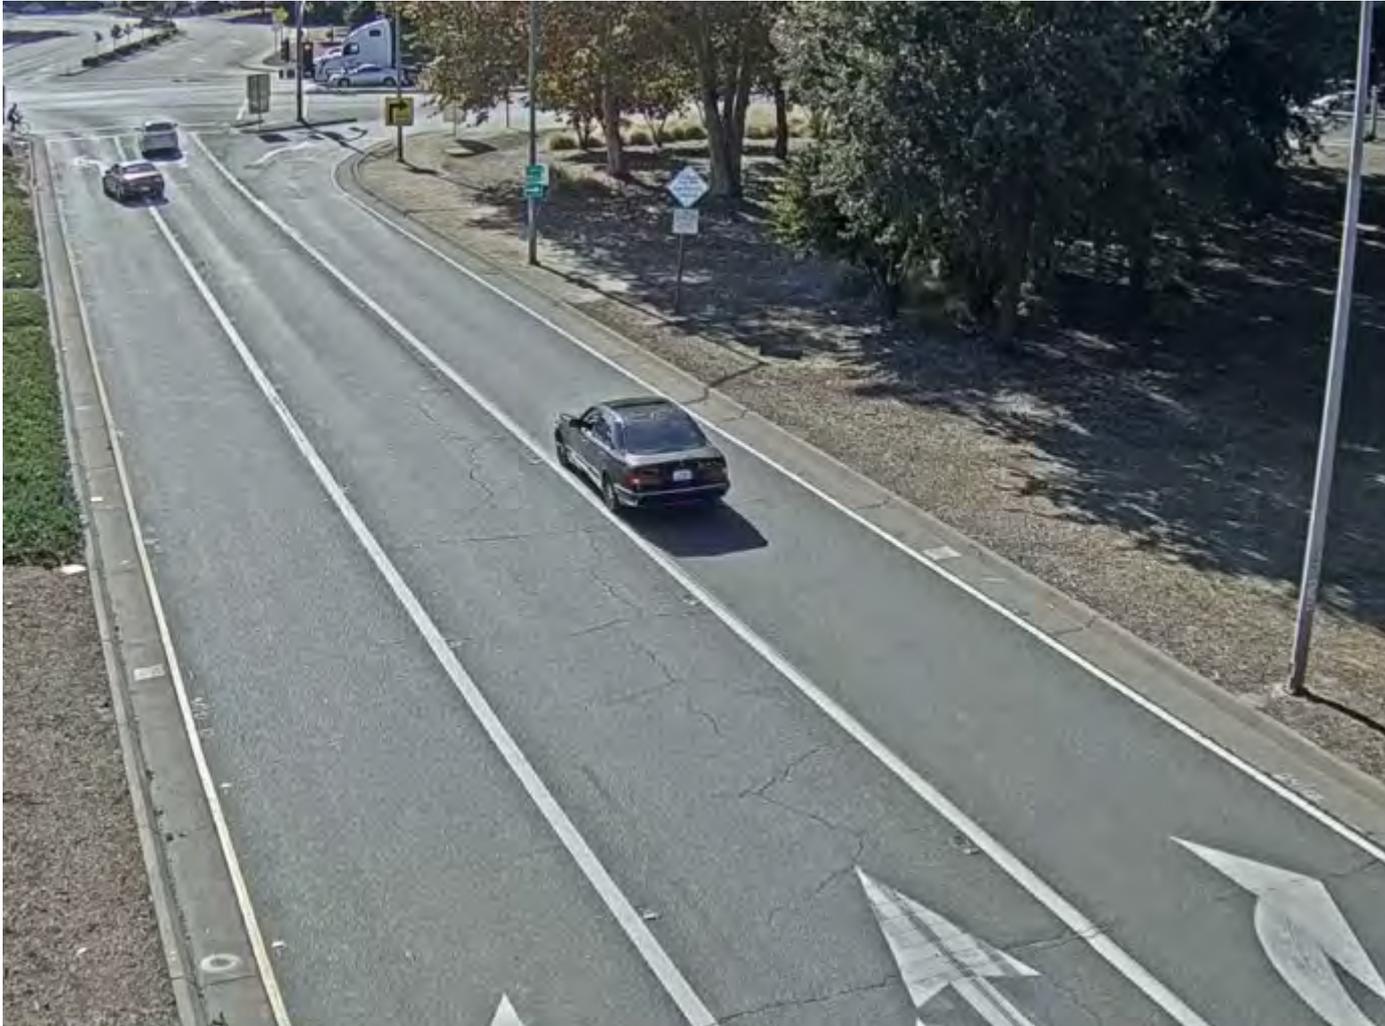
Not all detected wrong way movements were caused by motor vehicles.

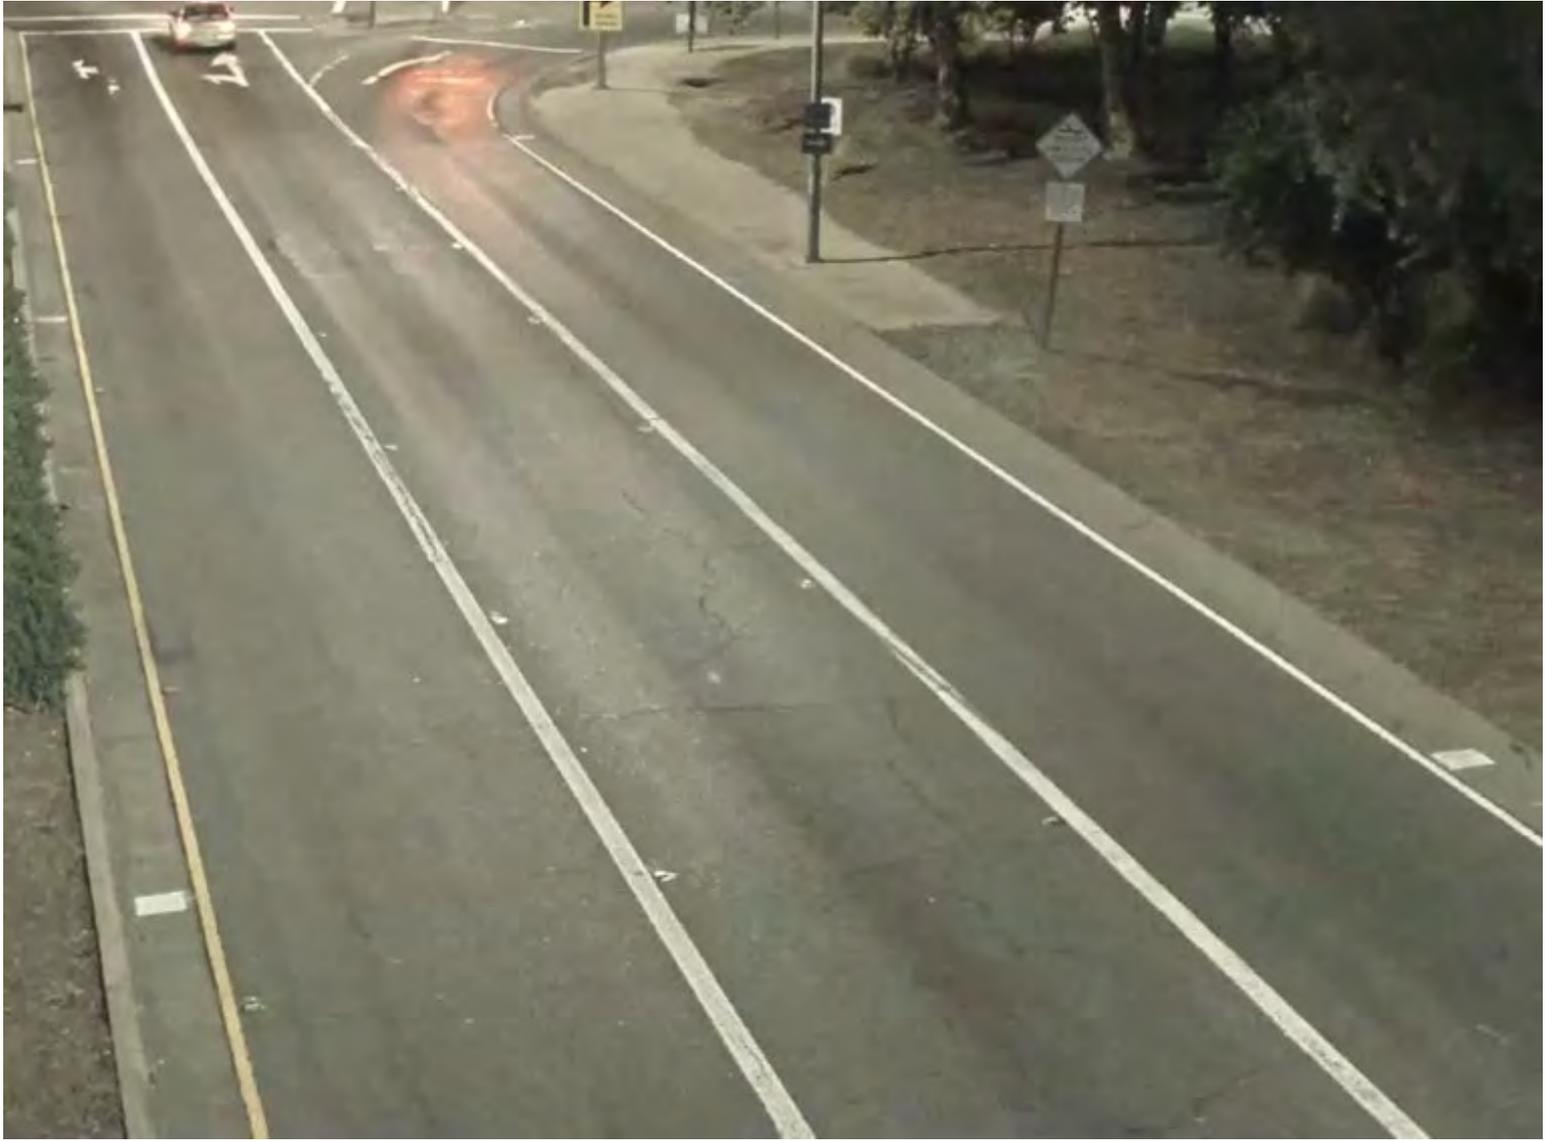
Not all detected wrong way movements were unintentional.

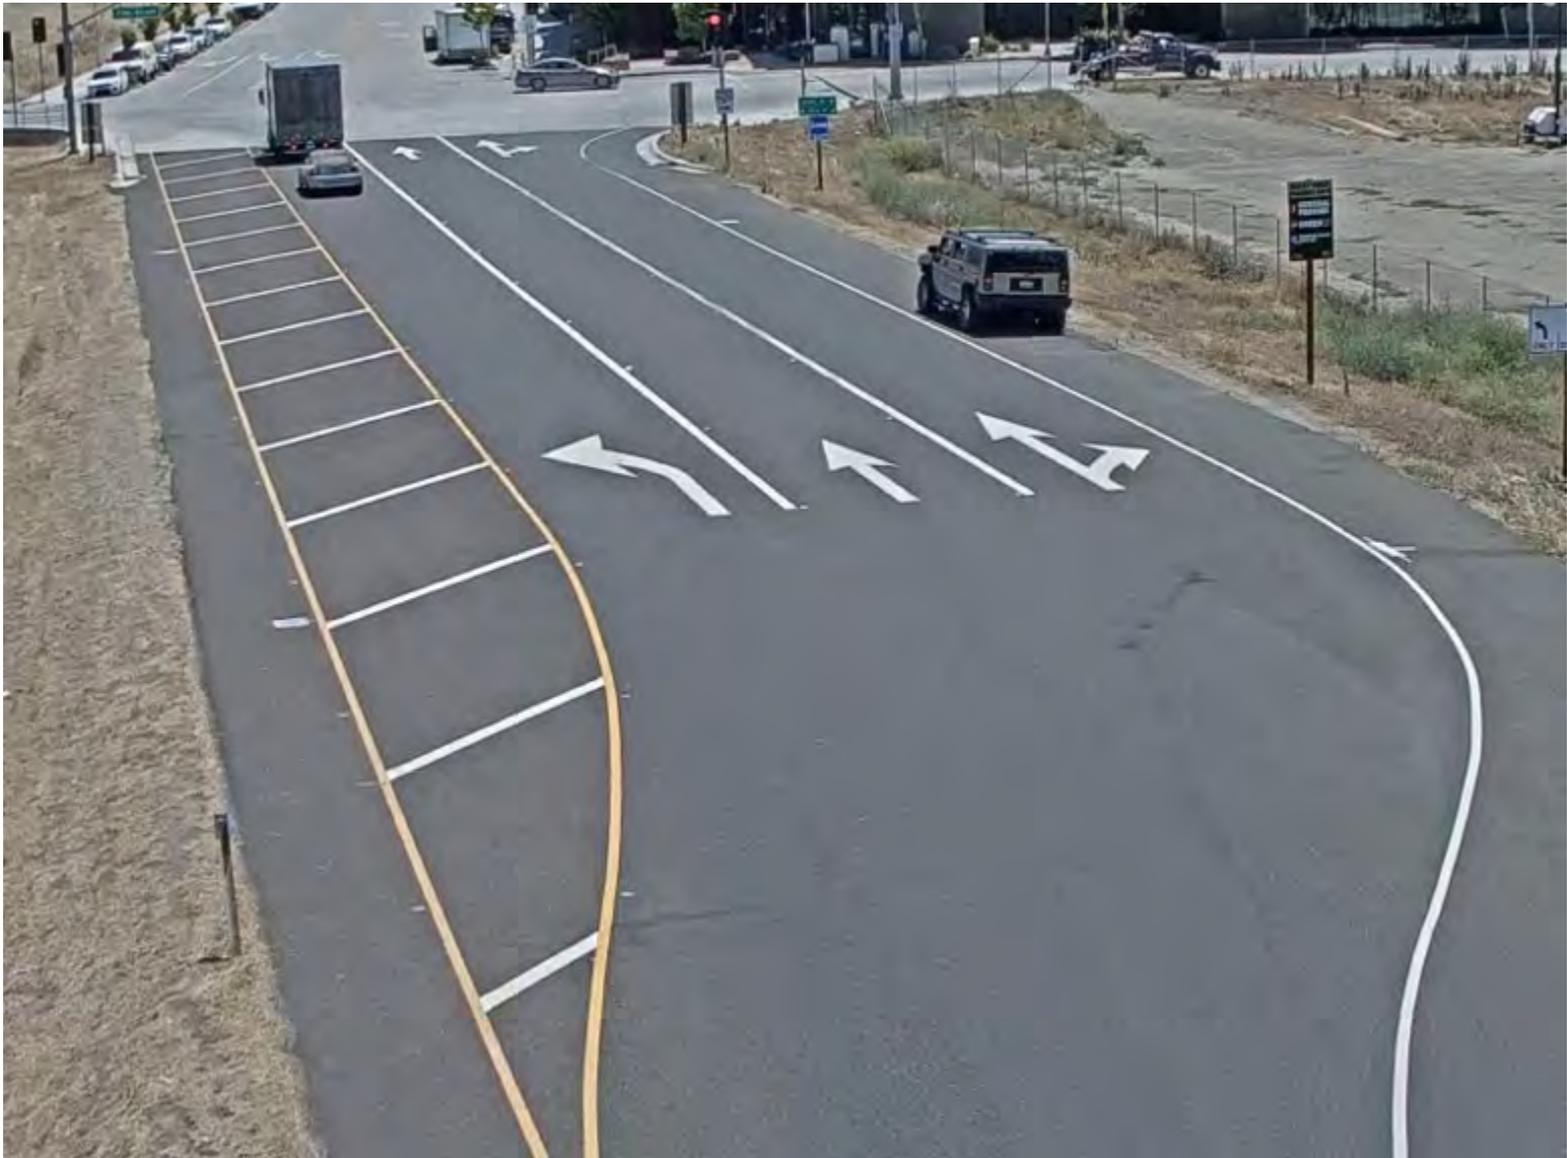
Not all detected wrong way movements were unintentional 2.

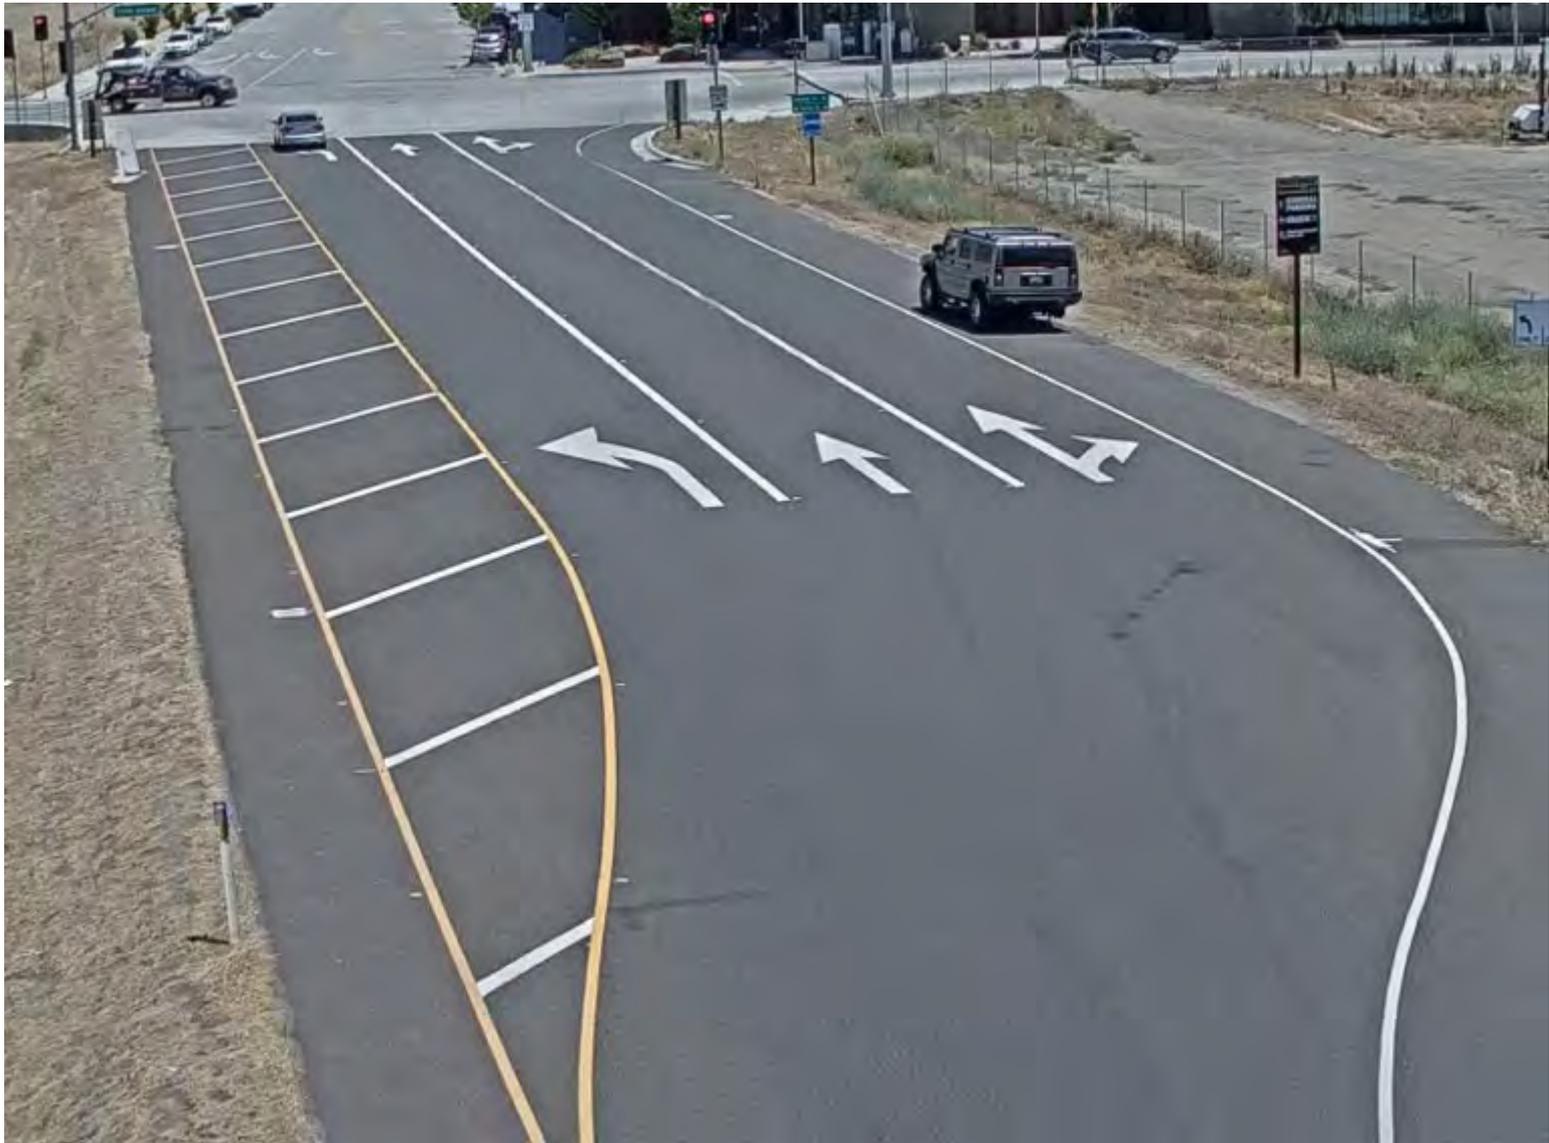
Not all detected wrong way movements were unintentional 3.

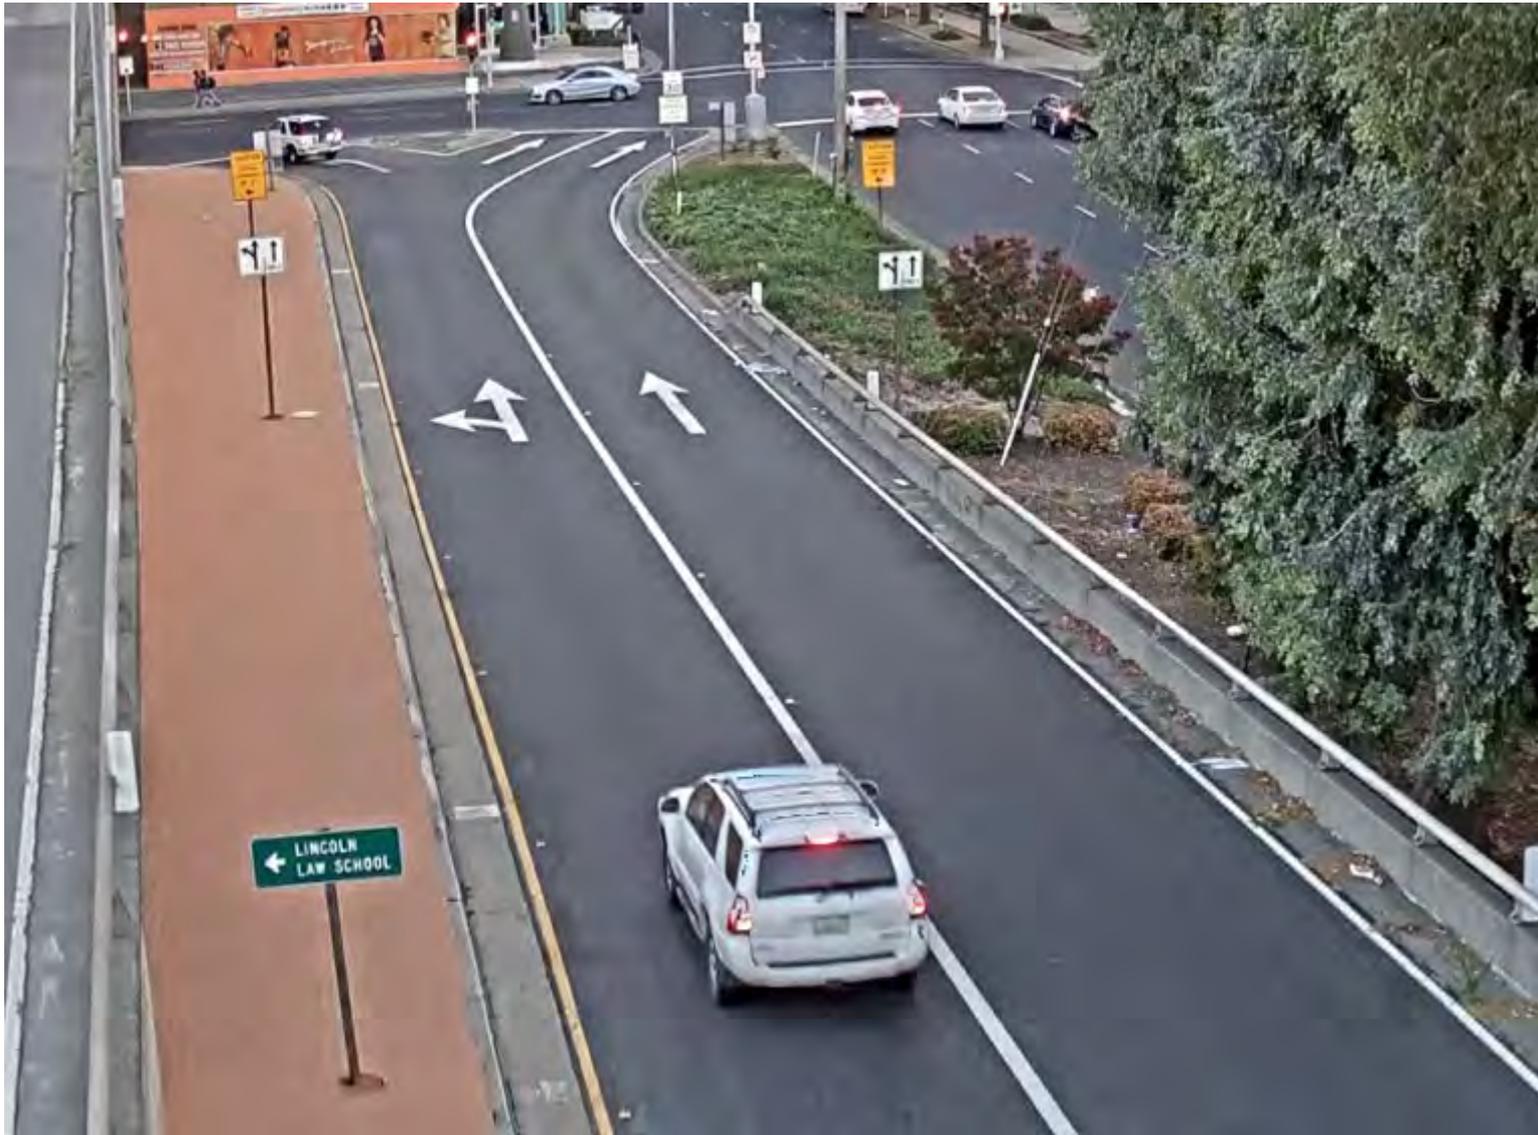
Not all detected wrong way movements were unintentional 5.

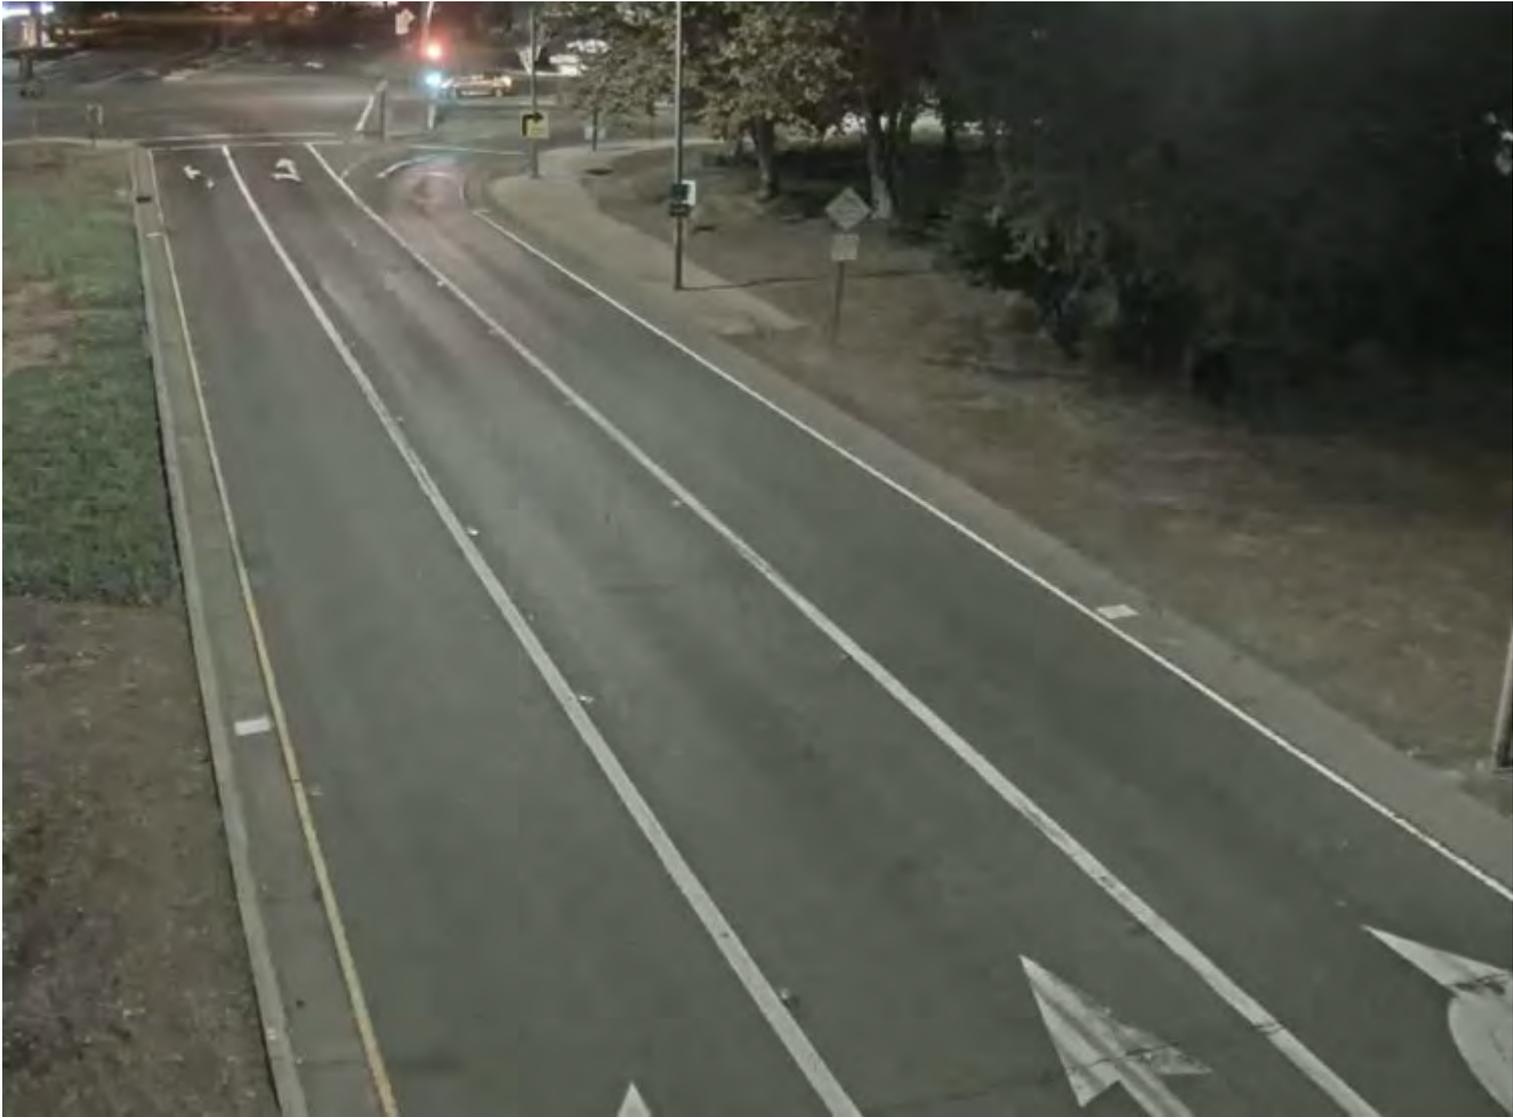
Other wrong way movements caused by mistakes by drivers

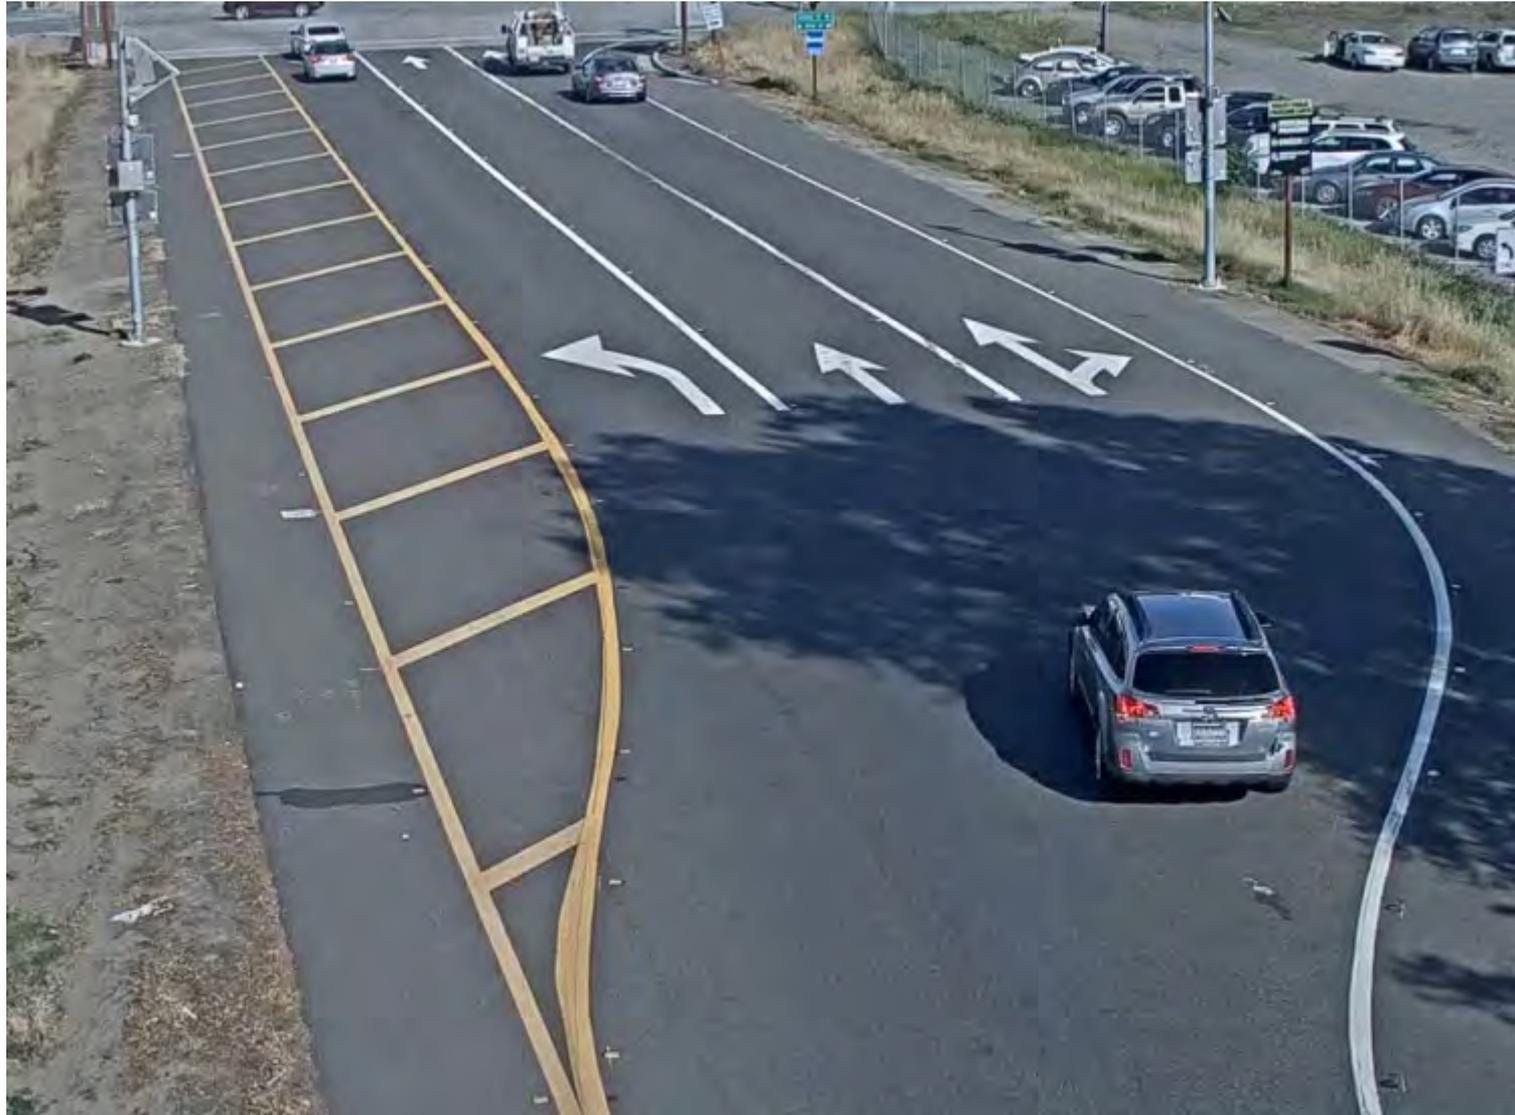
Other wrong way movements caused by mistakes by drivers 2

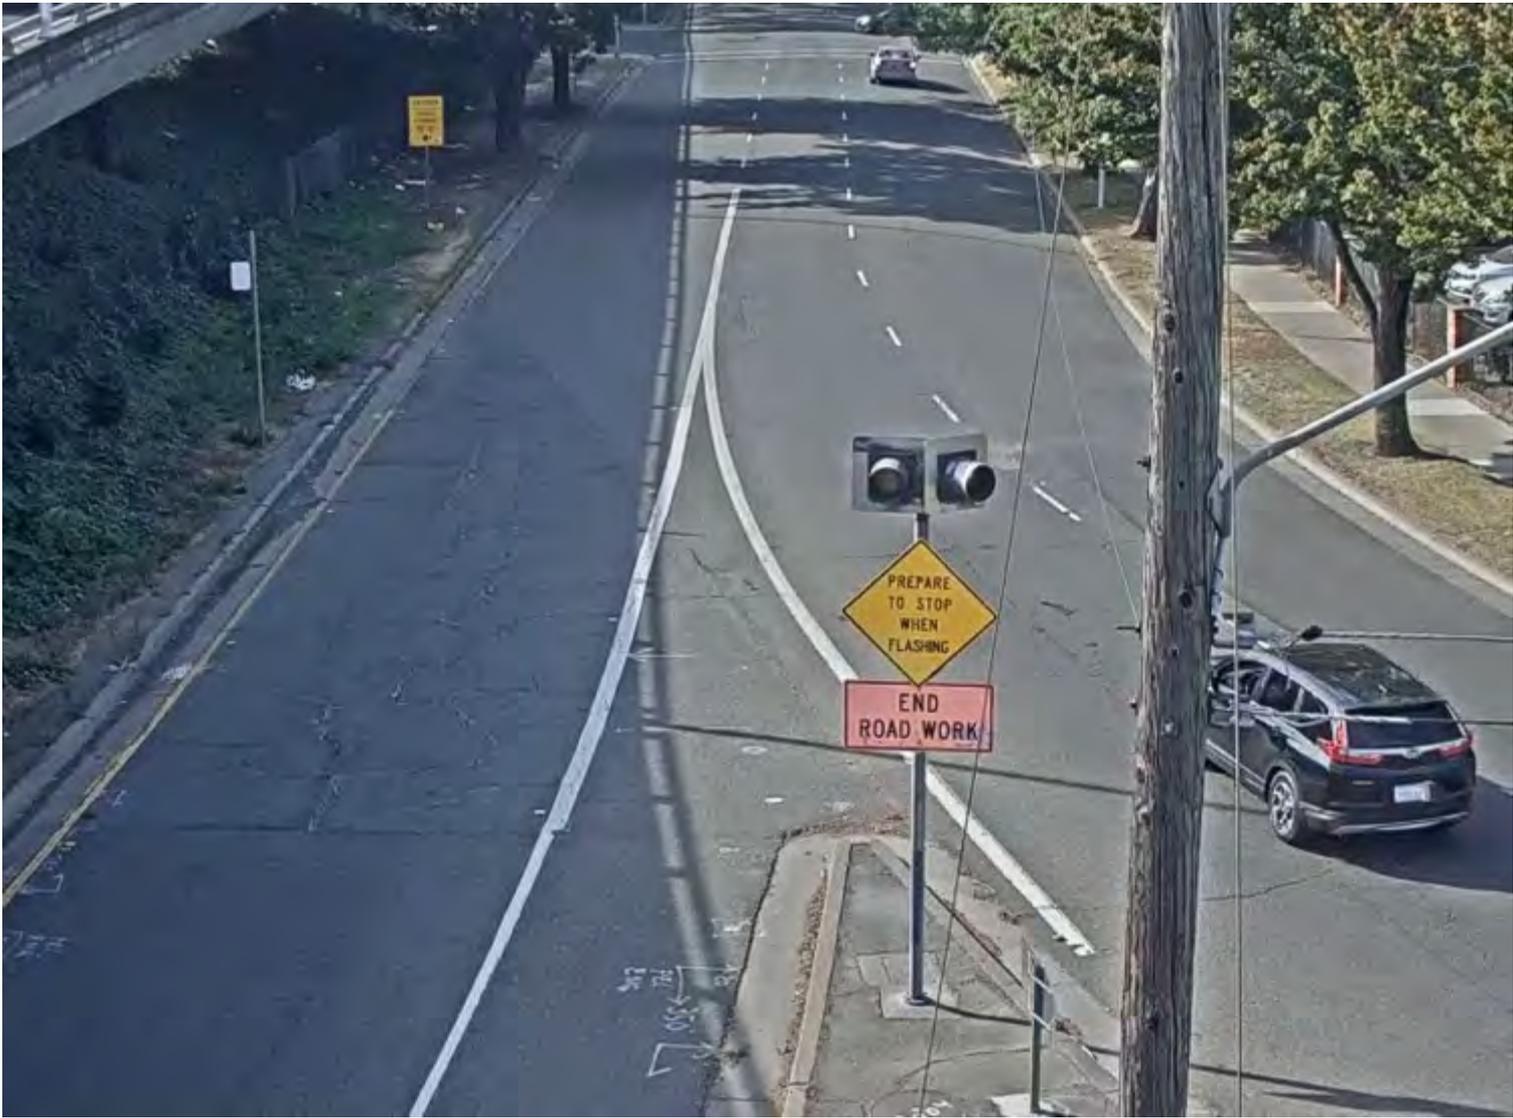
Other wrong way movements caused by mistakes by drivers 3
