Deterrence and Detection of Wrong-Way Drivers on California Highways

California Department of
Transportation

Western States Rural
Transportation
Technology Implementers
Forum

October 5th, 2021

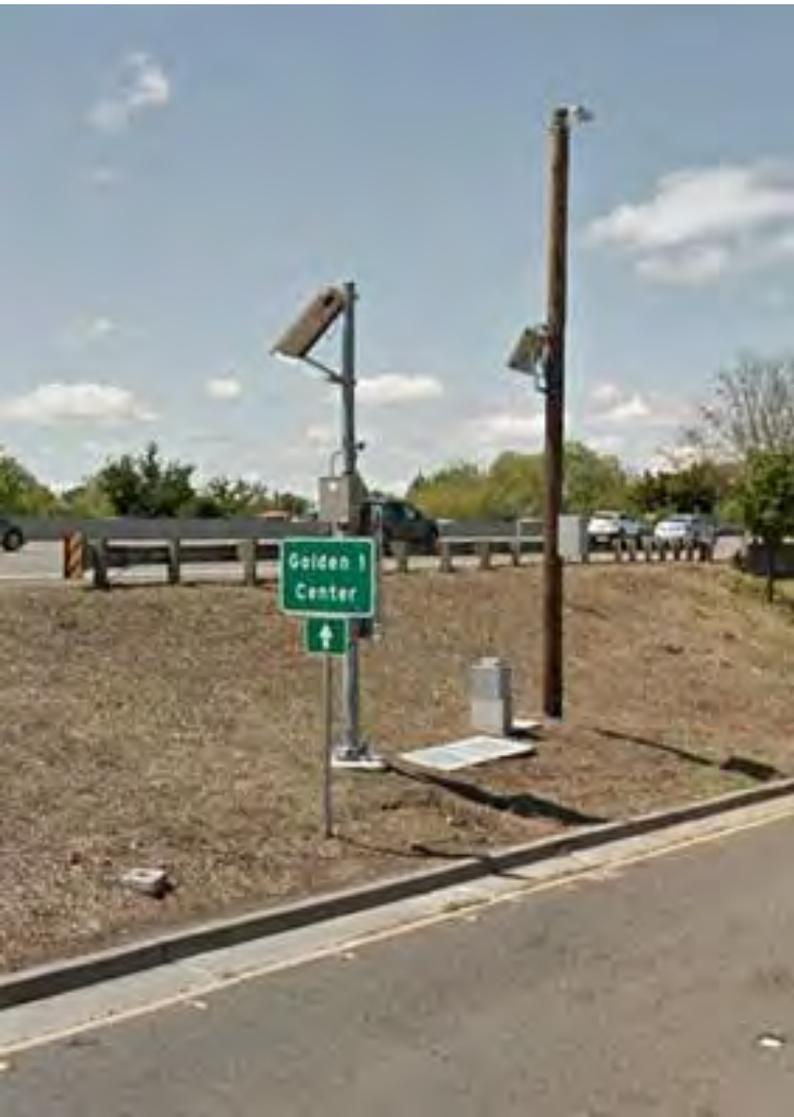
The newly installed directional sign to the Golden 1 Center blocked the rear-facing radar detector of the TAPCO system at US 50 and 16th Street. (The UC Davis detection system can be seen on the wood pole in the background.)

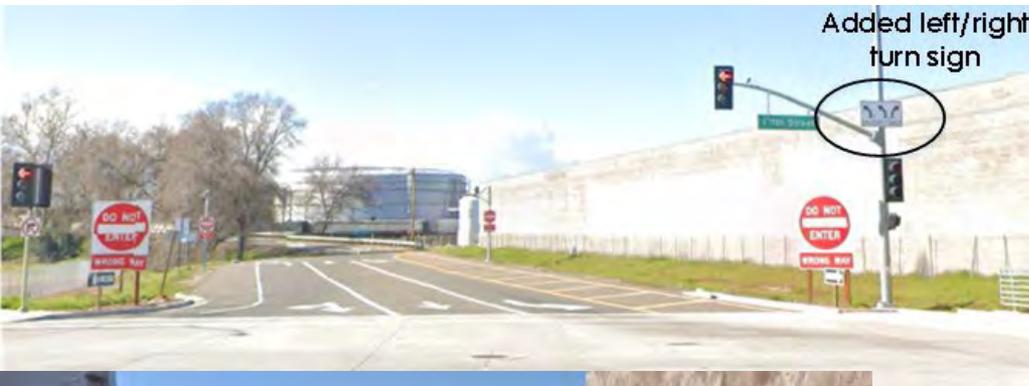
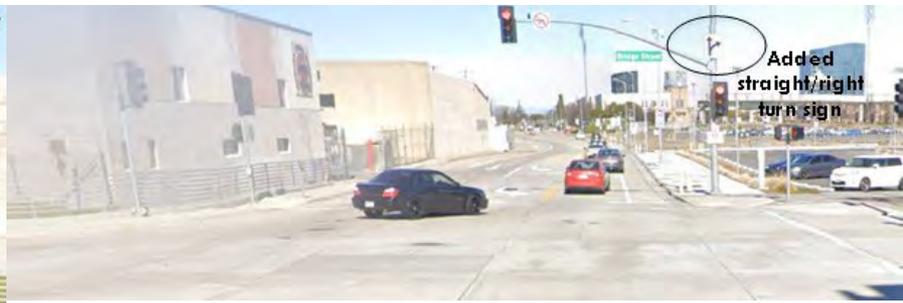
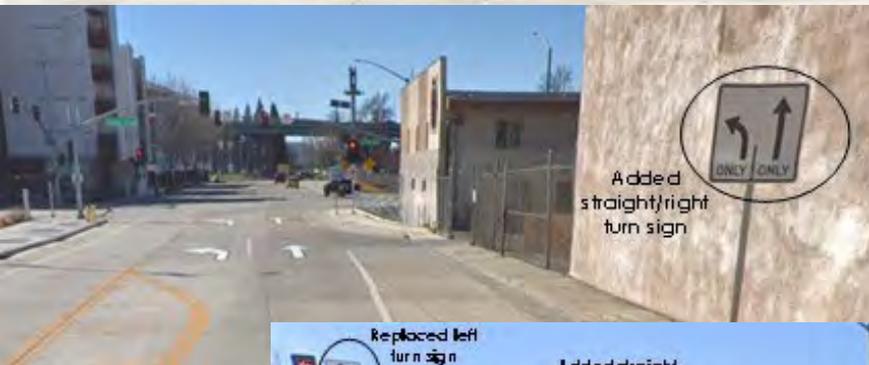
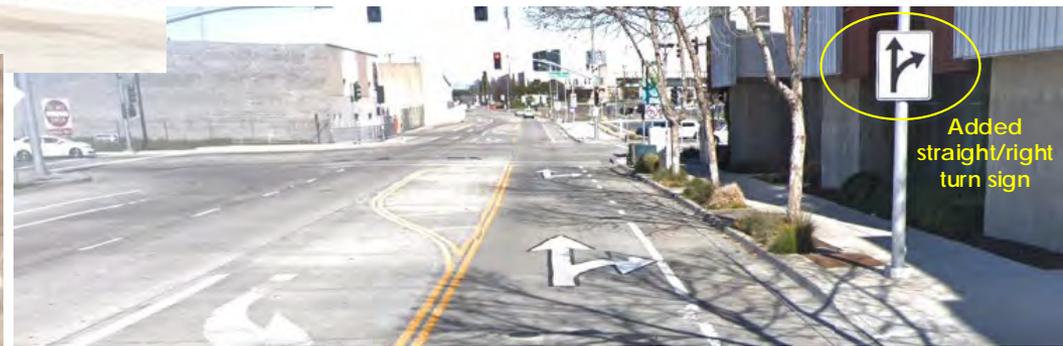
Signs were added to the intersection of US 50 WB exit ramp and South River Road to deter wrong way driving movements onto the exit ramp

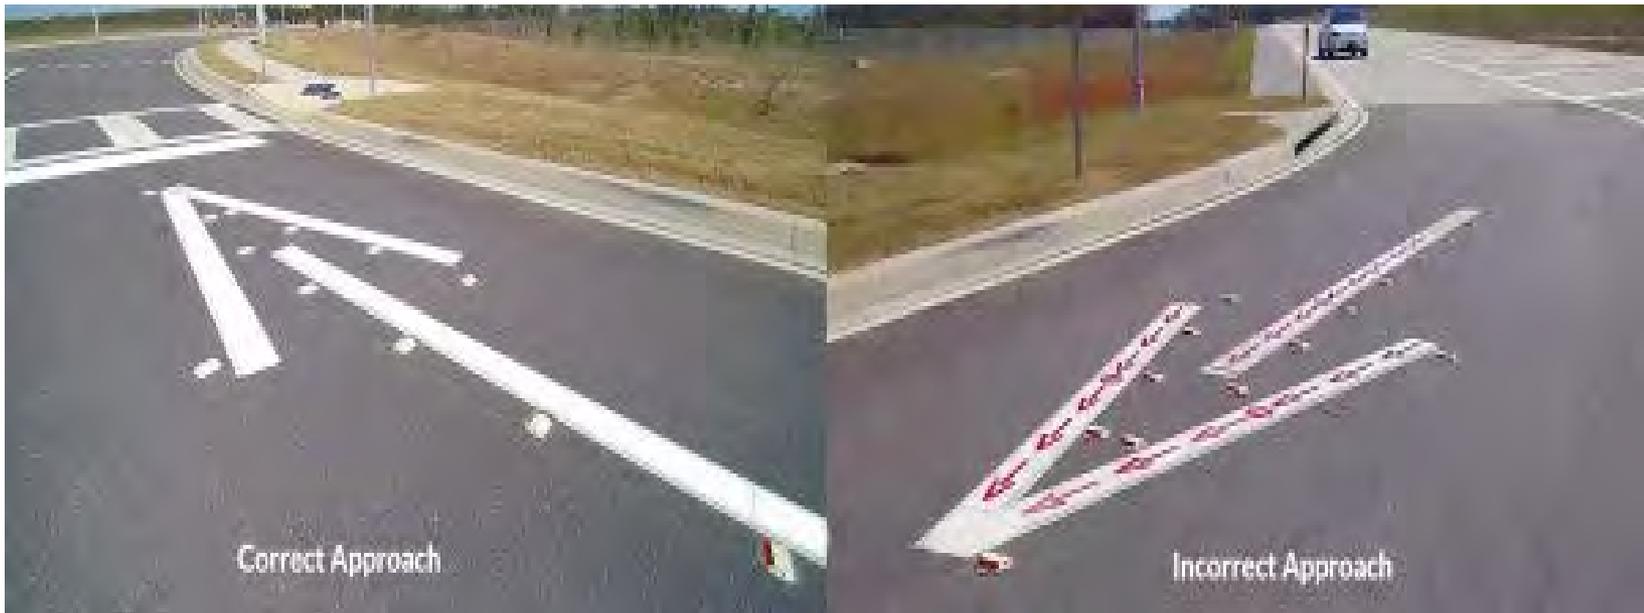
Bidirectional pavement markings use raised, angled surfaces to display a warning to wrong way drivers without distracting other drivers.

They were not part of the original pilot projects but were recently installed for pilot testing in San Diego County (**Caltrans District 11**).

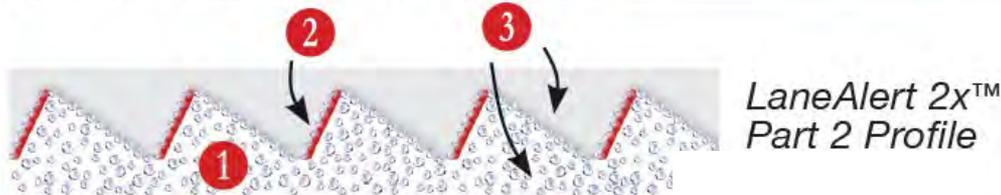
Pigmented coating provides high contrast visibility for messaging

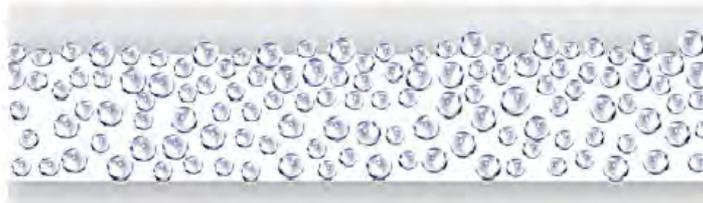
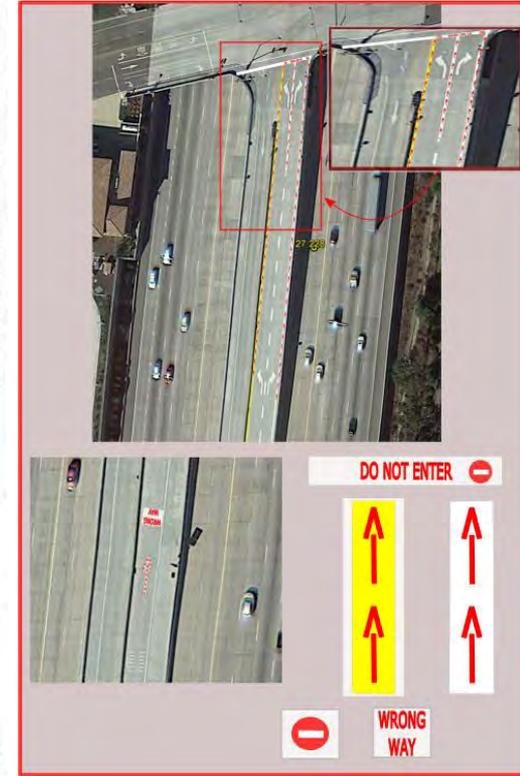
LaneAlert 2x™
Part 2 Field
Cutaway

Base color coated with glass beads for high visibility

Bidirectional pavement markings Installed at I-5 NB exit ramp @ Palomar Street in Chula Vista, CA

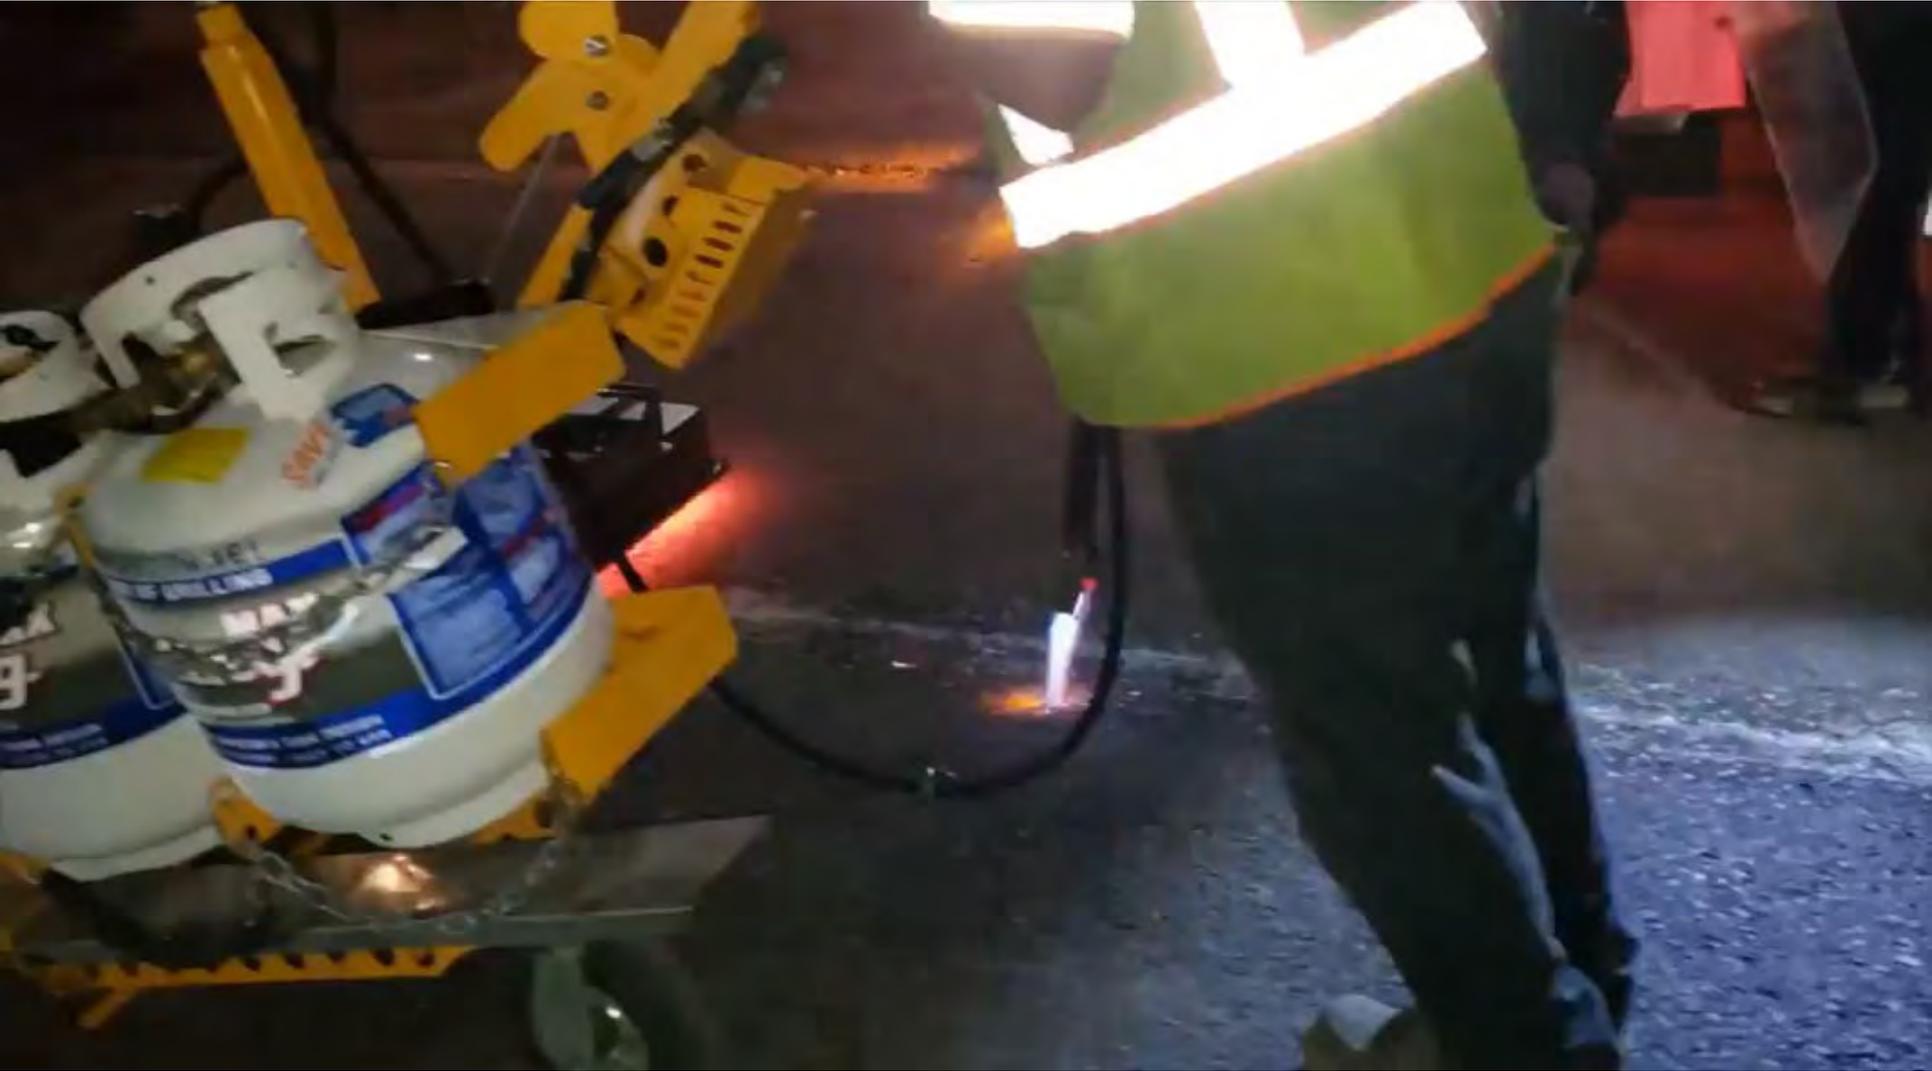
Bidirectional pavement marking Installation at I-5 NB exit ramp @ Palomar Street in Chula Vista, CA

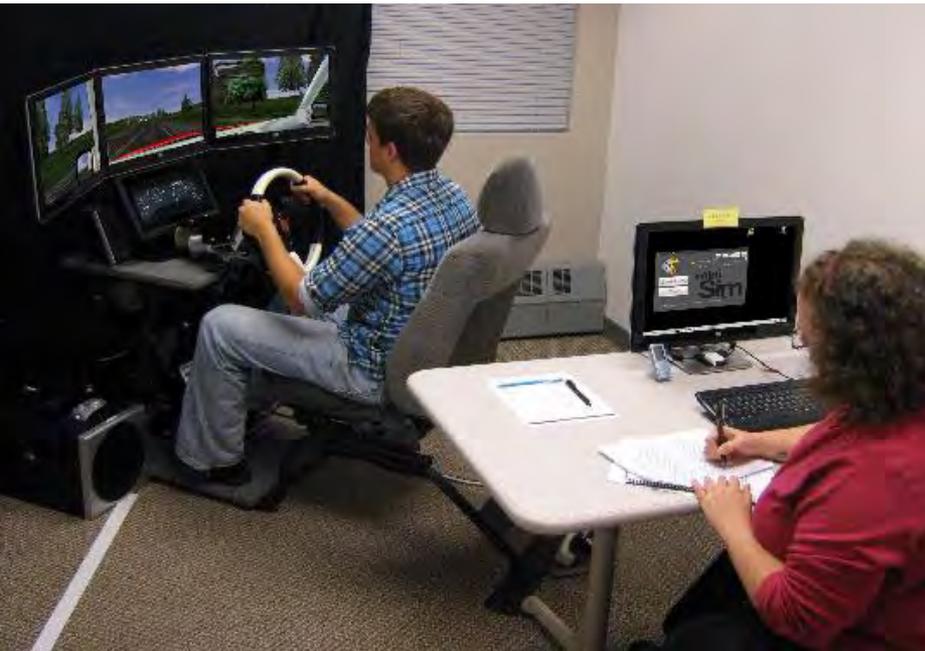
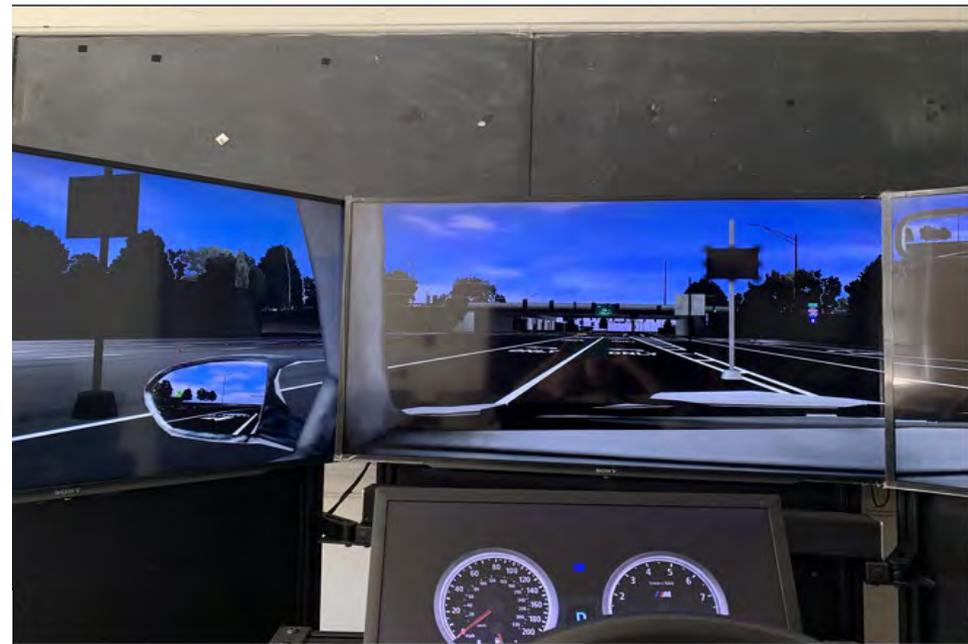
A **Caltrans** sponsored study at **Auburn University** is investigating the effectiveness of countermeasures specifically designed for **intoxicated wrong way drivers**.

The research will use **human subjects** in a **driving simulator** to test their responses to emerging countermeasure technologies such as **bidirectional pavement markings** and **directional rumble strips**, which generate vibrations to provide haptic feedback alerts to intoxicated drivers.

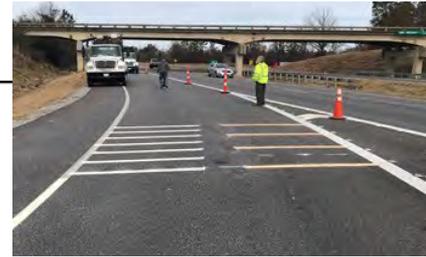
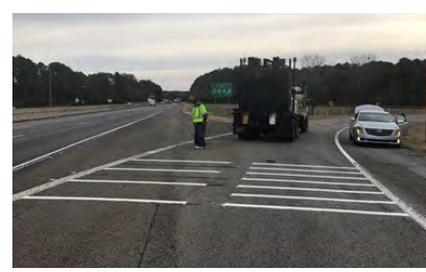
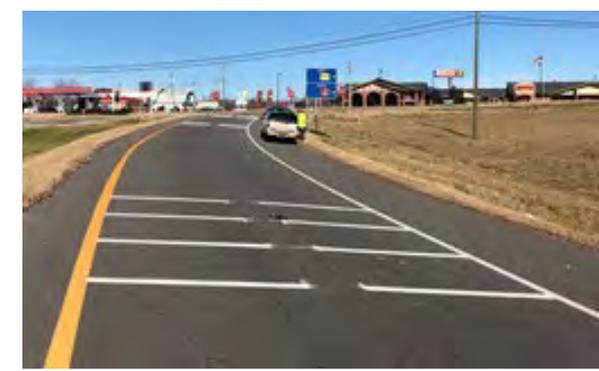
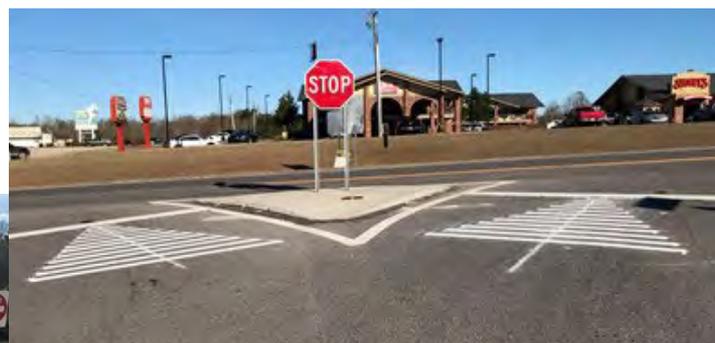
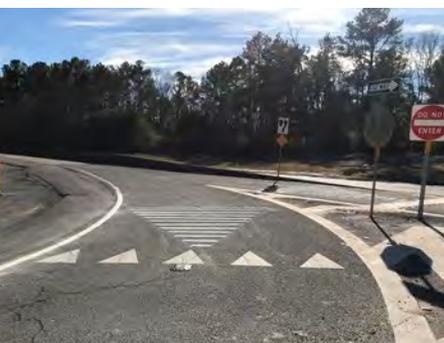
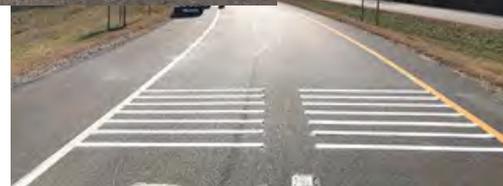
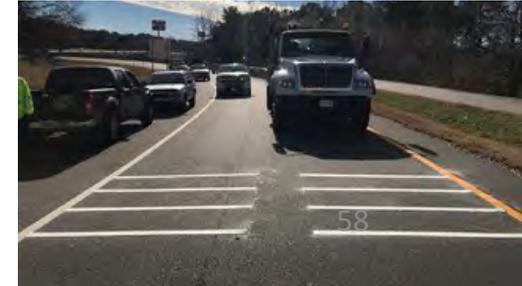
Directional rumble strips generate vibrations to provide haptic feedback alerts to intoxicated drivers

Three different patterns of **directional rumble strips** will be included in the driving simulator scenarios.

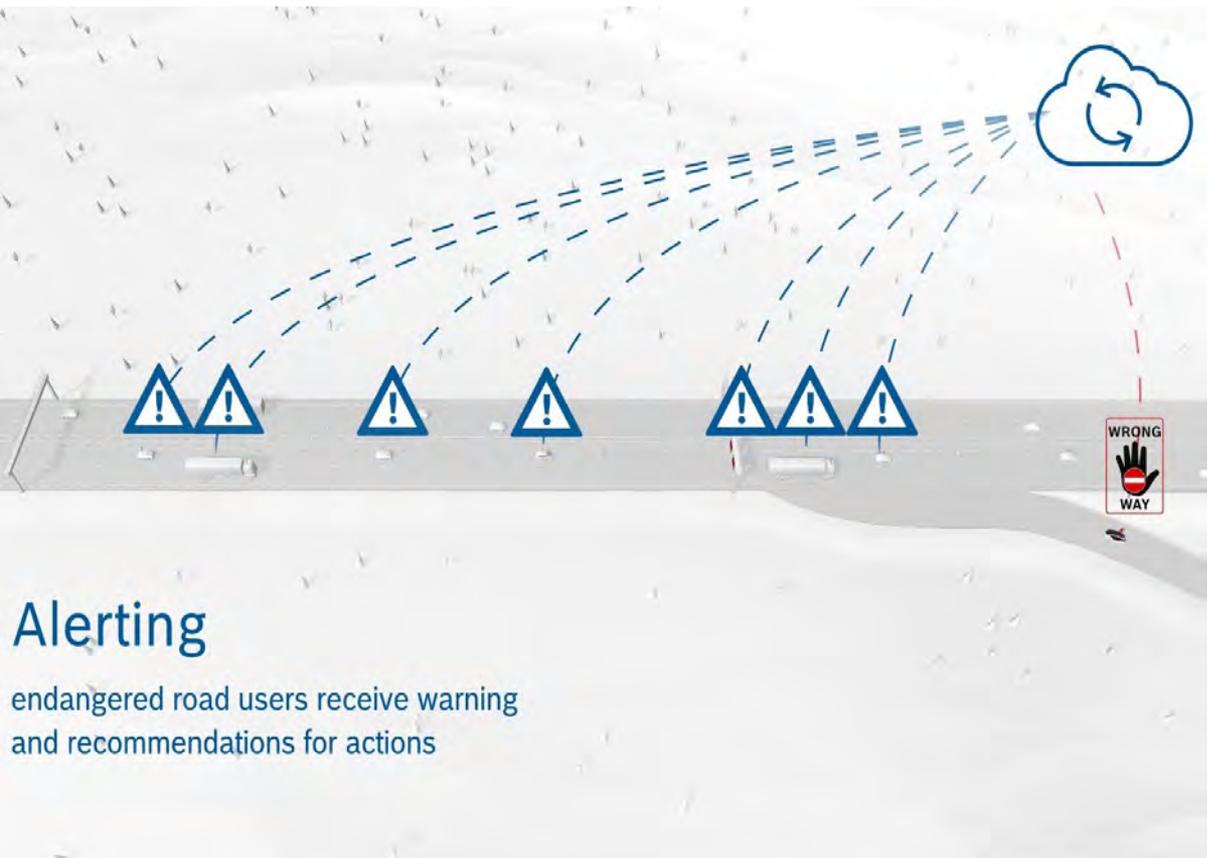
Bosch's software transmits regular, anonymized position data to a server in a central computing center. The server contains a web-based database of maps and corresponding permitted directions of travel. When the server detects a conflict in travel direction, the wrong-way driver, and **all proximate networked road users, automatically receive a warning presented through the third-party app 2.**
