# **Evaluation and Application of Fotokite Tethered Drones in Rural Areas of California and Washington 20<sup>th</sup> Western State Forum Yreka, California June 16<sup>th</sup> to 18<sup>th</sup> - 2025**

The Washington State Department of Transportation (WSDOT) Southwest Region collaborated with the California Department of Transportation (Caltrans) to pilot tethered drone technology, funded through the Western States Rural Transportation Consortium (WSRTC). The initiative aims to enhance situational awareness and improve traffic monitoring in rural areas.

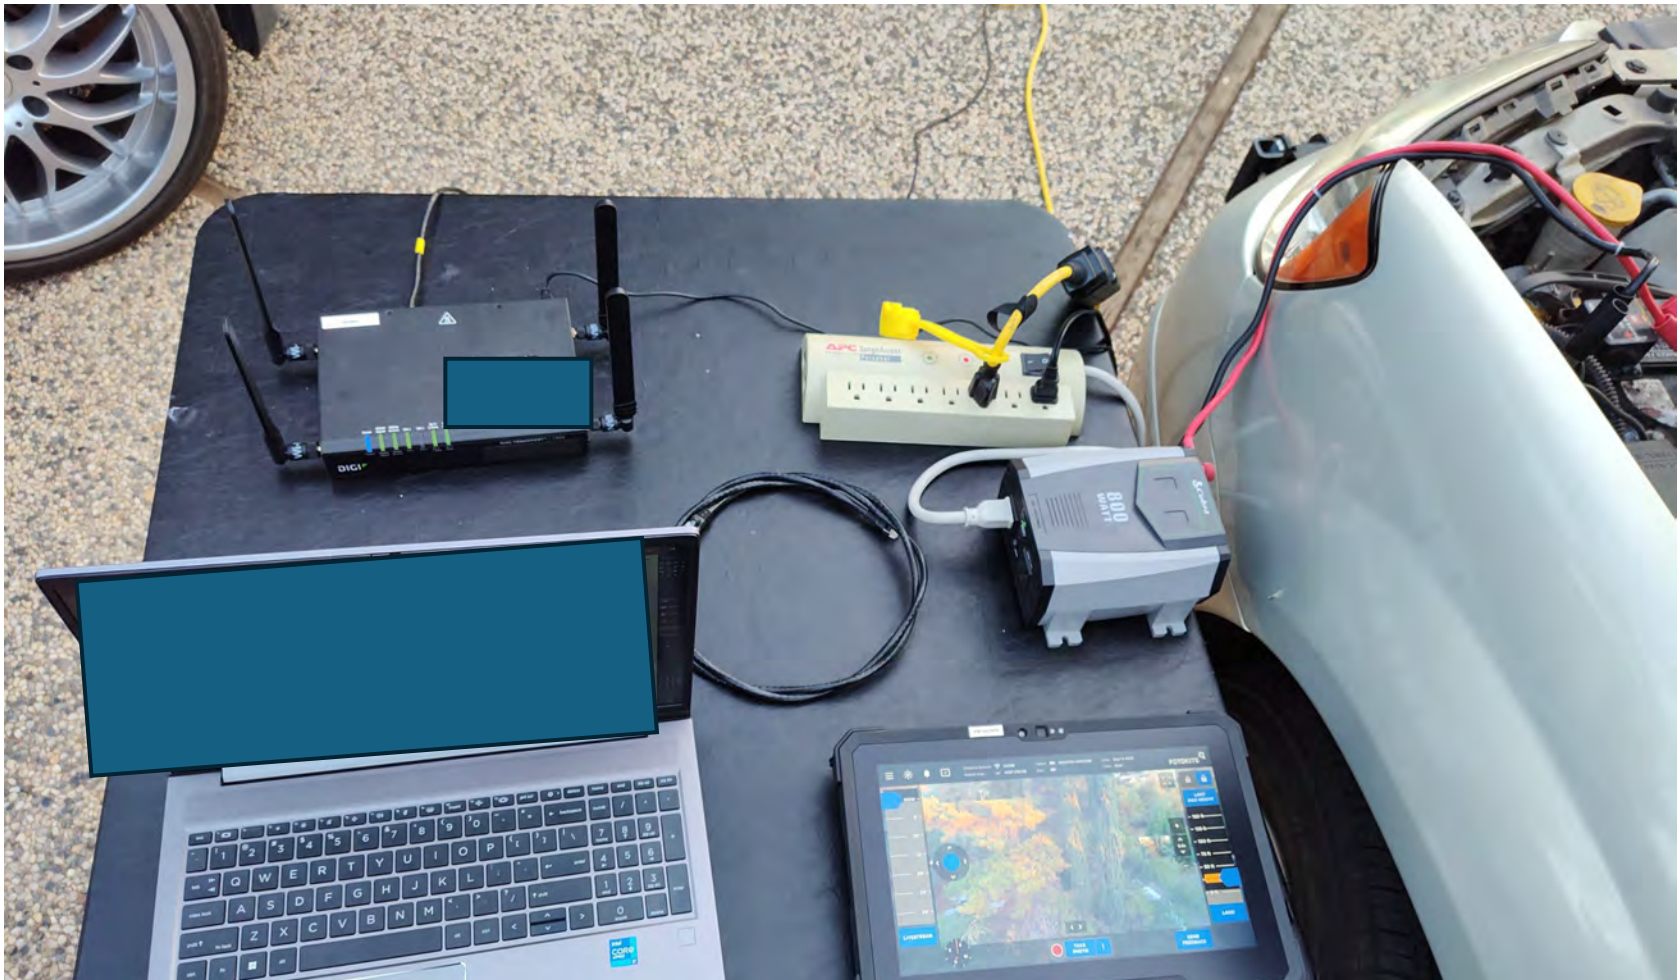
Figure 4: Fotokite system setup to communicate with Caltrans TMC

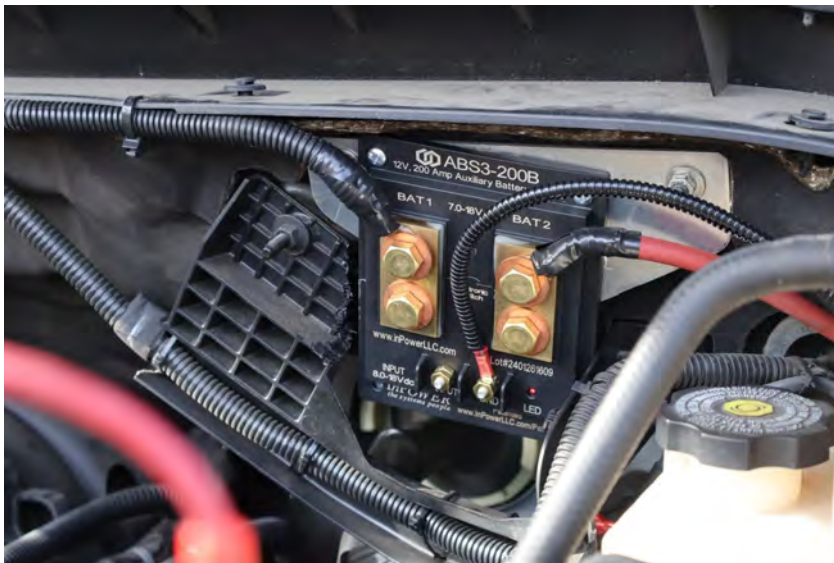
Figure 12: Malfunctioned auxiliary battery switch

- September 2024
  - Vendor investigated and identified remote ID issue. Possible software fix identified. Software changes must be FAA compliant.
  - Unable to power from newer model trucks for more than 30 minutes. Root cause was identified as malfunctioning auxiliary battery switch and an idle kill switch on the truck. Solution was to manually disable the idle kill switch and replace the auxiliary battery switch.
- October 2024
  - Caltrans tested the Fotokite using Starlink network. The test was successful.
  - Remote ID issue was still pending. Fotokite was in the process of modifying the code logic to prevent user lockout.

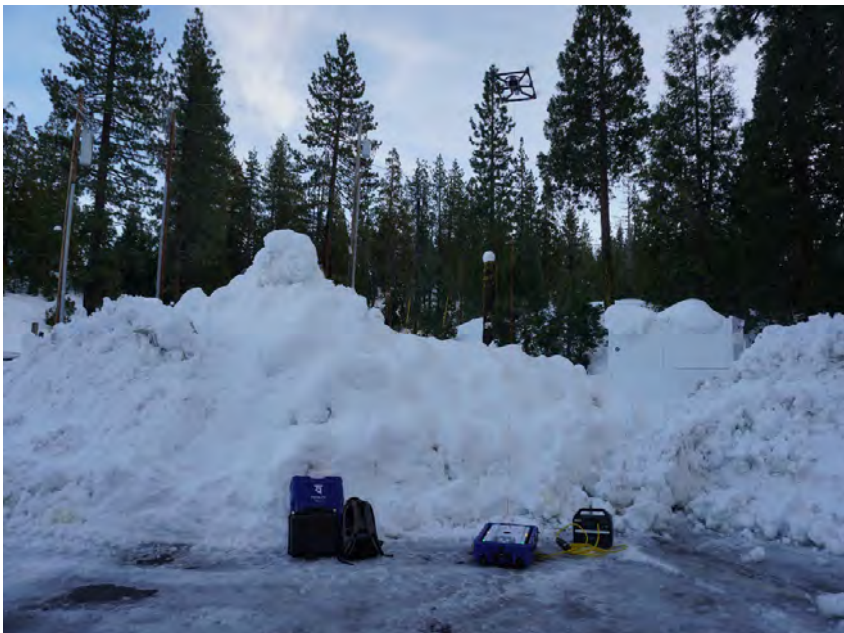
Figure 14: Fotokite operated in cold weather conditions the day prior to the tether power failure

- November 2024
  - Although Fotokite had software release to mitigate remote ID issue, DOTs still experienced remote ID issue, and it prevented the Fotokite from being launched.
- December 2024
  - Issue with the camera's vertical movement (unable to control its up-and-down motion). A loose shaft was suspected to be the cause. However, when the issue was tested and attempts were made to replicate it, the problem resolved itself. Regardless, Fotokite replaced the camera.
  - Cradle failed to provide power to the drone due to internal short during cold weather testing. Fotokite downtime was about a month.

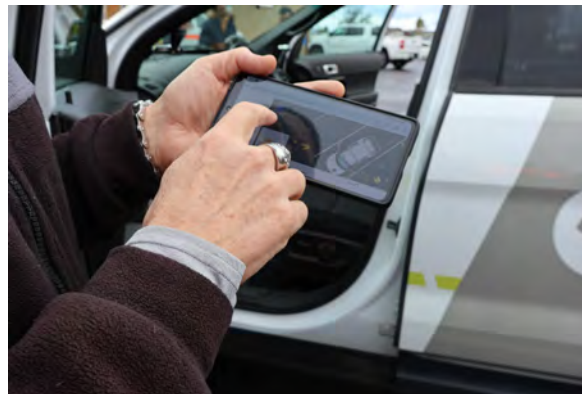
Figure 16: Remote control camera feature demonstrated via a user phone

- January 2025
  - Remote camera control was introduced via firmware upgrade.
  - The heating issue with the backup battery was traced to the internal system layout. Specifically, the tether retraction motor was positioned too close to the temperature sensor. As the motor heated up during operation, it influenced the sensor's readings, leading to inaccurate and corrupted temperature data.
  - Premature landings in high-temperature conditions were addressed by improving the temperature monitoring process. A software update was implemented to enhance the accuracy of temperature readings and prevent false positives caused by heat generated from the motor.
  - Remote ID issue: partially addressed. Fotokite needs recertification from the FAA to make significant changes.

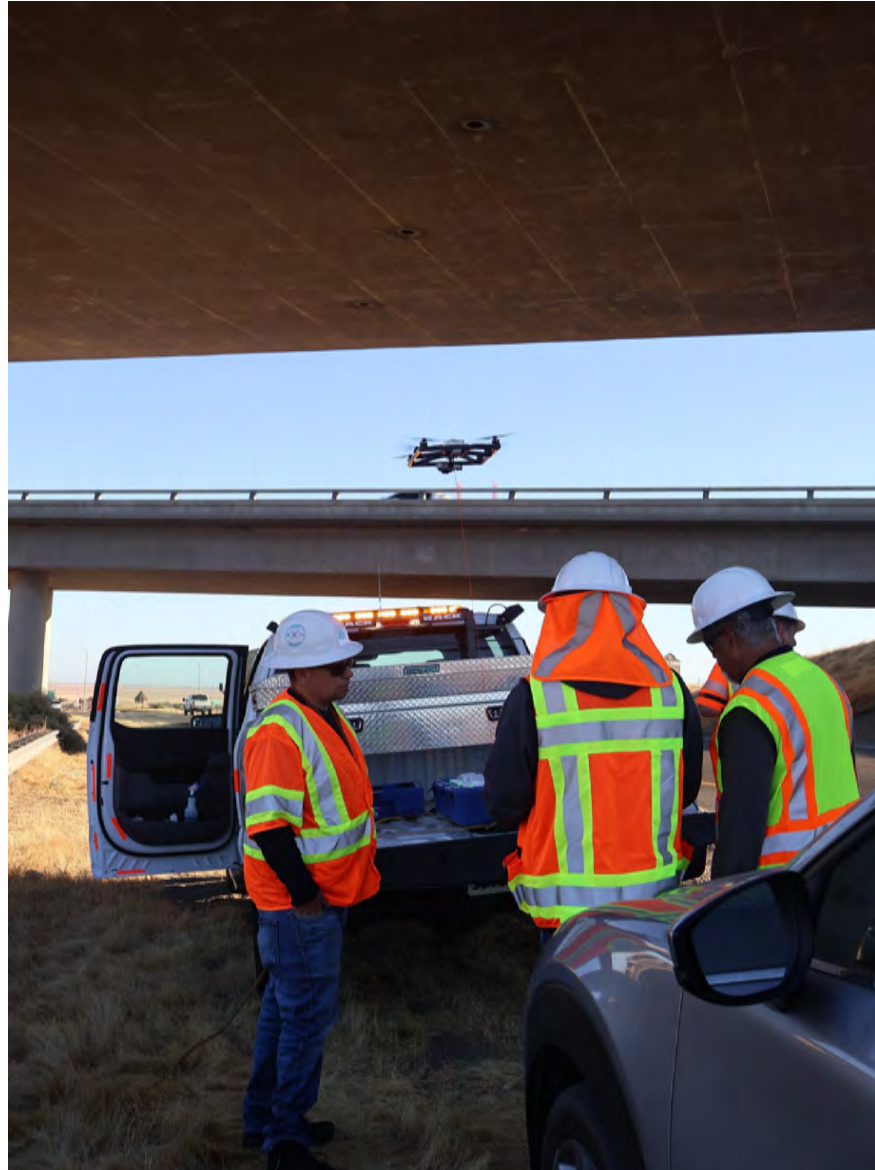
Starlink: High Performance Flat Dish

Figures 28, 29, and 30: Fotokite used Starlink network in a rural area

- On October 17, 2024, Caltrans held its Annual Great Shakeout Earthquake Exercise Statewide. D6 was tasked to use the Fotokite to livestream a mock structure inspection Statewide.
- The Fotokite used a Starlink satellite internet connection to achieve this.
- The Fotokite was flown for 2 continuous hours livestreaming to a maximum of 38 viewers, with a continuous 25 viewers at all times.
