# Evaluation and Application of Fotokite Tethered Drones in Rural Areas of California and Washington 20<sup>th</sup> Western State Forum Yreka, California June 16<sup>th</sup> to 18<sup>th</sup> - 2025

# Background

The Washington State Department of Transportation (WSDOT) Southwest Region collaborated with the California Department of Transportation (Caltrans) to pilot tethered drone technology, funded through the Western States Rural Transportation Consortium (WSRTC). The initiative aims to enhance situational awareness and improve traffic monitoring in rural areas.

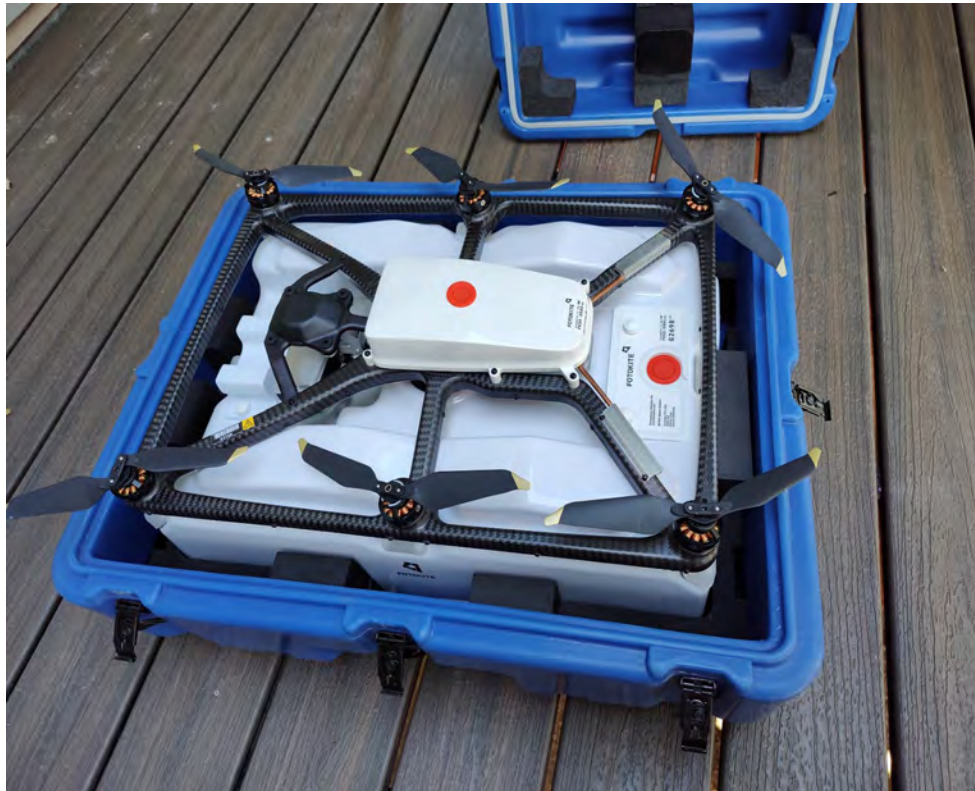
Figure 1: Fotokite cradle and flight unit

**Dimensions:** 20.2 x 13.7 x 8.4 in  
**Ground Base Weight:** 22.2 lbs  
**Flight Unit Weight:** 2.78 lbs  
**Power Source:** 110-230 (50-60 Hz) VAC  
**Flight Power Consumption:** 300-400W  
**Weather Ratings:** light to medium rain/snow, wind up to 25 mph  
**Operating Temperature:** 14°F to 104°F  
**Flight altitude:** 150 ft (with GPS), 82 ft (without GPS)  
**Flight time:** 24 hours +  
**FAA Compliance:** No Part 107 pilot license, waiver or authorization (COA), or aircraft certification needed for Public Safety Officers

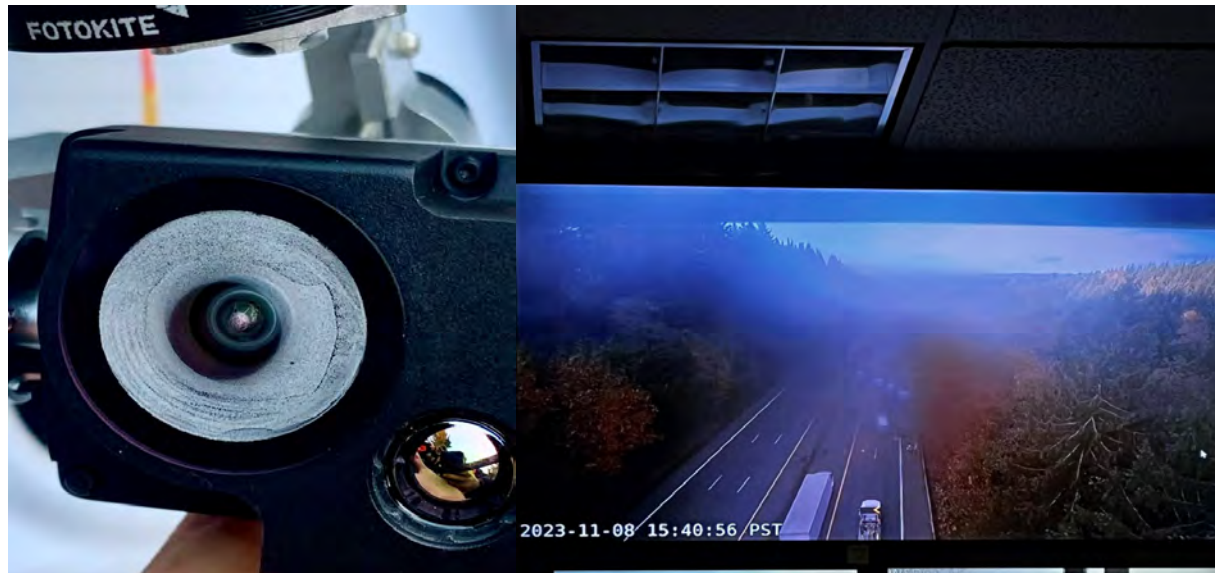
Figure 7: Condensation at the Fotokite camera lens

- July to October 2023
  - Procurement period.
  - 3 units procured for California
  - 2 units procured for Washington
- End of October 2023
  - Motor malfunction issue experienced by WSDOT
- November 2023
  - Camera lens condensation experienced by WSDOT

- January 2024
  - Recalled all units due to motor malfunction issue. Root cause was identified as MOSFETs from different manufacturer. All units were sent back for RMA repairs. Four of the 5 units were affected by this issue.
  - Insufficient voltage issue was caused by a malfunctioned charging circuit.
  - Lens condensation was caused by a crack in the lens.
  - Downtime for all units was about a month.
- February 2024
  - Two tablets had a software issue experienced by WSDOT. One table was fixed remotely. The second unit was replaced by Fotokite.
- March 2024
  - Wind caused by passing trucks affects Fotokite stability. Control algorithm did not react as intended during the drone flight.
- May 2024
  - Live stream experienced delays.
  - Fotokite was tested and could perform self-leveling and descending during strong wind.

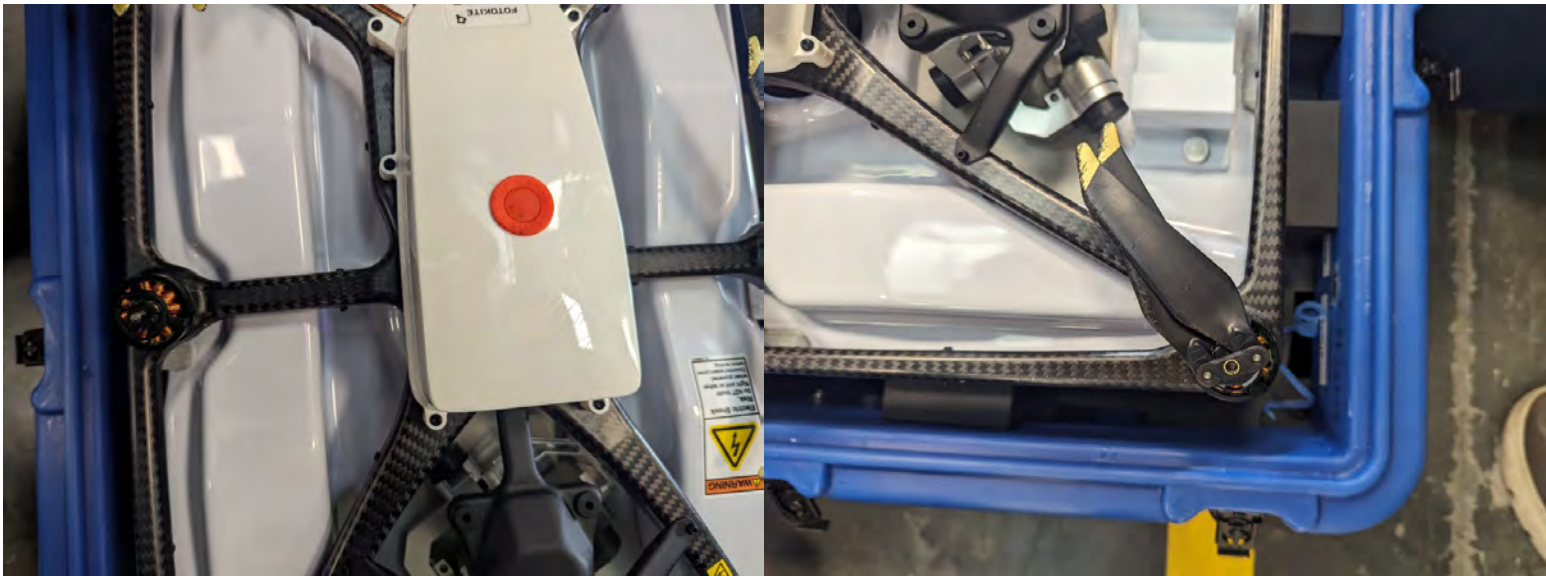
Figure 8: Damages sustained from the crash

- End of November 2023
  - In California, a second Fotokite unit experienced the same motor failure causing it to crash. Fotokite crashed upside down, thus only the frame and propellers were damaged.

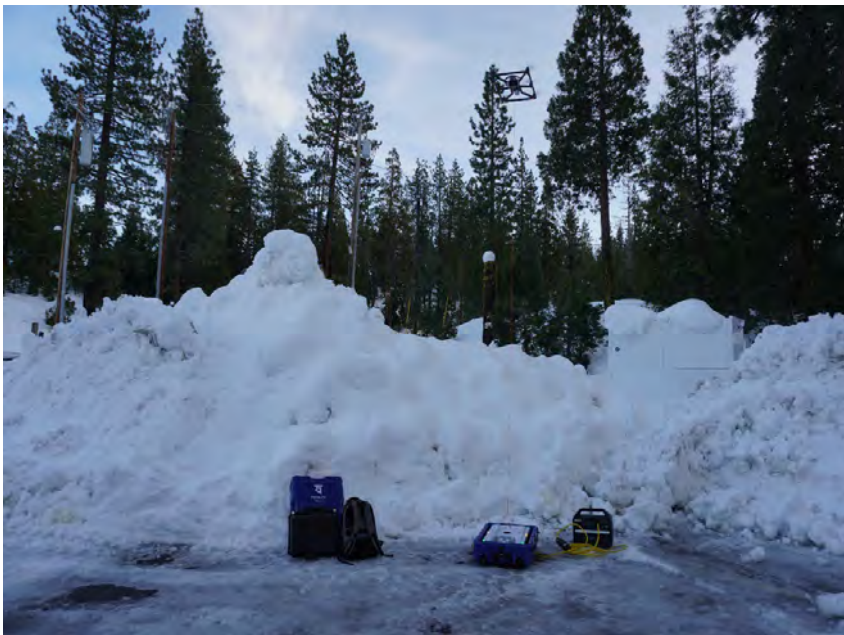
Figure 14: Fotokite operated in cold weather conditions the day prior to the tether power failure

- November 2024
  - Although Fotokite had software release to mitigate remote ID issue, DOTs still experienced remote ID issue, and it prevented the Fotokite from being launched.
- December 2024
  - Issue with the camera's vertical movement (unable to control its up-and-down motion). A loose shaft was suspected to be the cause. However, when the issue was tested and attempts were made to replicate it, the problem resolved itself. Regardless, Fotokite replaced the camera.
  - Cradle failed to provide power to the drone due to internal short during cold weather testing. Fotokite downtime was about a month.

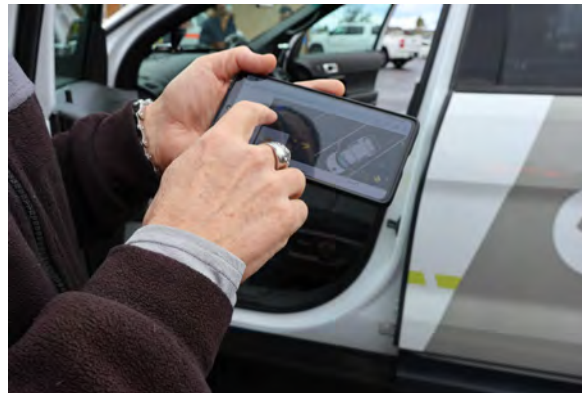
Figure 16: Remote control camera feature demonstrated via a user phone

- January 2025
  - Remote camera control was introduced via firmware upgrade.
  - The heating issue with the backup battery was traced to the internal system layout. Specifically, the tether retraction motor was positioned too close to the temperature sensor. As the motor heated up during operation, it influenced the sensor's readings, leading to inaccurate and corrupted temperature data.
  - Premature landings in high-temperature conditions were addressed by improving the temperature monitoring process. A software update was implemented to enhance the accuracy of temperature readings and prevent false positives caused by heat generated from the motor.
  - Remote ID issue: partially addressed. Fotokite needs recertification from the FAA to make significant changes.

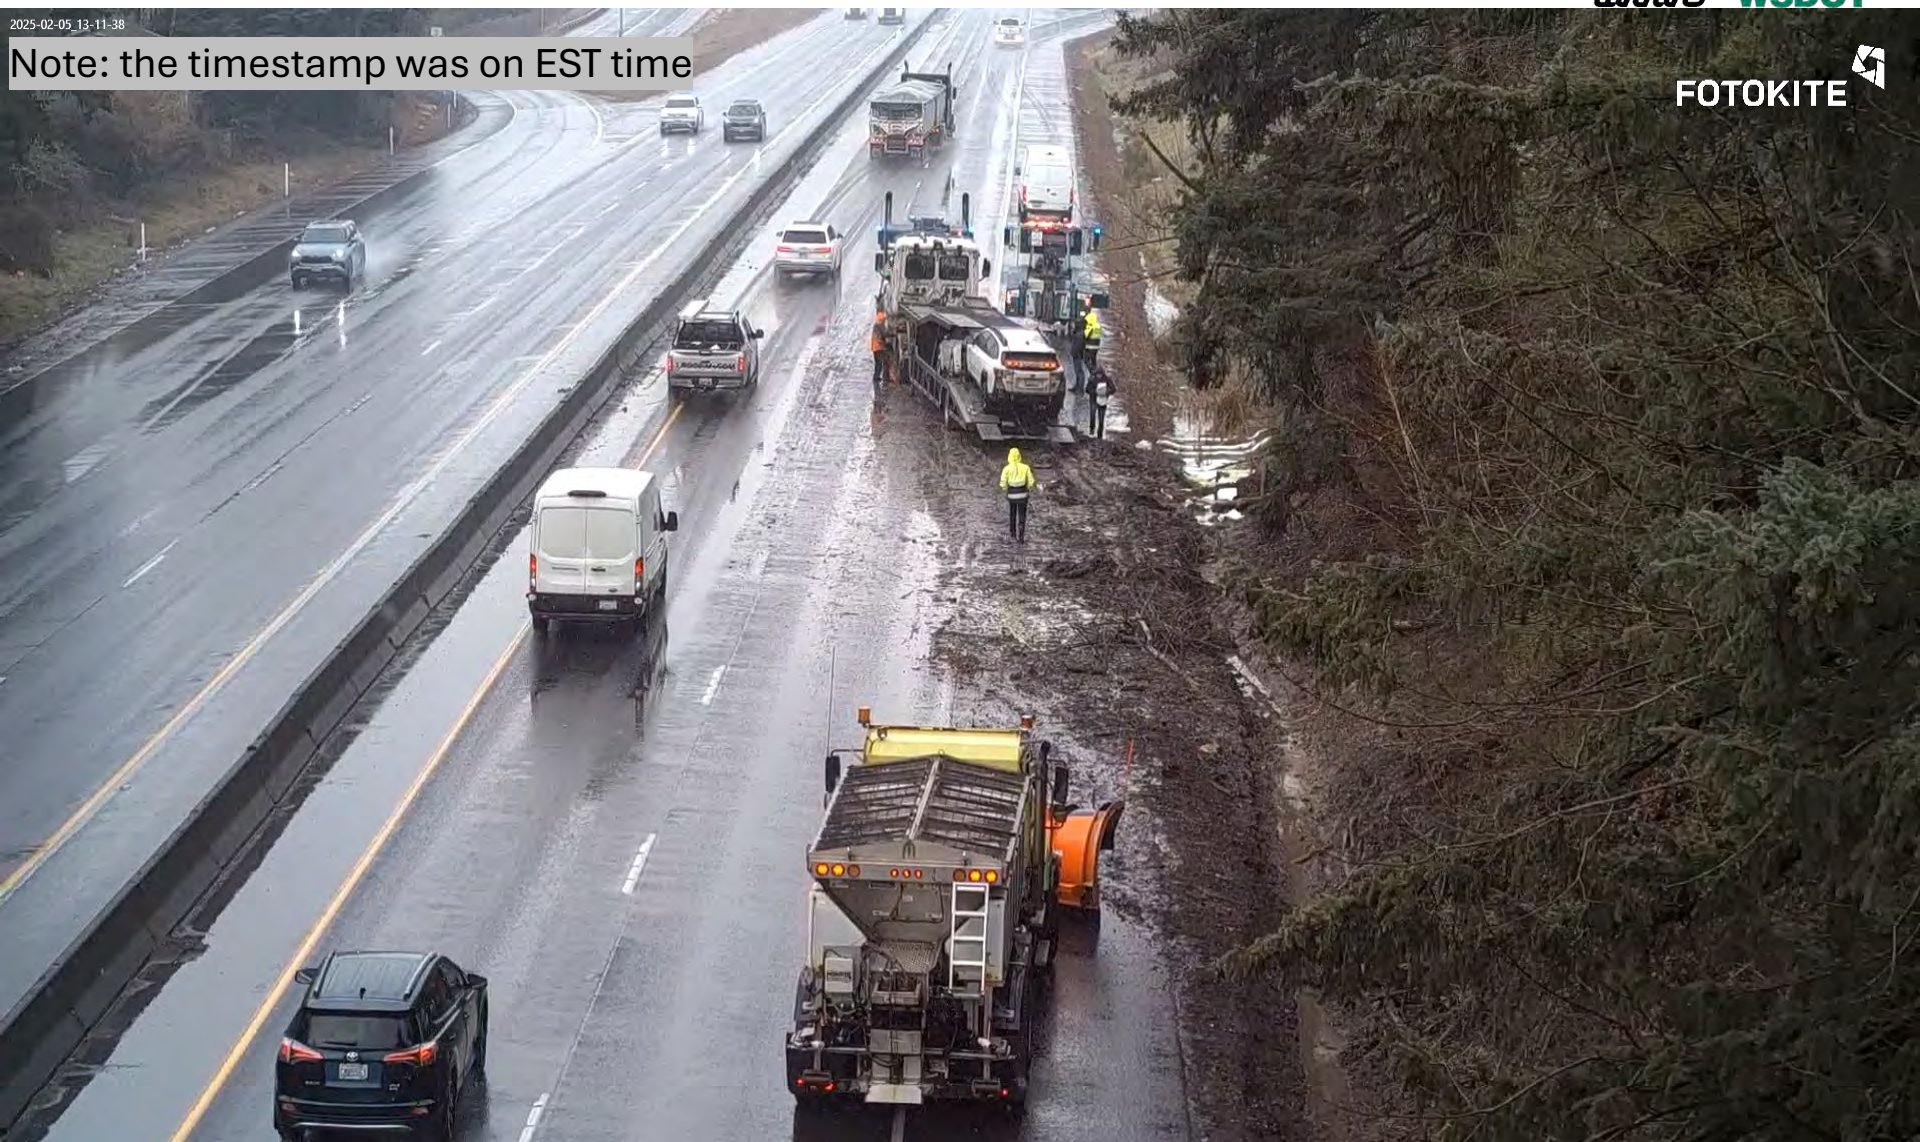
Figure 19: Crash site captured by Fotokite

- On February 5, 2025, at approximately 10 AM on I-5, a vehicle accident occurred when a car veered off the road and into a ditch.
- An emergency lane closure was implemented because of the accident. The WSDOT Rapid Response Team documented the scene for safety and insurance purposes. In addition, WSDOT TMC utilized the Fotokite livestream to monitor traffic conditions in real time.
- Another incident was captured by the Fotokite system for the TMC; however, the exact location of this incident is unknown.

Note: the timestamp was on EST time

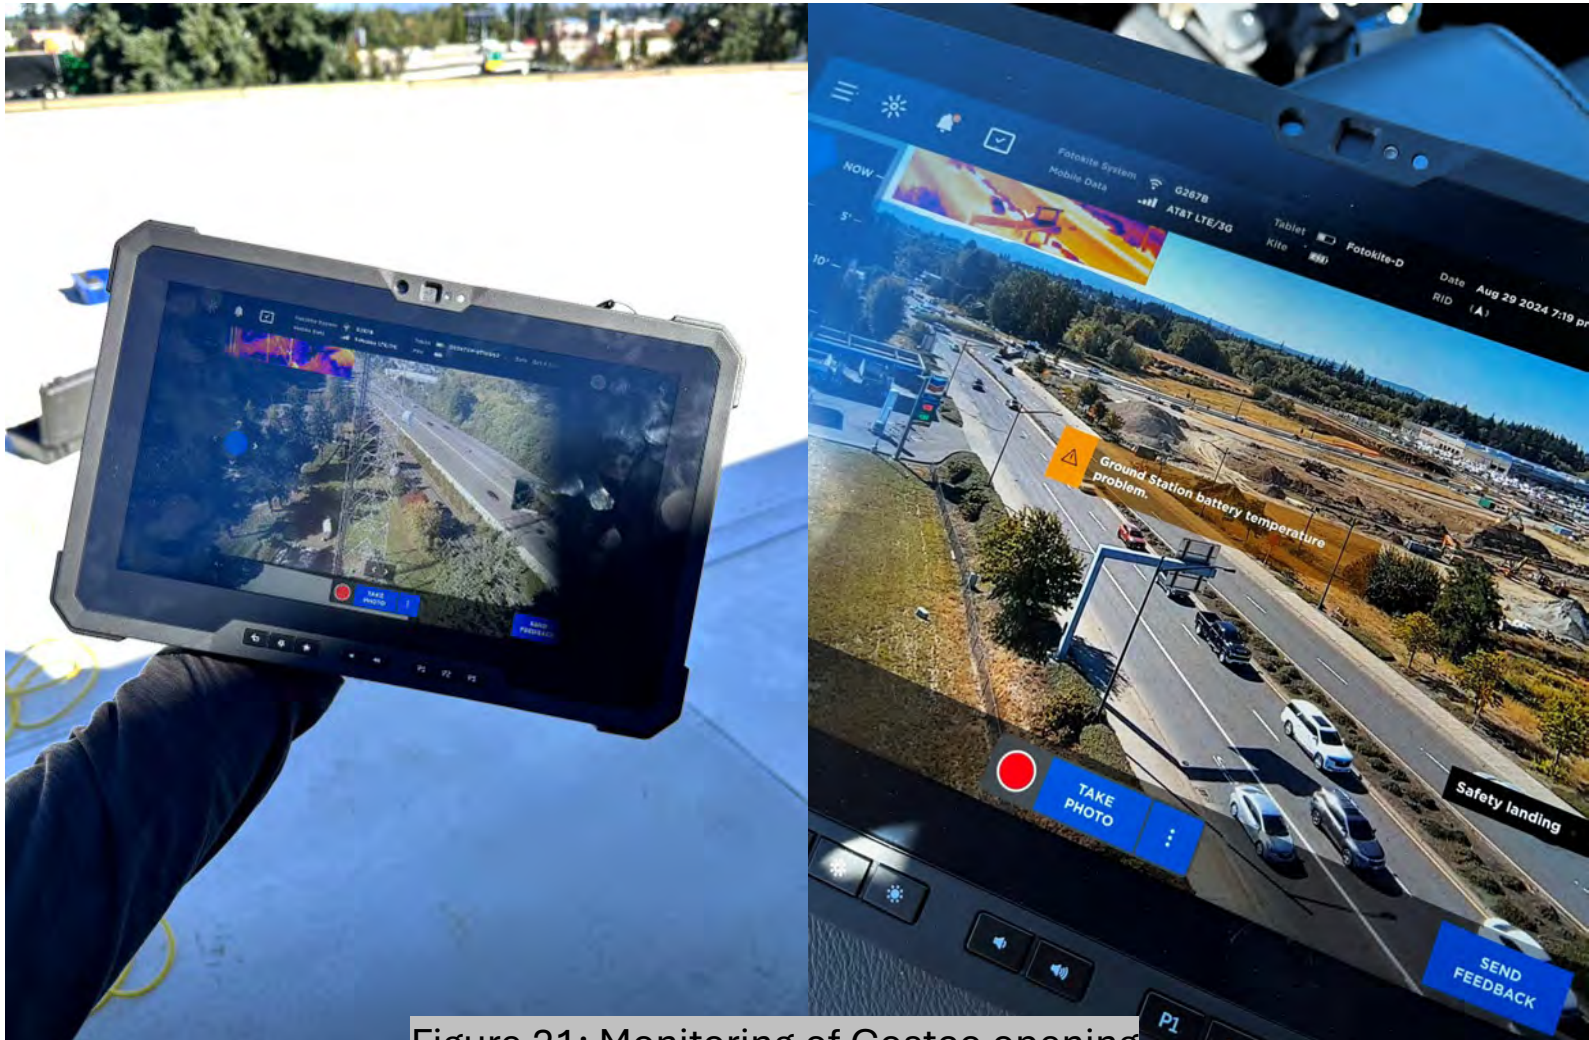
Figure 21: Monitoring of Costco opening

- Fotokite was used to monitor a Costco opening for approximately 5 hours.
- The livestreaming was broadcast in the TMC room for traffic monitoring.
- Fotokite required a 30-minute rest period in the shade one time between flights. After cooling down, it was re-launched and successfully completed the mission.

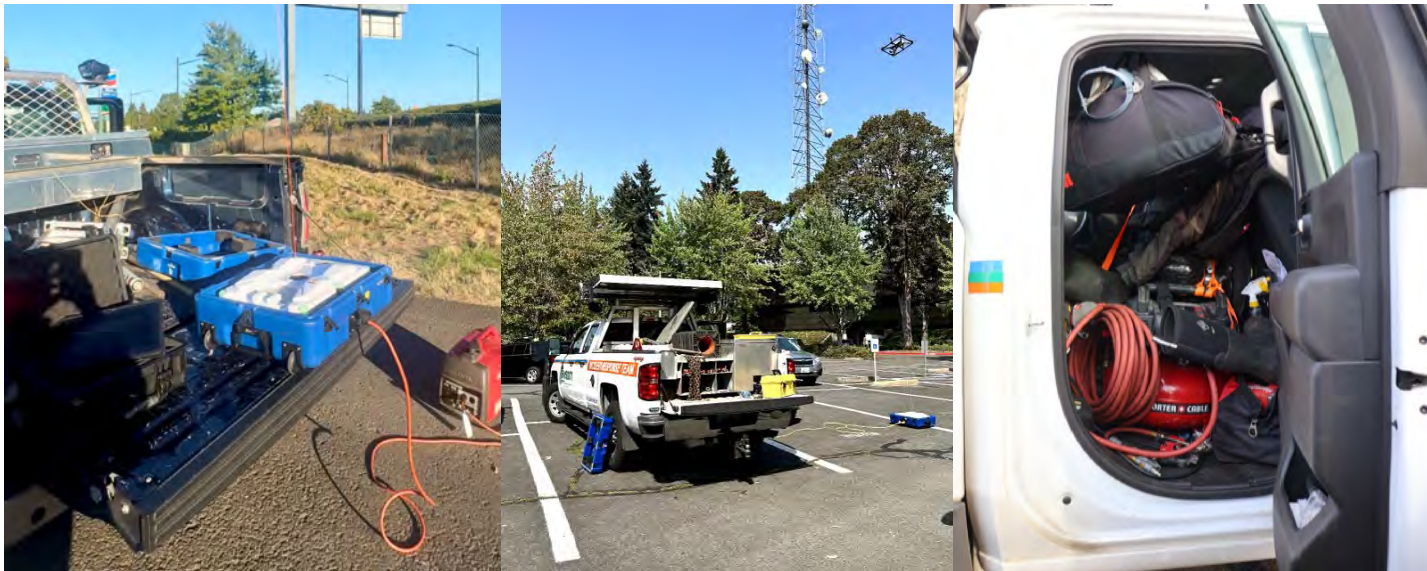
Figure 22: Fotokite and WSDOT rapid incident response trucks

- The size of the portable Fotokite unit poses a challenge for storage and deployment for WSDOT incident response trucks.
- Out of approximately 20 incidents per day and around 400 incidents per month (excluding off days), Fotokite is deployed about twice a month, resulting in a usage rate of less than 1%.

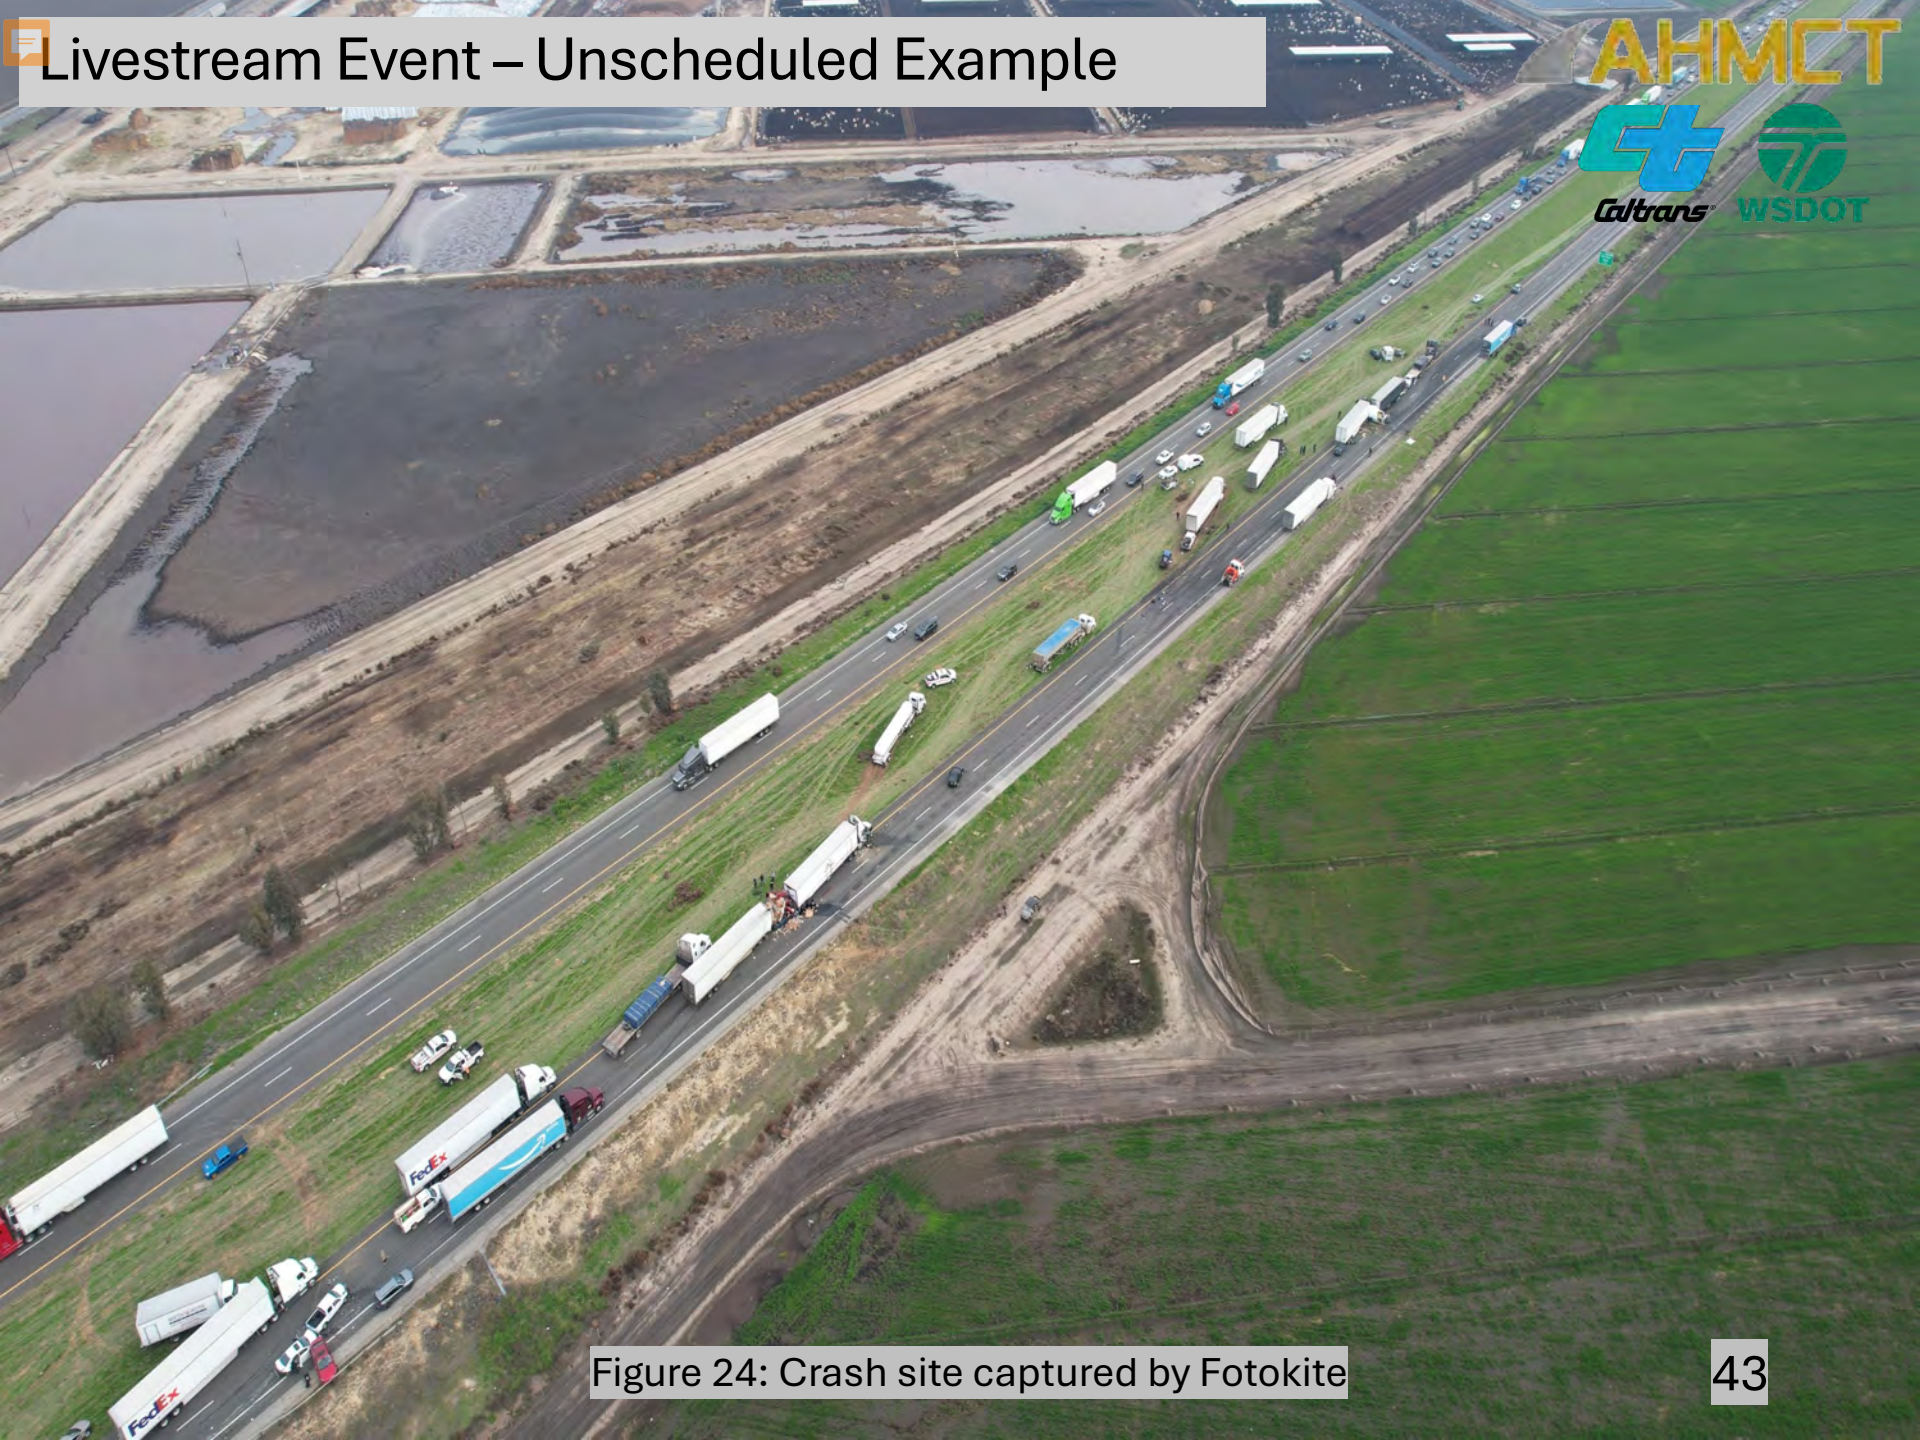
Figure 24: Crash site captured by Fotokite

- On January 6, 2024, at approximately 7:30 a.m. on southbound I-5 at Millux Road, roughly 100 miles north of Los Angeles, a multiple vehicle collision occurred:
  - Involving a total of 35 vehicles: 17 passenger vehicles and 18 big rigs
  - Resulting in 2 fatalities and 9 injuries
  - Closed southbound I-5 for over 24 hours
  - Included a hazardous material gas leak

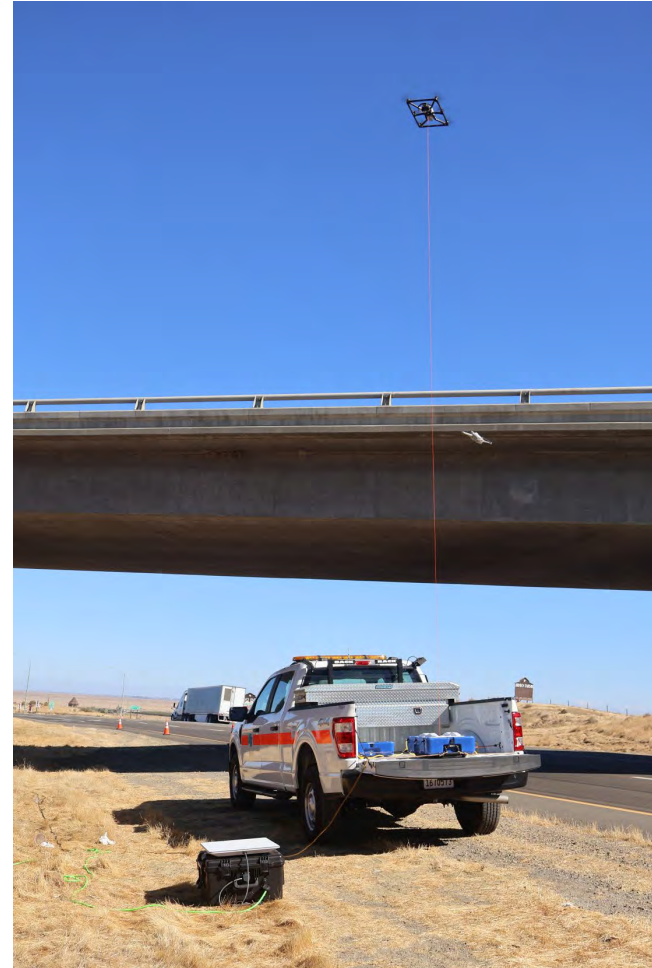
Figure 27: Fotokite used Starlink network in a rural area

- On October 17, 2024, Caltrans held its Annual Great Shakeout Earthquake Exercise Statewide. D6 was tasked to use the Fotokite to livestream a mock structure inspection Statewide.
- The Fotokite used a Starlink satellite internet connection to achieve this.
- The Fotokite was flown for 2 continuous hours livestreaming to a maximum of 38 viewers, with a continuous 25 viewers at all times.

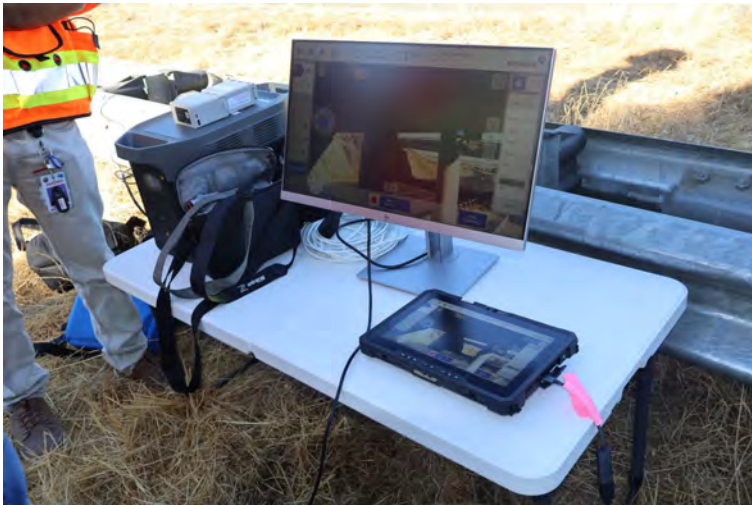
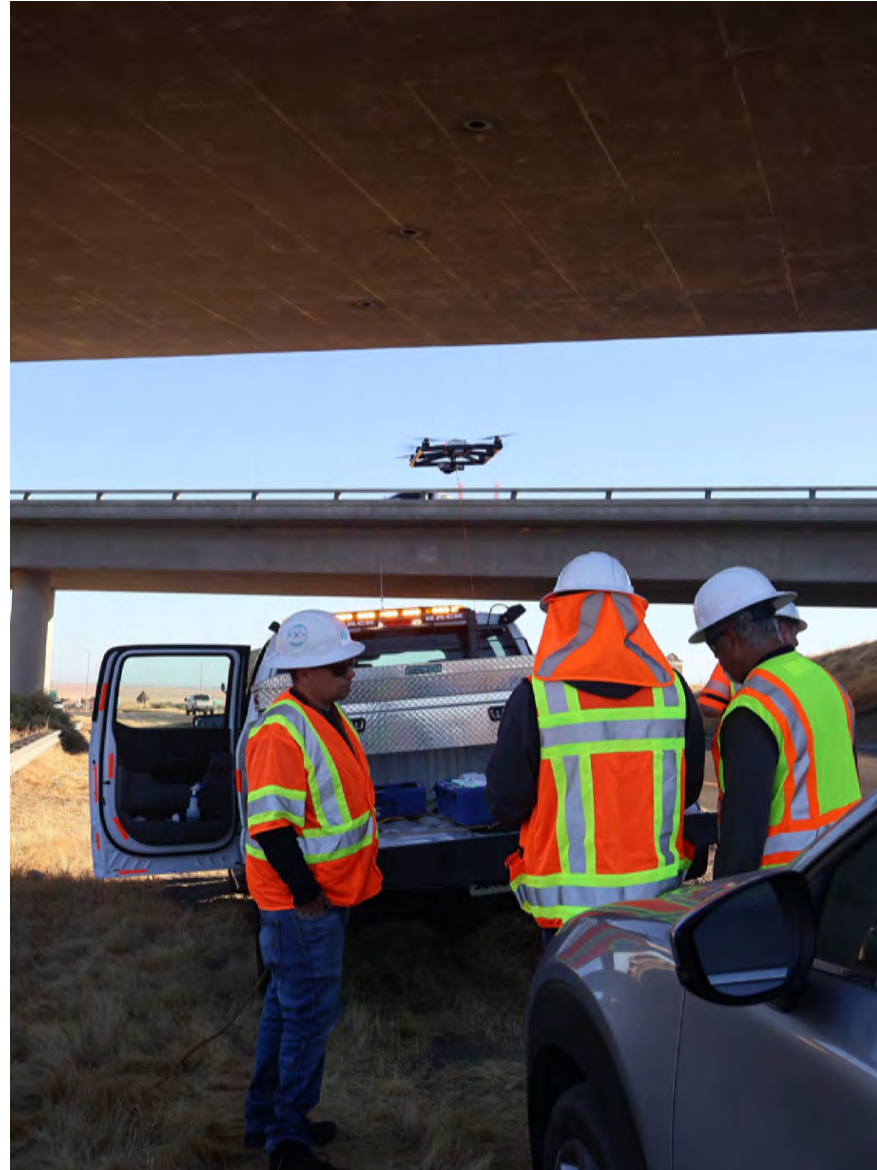
Figures 28, 29, and 30: Fotokite used Starlink network in a rural area

Starlink: High Performance Flat Dish

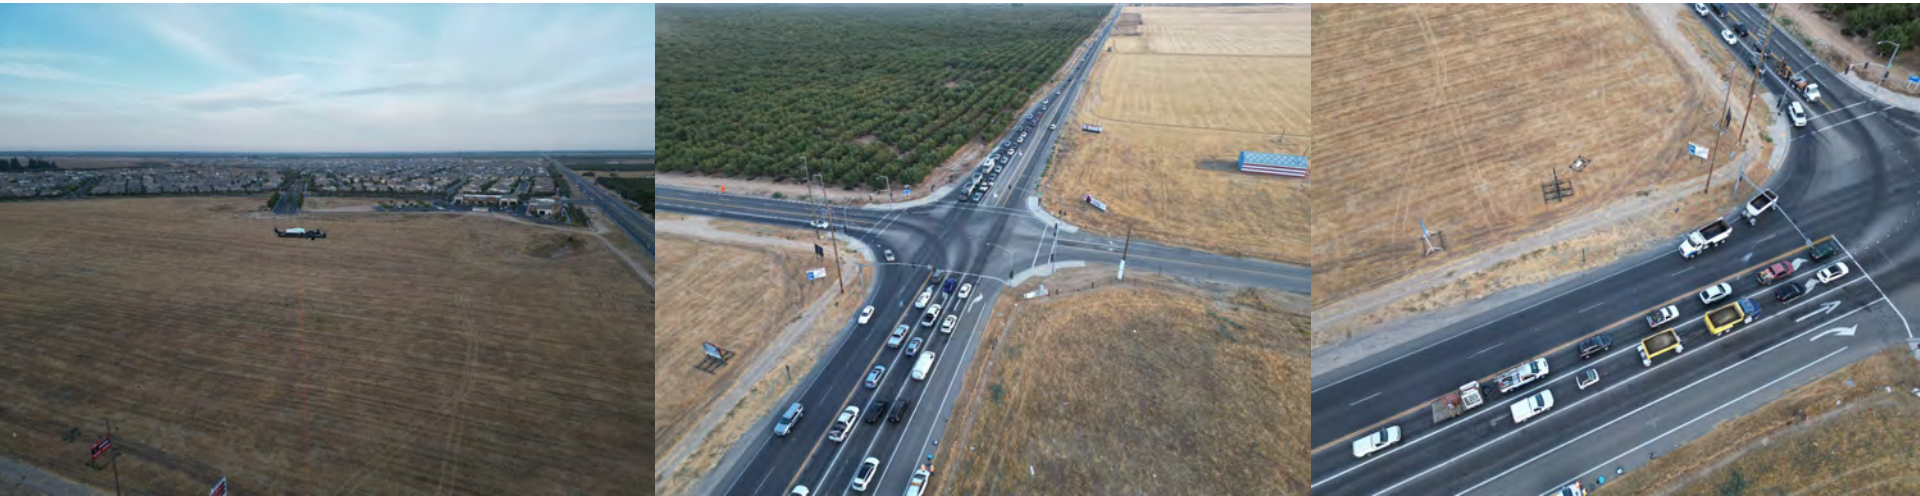
Figures 34, 35 and 36: Fotokite used for traffic surveillance

Recording/Monitoring traffic patterns during peak hour(s)
