## ITS, Signage, Signals, and Structures Condition Rating Dashboard

Doug Spencer, P.E. Standards Engineer Intelligent Transportation Systems Oregon Department of Transportation

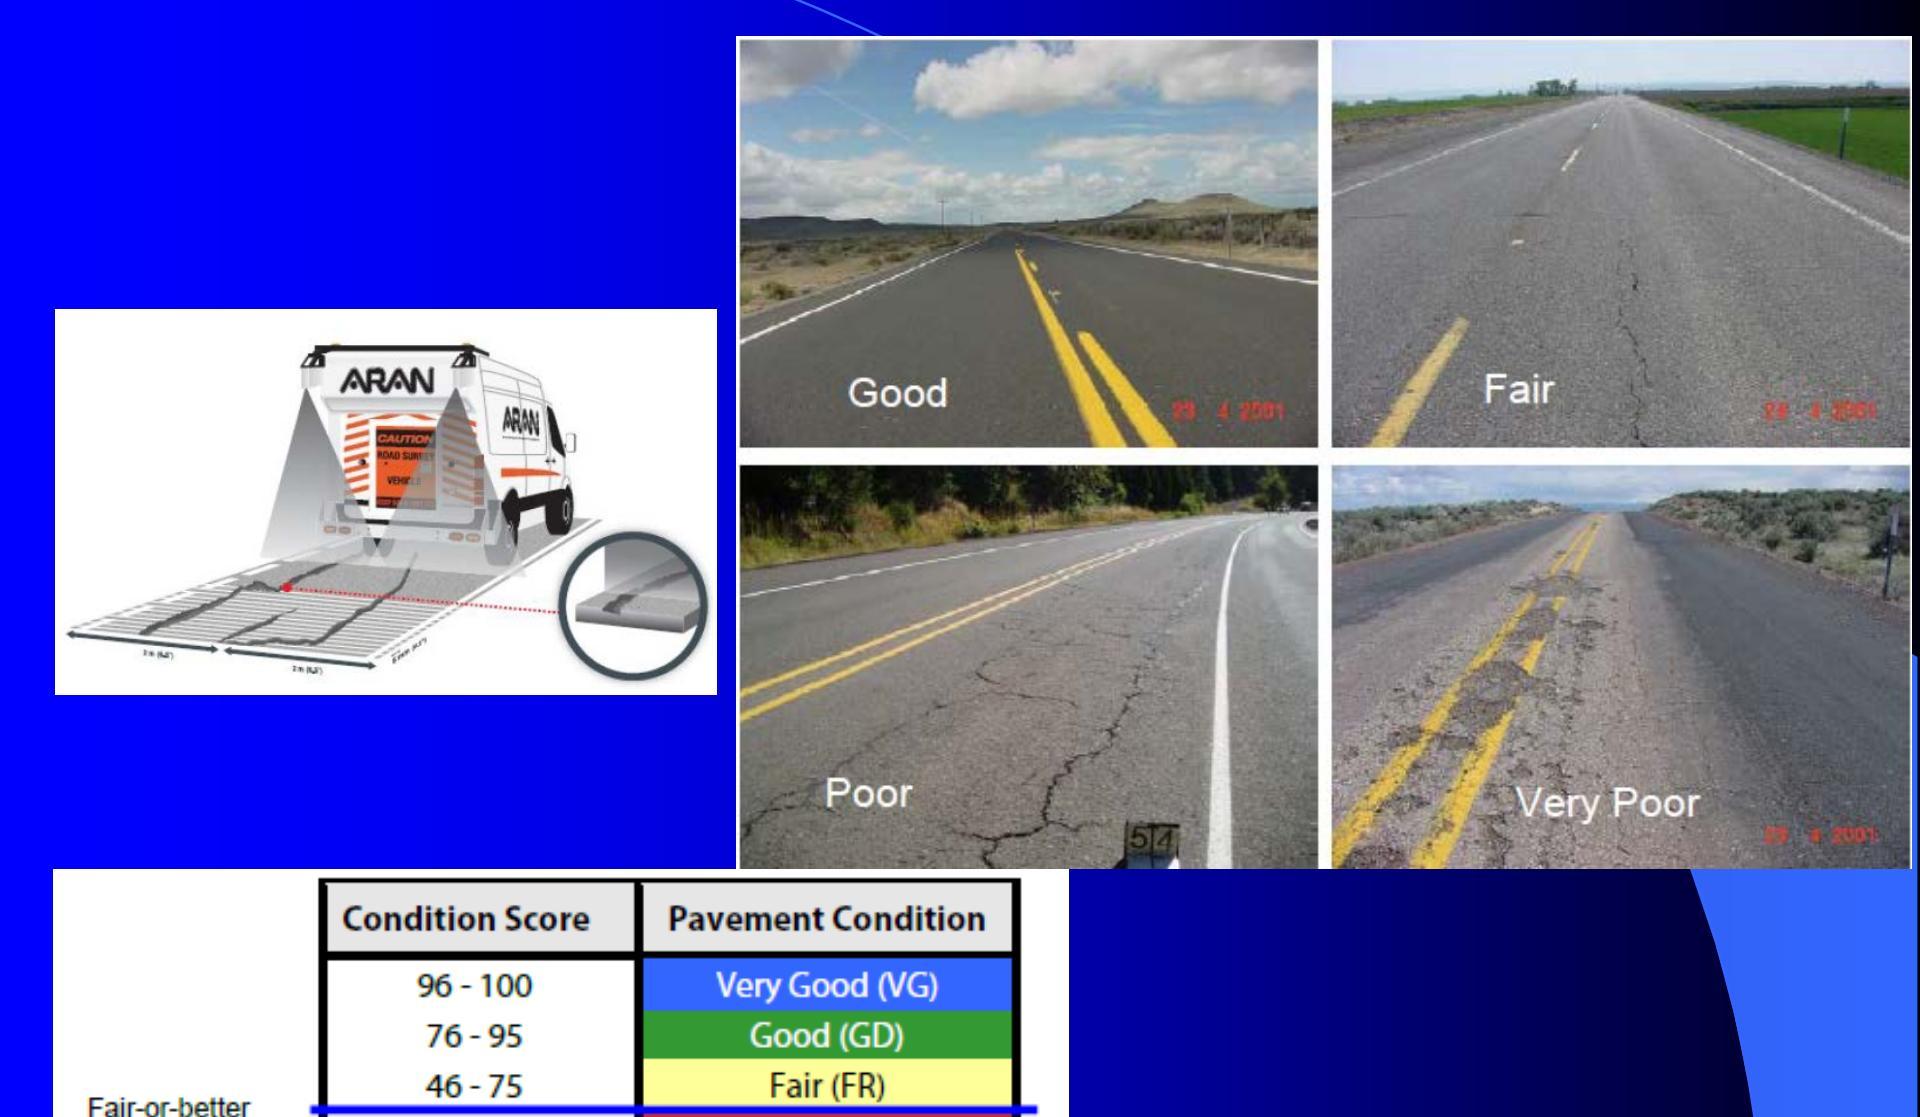
### Pavement Conditions – Score to Conditions

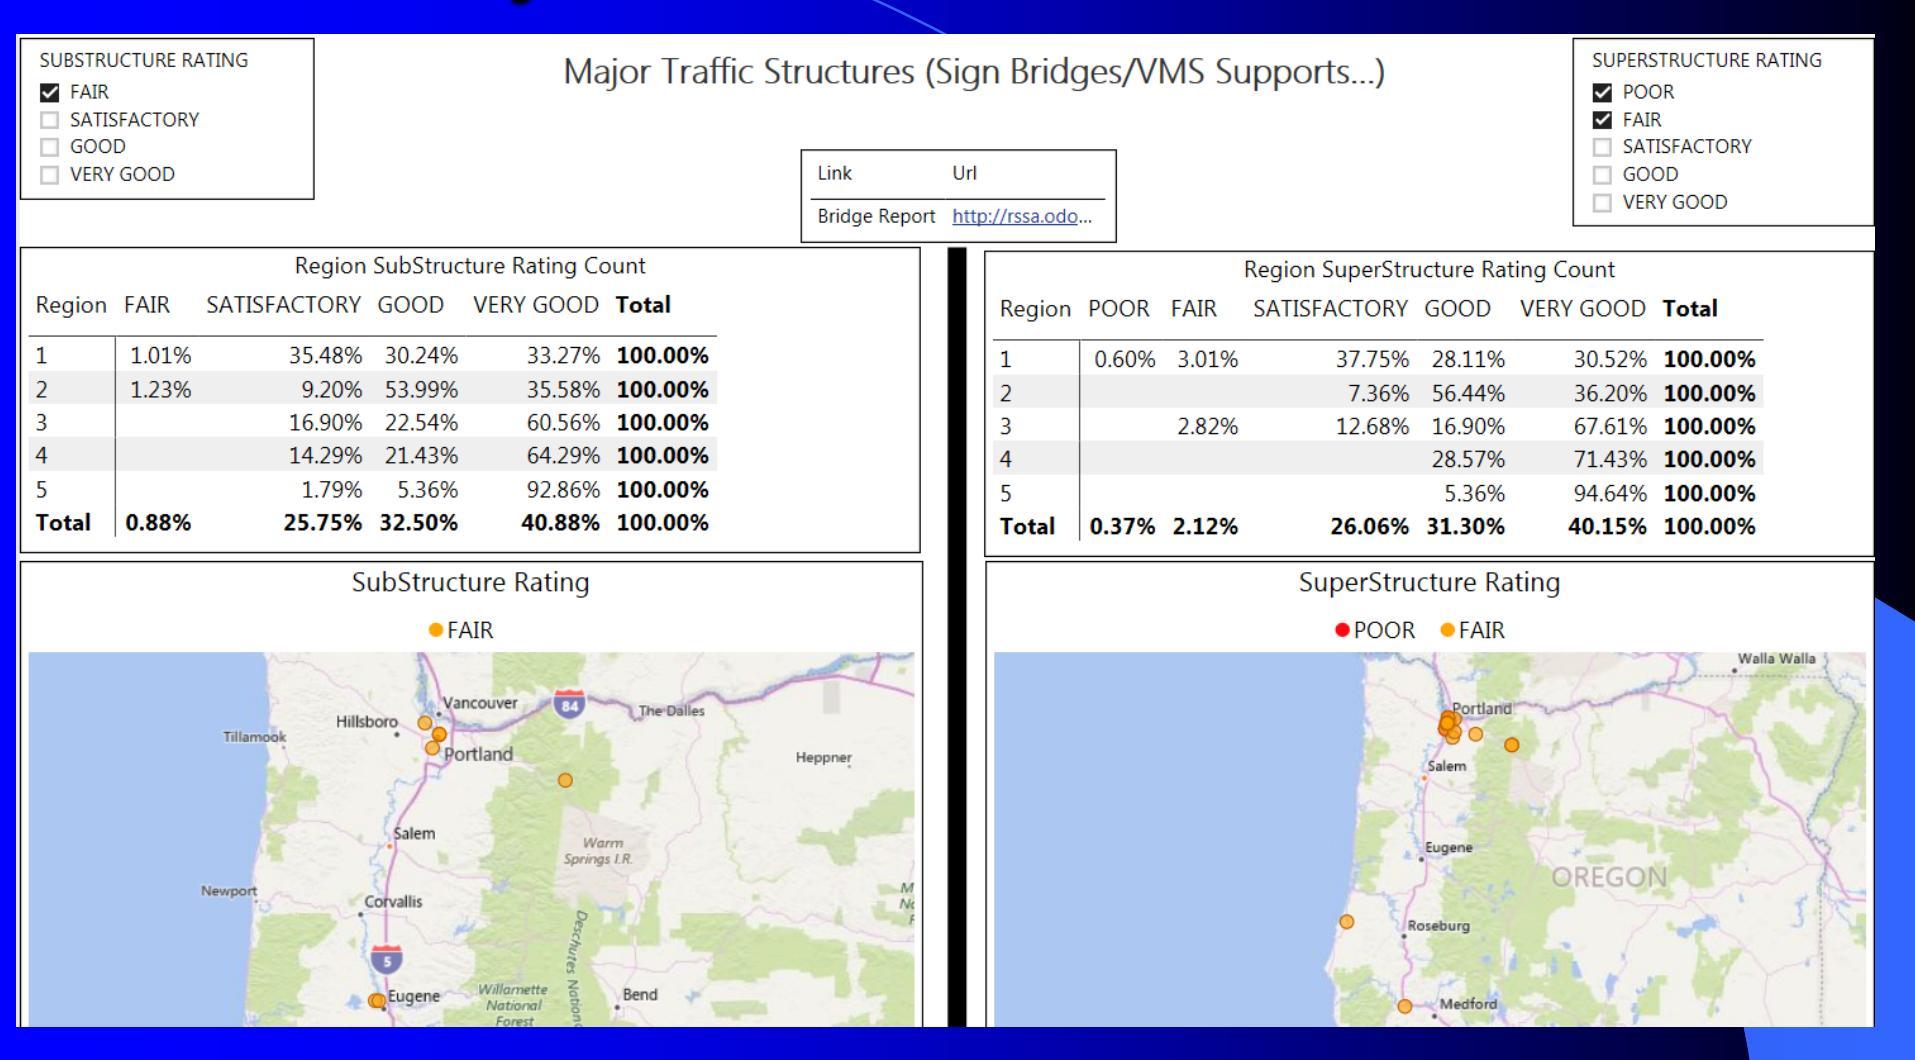
# **Major Traffic Structures**

Welded steel truss sign bridge. Truss has freckle rust throughout. Some isolated base metal exposed. The 4 steel columns have been repainted recently - CS1. Columns on the N. end are buried in debris - can't inspect bolts. Broken welds on bracing to bottom chord. Deformed bottom chord in WB lanes from high load hit. The upper cross bracing at the South Columns has rusted through and several other cross braces have rust holes with section loss. Bucket truck inspection w/ E. Portland crew on 10/2010. 20' 8 inches from EB fog line, 20' 7 inches from WB fog line (7/12). Use ladder to inspect during routine.

High load impact in WB lanes. Distorted lower chord by up to 2 inches. Cross bracing has been repaired. High hit in EB lanes, no damage to the lower chord but angle damaged and cracked.
